# An Experimental Investigation of the Failure of a Stepped Composite Plate

Thesis by  
Steven C. Gortsema

In Partial Fulfillment of the Requirements for the Degree of  
Aeronautical Engineer

## Abstract

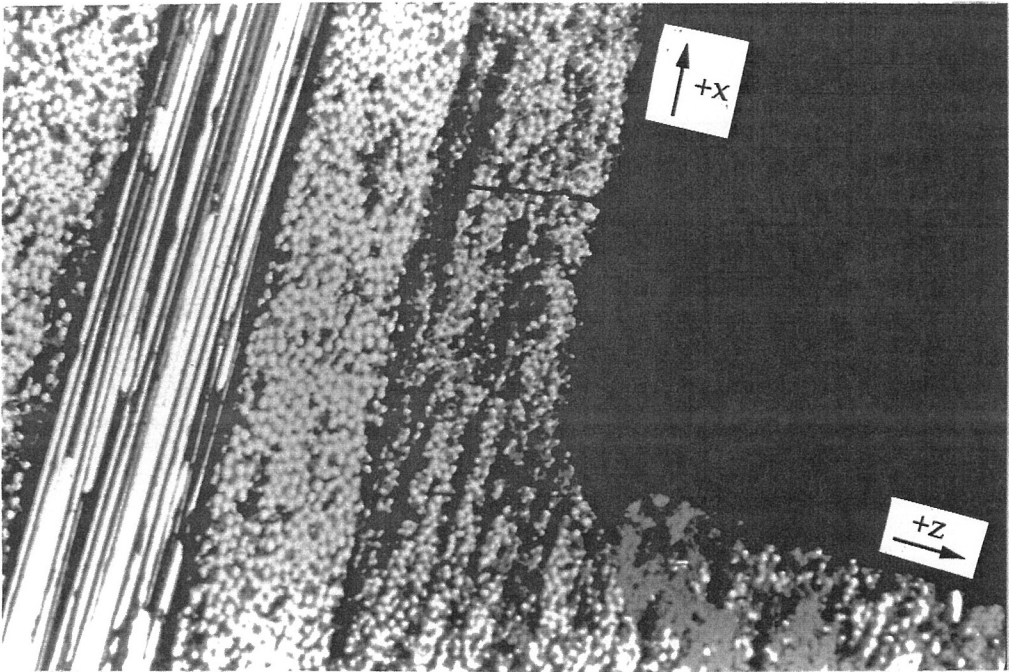
1. ( $M \approx 39\%$  of  $M_{fp}$ ) The  $90^\circ$  ply (plate interface ply) cracks near the step, usually at values of  $x$  between 1 and  $1\frac{1}{2}t$ , where  $t$  is the ply thickness (Figure 10a).

Figure 10a.<sup>en</sup> First crack to appear on the positive edge.

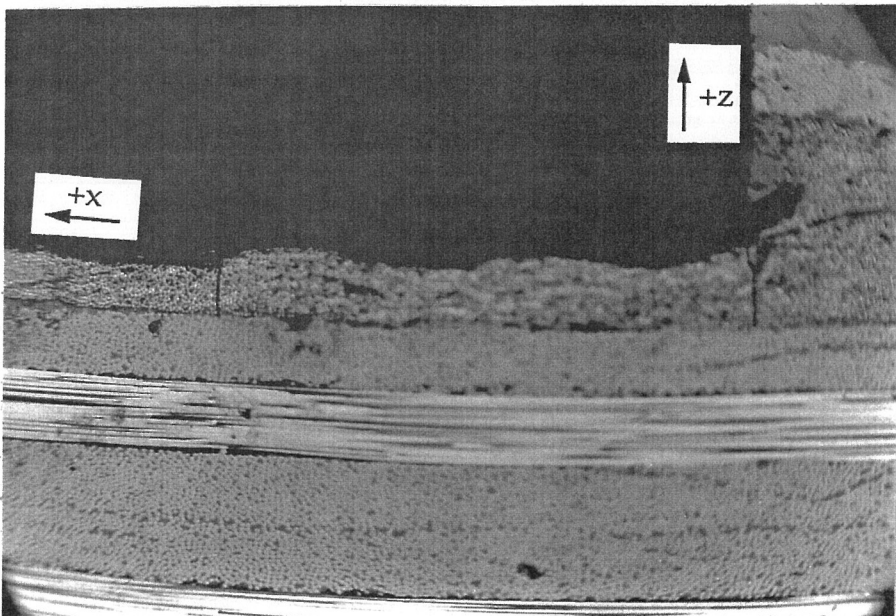
Figure 10b.<sup>en</sup> Additional cracking in the plate interface ply.

2.  $\{M \approx 53\% \text{ of } M_{fp}\}$  More cracking in the  $90^\circ$  ply develops further away from the step at larger values of  $x$  (Figure 10b).

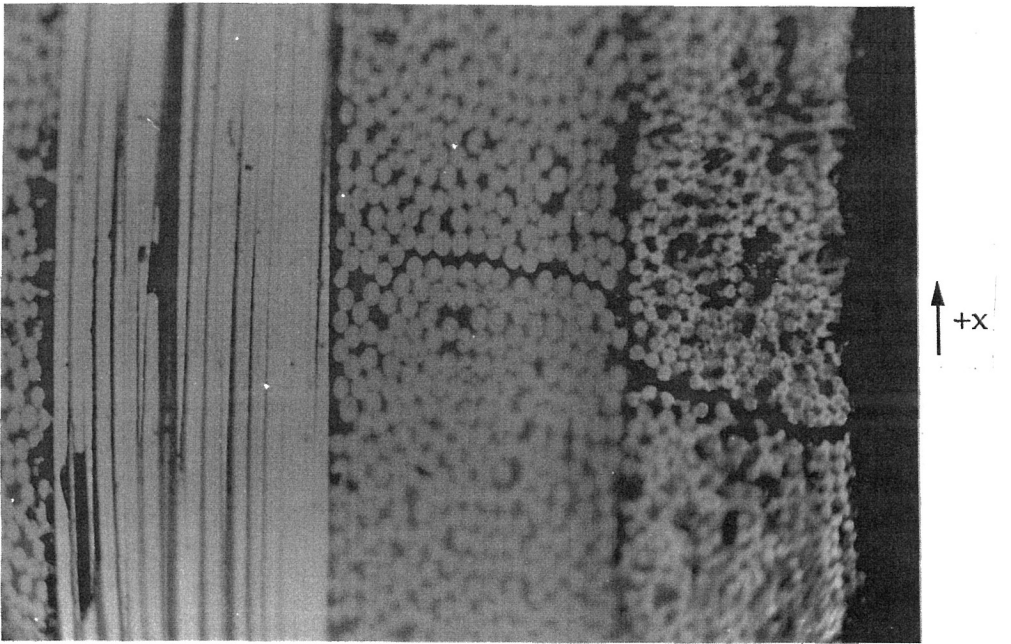
Figure 10c. Crack across the 90° plate interface ply and the 45° ply.

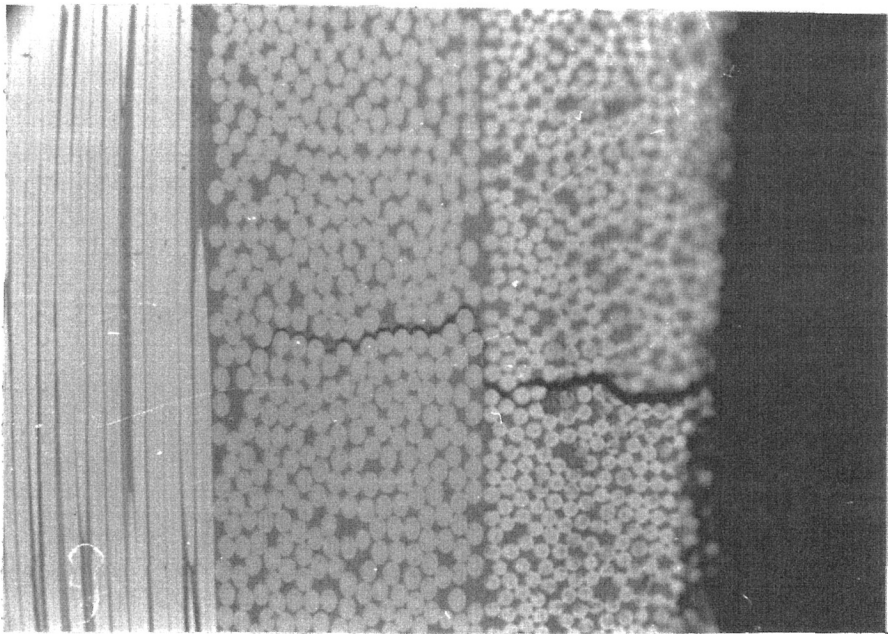
Figure 10d. Crack across the 90° plate interface ply and the 45° ply.

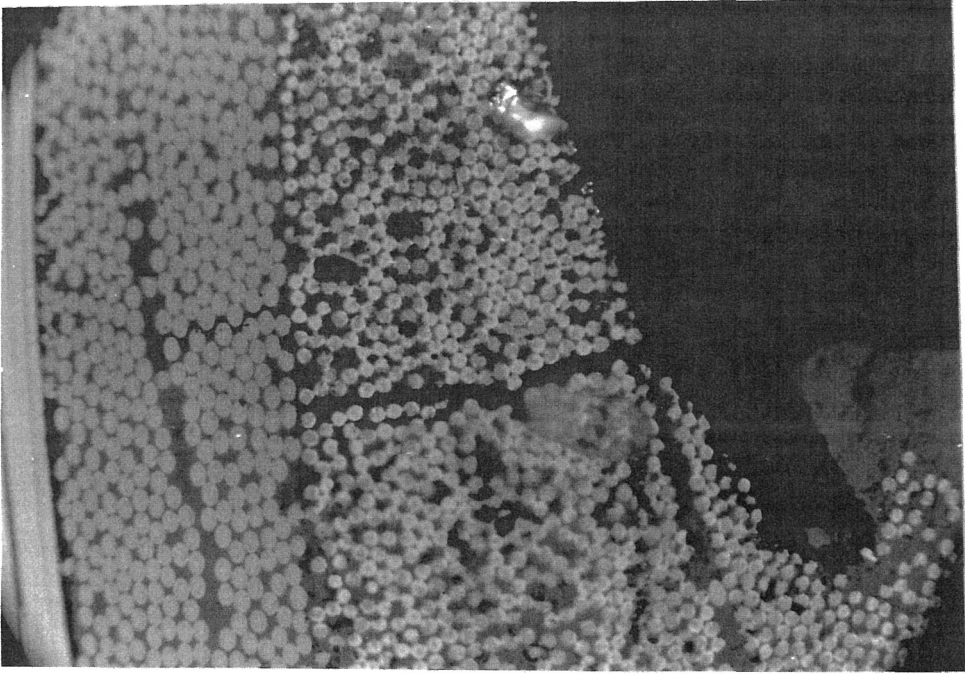
Figure 10e. Extension of the corner crack into the 45° ply.

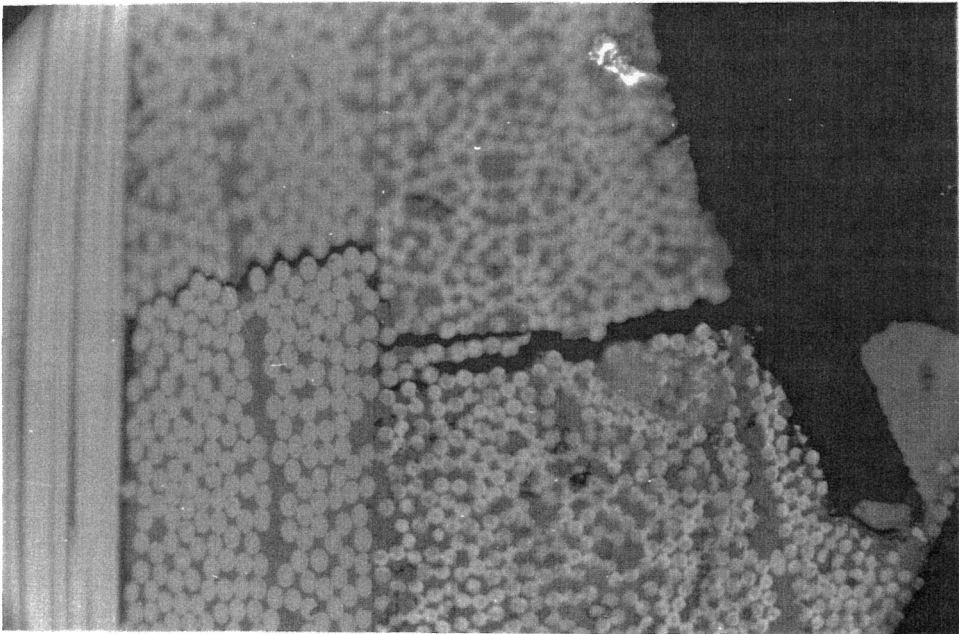
Figure 10f. Extension of the corner crack across the 45° ply.

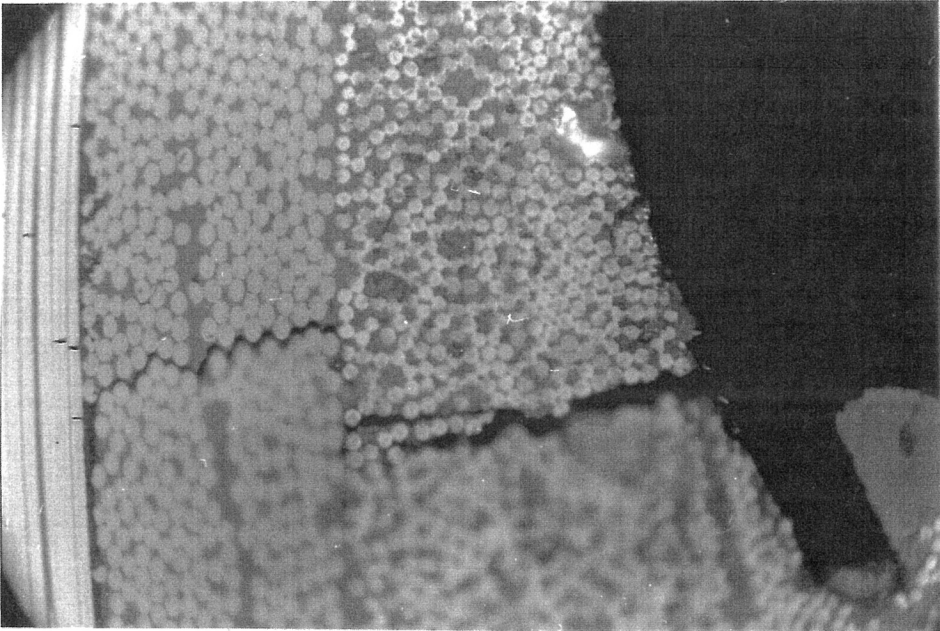
Figure 10g.<sup>en</sup> 0° fiber fractures and increased "mode III" displacement.

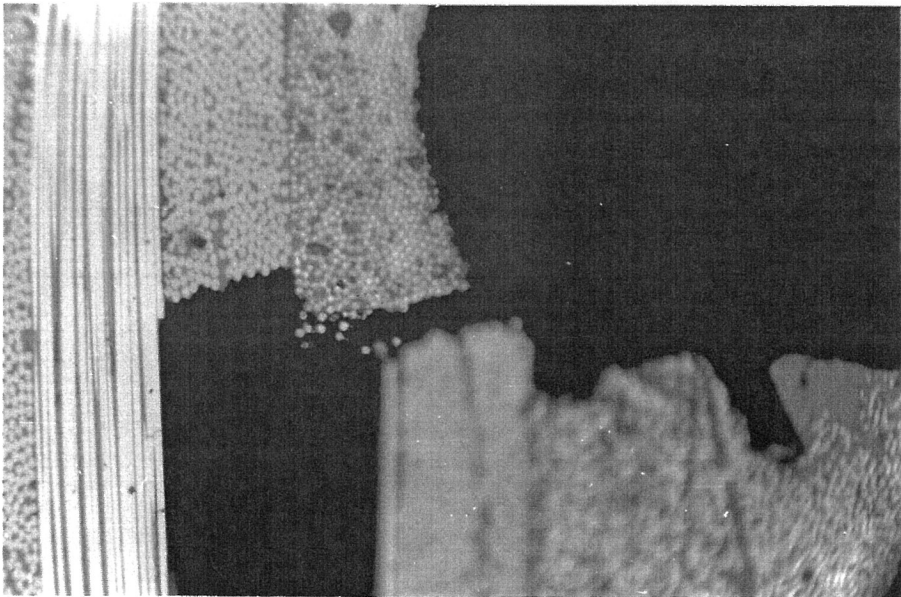
Figure 10h. Failed specimen.

7. ( $M = M_{fp}$ ) As the load increases further, the corner crack turns and propagates along the 45/0 interface into the thicker portion of the specimen, leading to catastrophic failure. As this delamination crack propagates down the interface in the  $-x$  direction, it usually moves over into the  $0^\circ$  ply and peels that ply apart as it continues propagating toward the end of the specimen (Figure 10h).

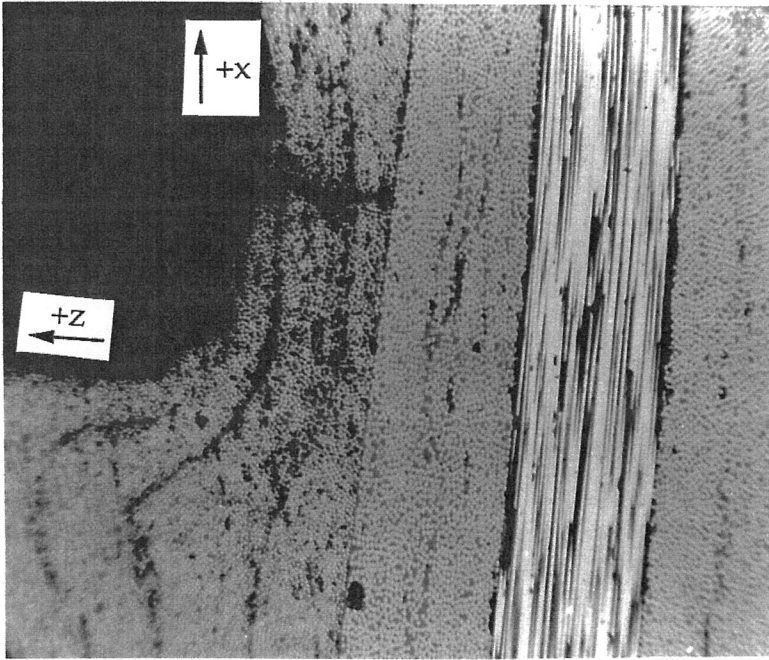
1.  $\{M \approx 41\%$  of  $M_{fn}$ , where  $M_{fn}$  is the moment loading at ultimate failure for this specimen} The first damage seen on the negative edge is also the cracking of the  $90^\circ$  ply near the step (Figure 12a).<sup>††</sup> This crack, and the others which later develop in the  $90^\circ$  ply, cross the entire width of the specimen.\*

Figure 12a. First crack to appear on the negative edge.

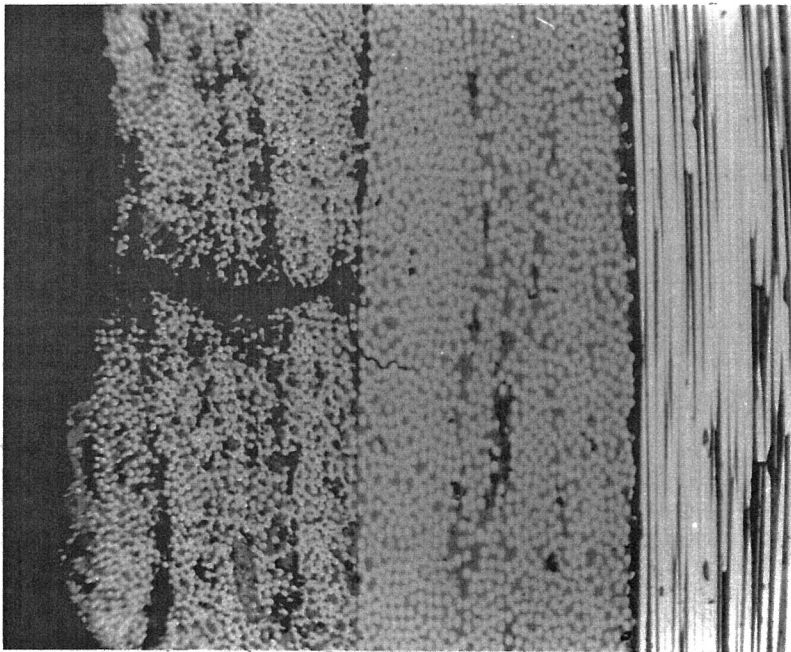
Figure 12b.<sup>en</sup> Cracking in the 45° ply.

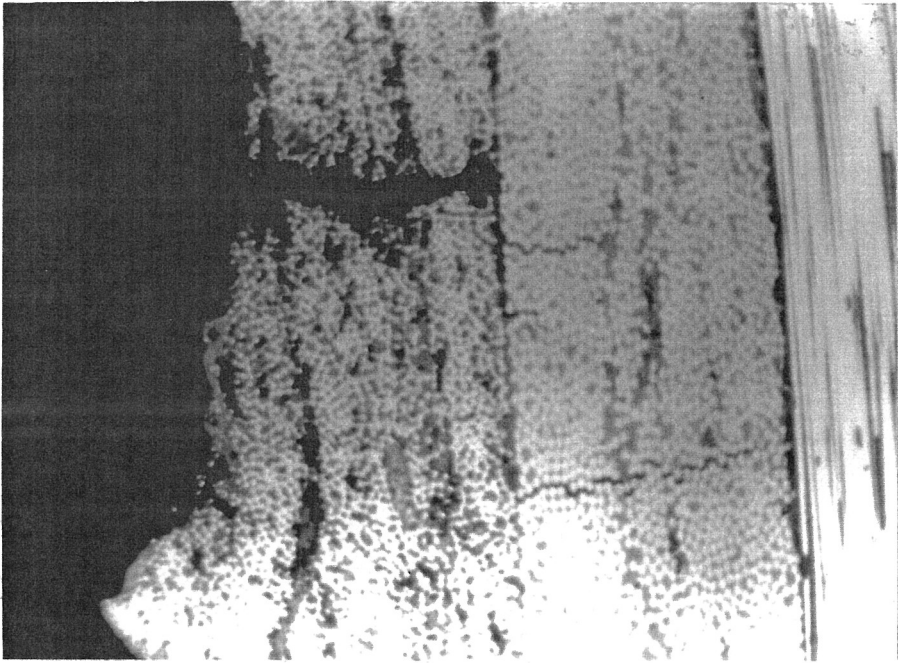
Figure 12c. The early stages of delamination propagation.

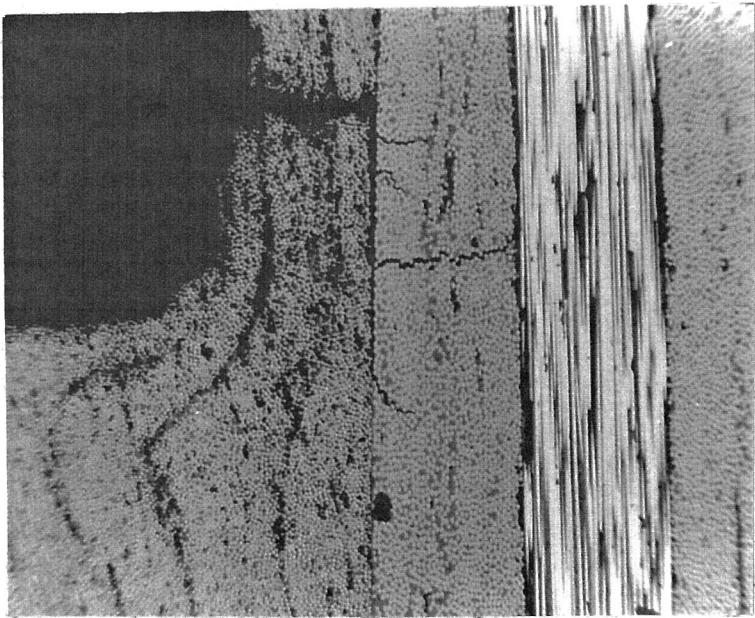
Figure 12d.<sup>en</sup> Continued delamination propagation.

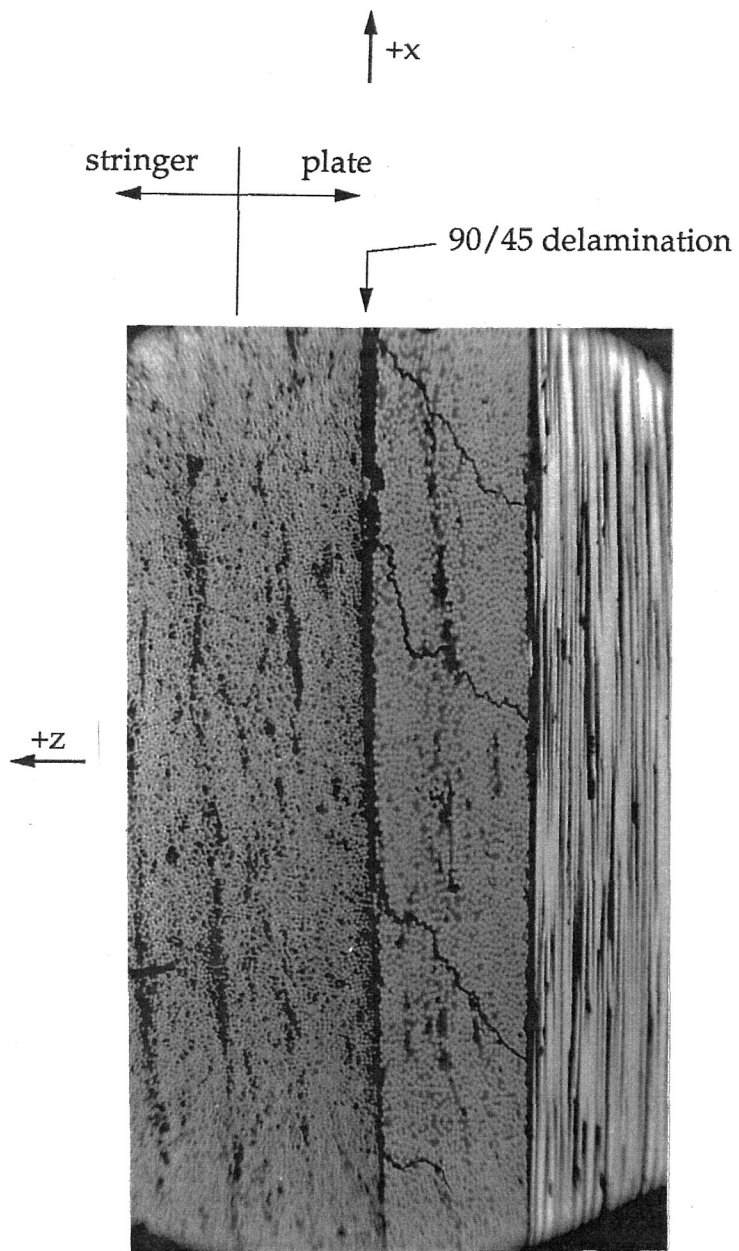
Figure 12e.<sup>en</sup> Continued delamination propagation.

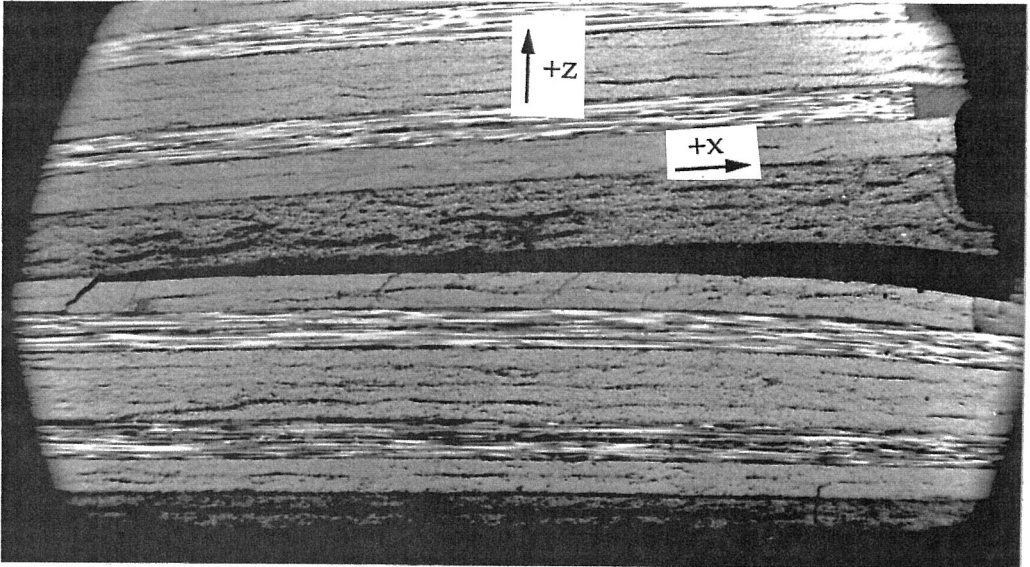
5.  $\{M = M_{fn}\}$  Finally, after crossing the  $45^\circ$  ply, the crack with the most negative value of  $x$  turns and propagates along the  $45/0$  interface. As seen on the positive edge, the area where the crack starts to propagate on this interface usually contains several broken  $0^\circ$  fibers. At this point the crack propagation is usually unstable and leads to catastrophic failure. Again, as noted in the observations on the positive edge, this crack often moves from the interface to within the  $0^\circ$  ply as it runs toward the end of the specimen (Figures 12f and 12g).

Figure 12f. Failed specimen.

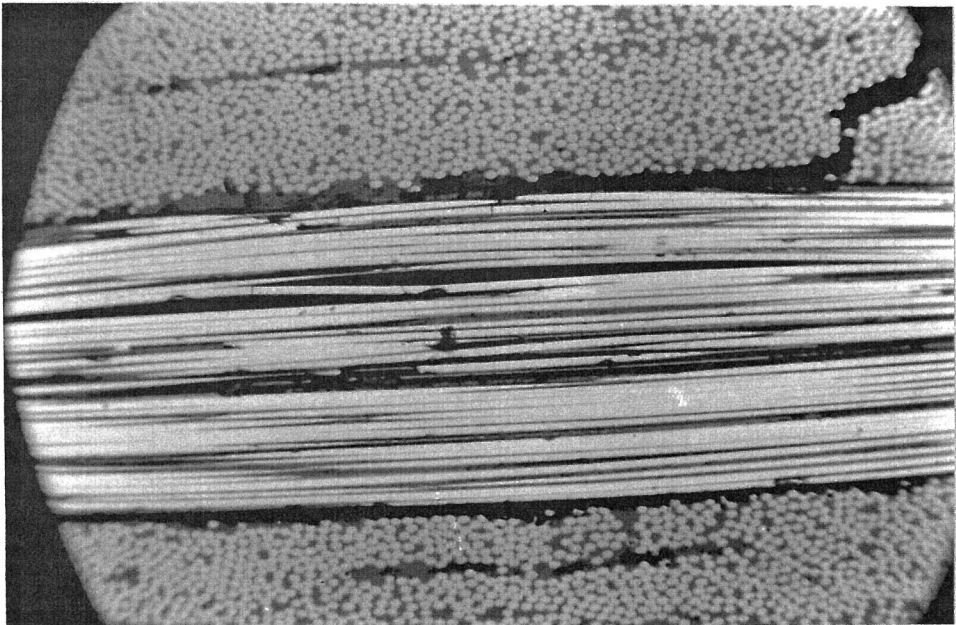
Figure 12g. Close-up of the region near the left of Figure 12f, where 45/0 delamination began.

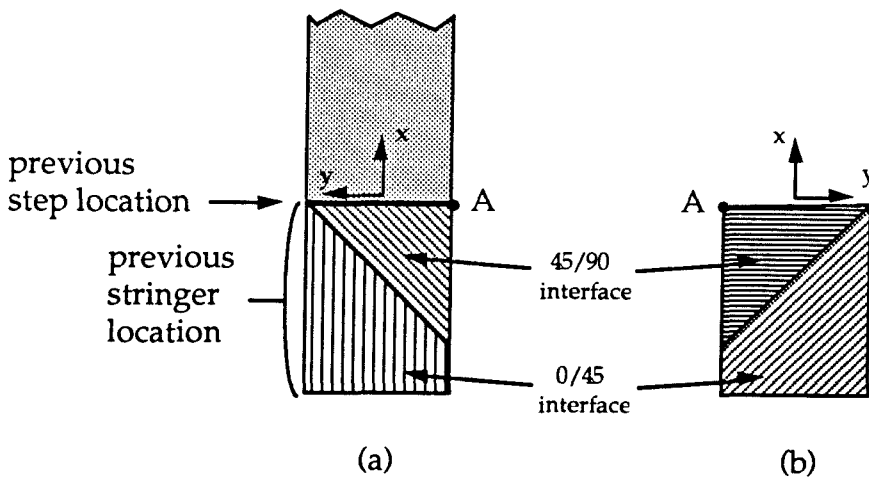
The details of the 45/0 delamination are most easily recognized by analyzing the fracture surface. In all of the case 1 and 4 specimens, the fracture surface can be represented by Figure 24.

Figure 24. Fracture surface of case 1 and 4 specimens. (a) Plate side of the fracture surface. (b) Stringer side of the fracture surface.

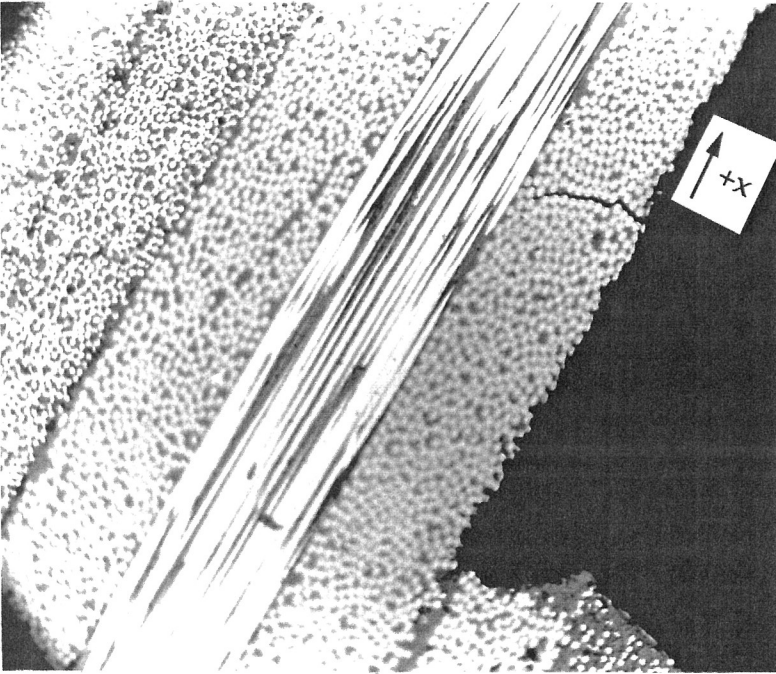
Figure 28a. First crack to appear on the positive edge.

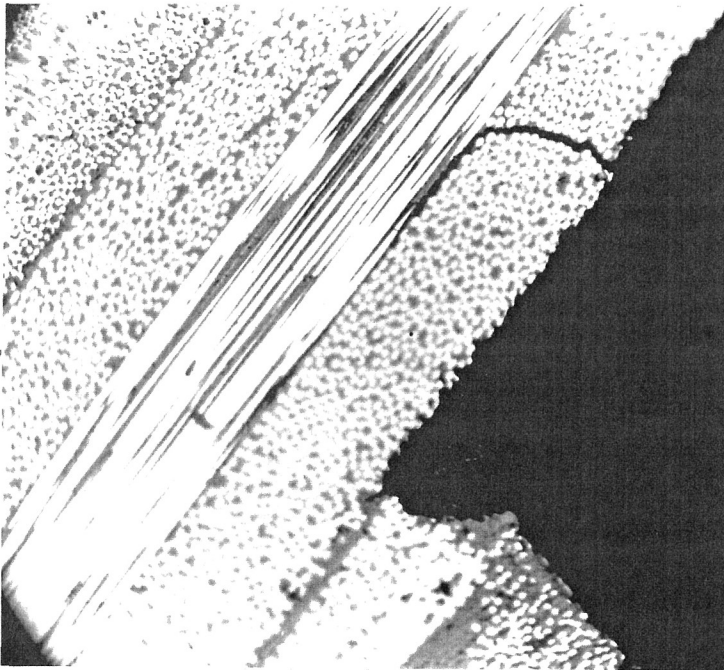
At approximately the same load,  $0^\circ$  fiber fractures are often observed ahead of the  $45^\circ$  ply crack nearest the corner (shown by "2B" in Figure 27). In some cases this crack even turns and begins to propagate stably in the  $-x$  direction along the  $45/0$  interface (Figure 28b).

Figure 28b. Stable propagation along the 45/0 interface.

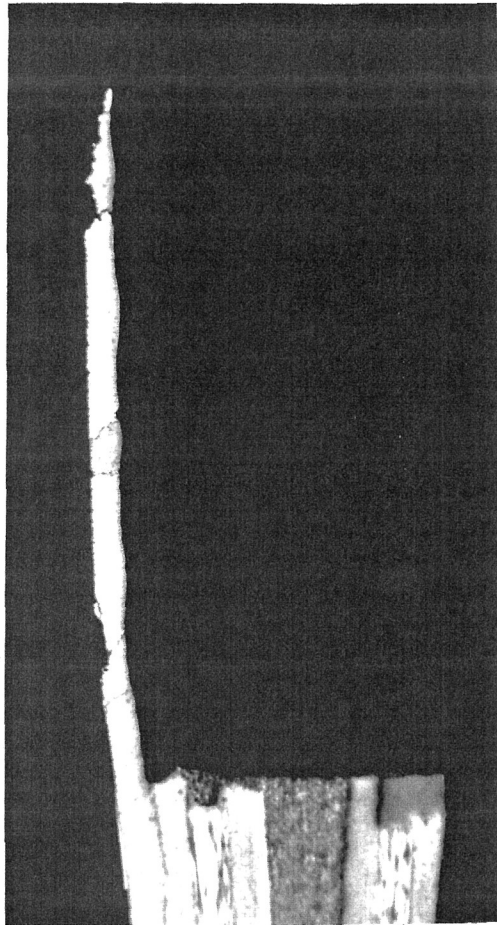
Figure 28c. Failed specimen.

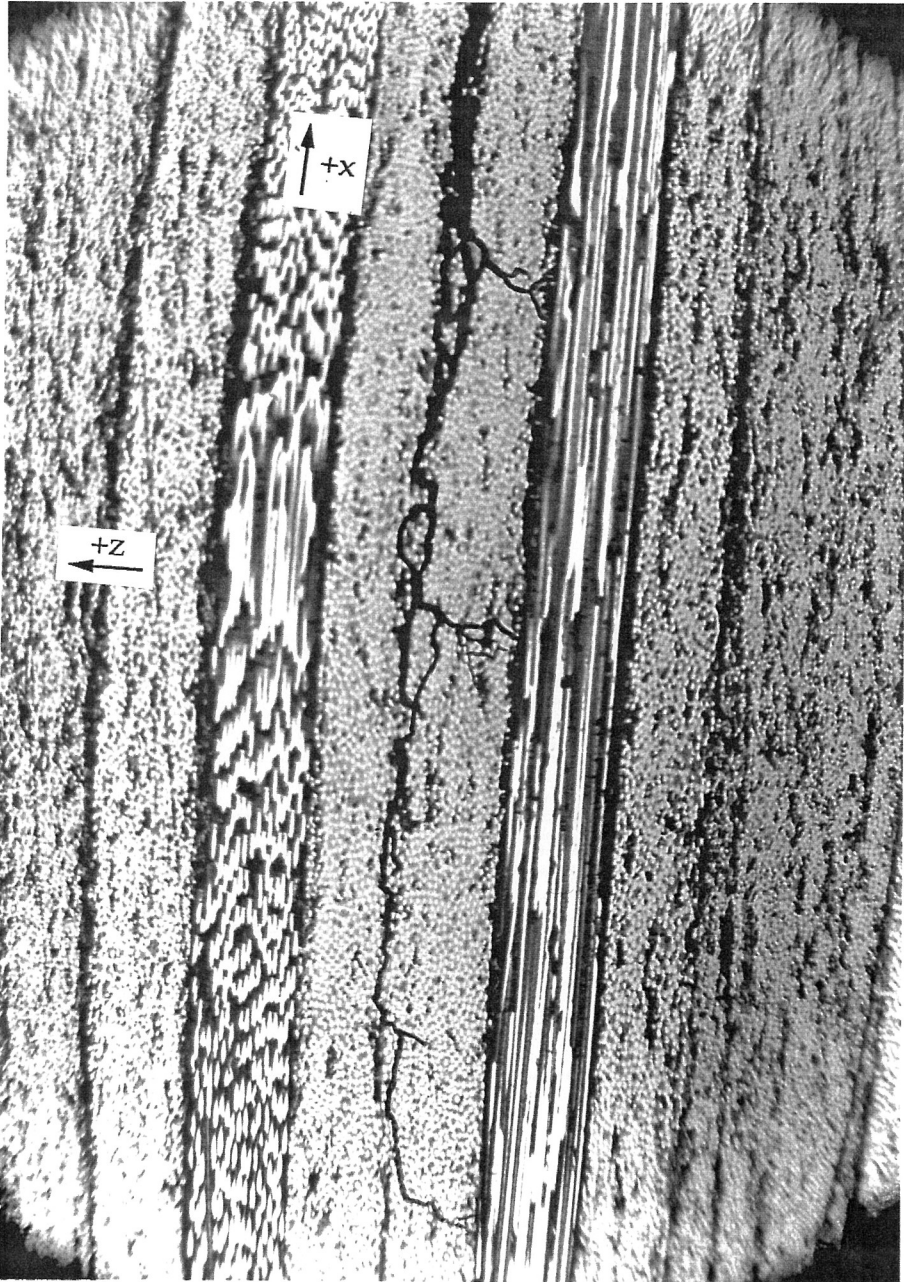
Figure 30.<sup>en</sup> Delamination propagation on the negative edge.

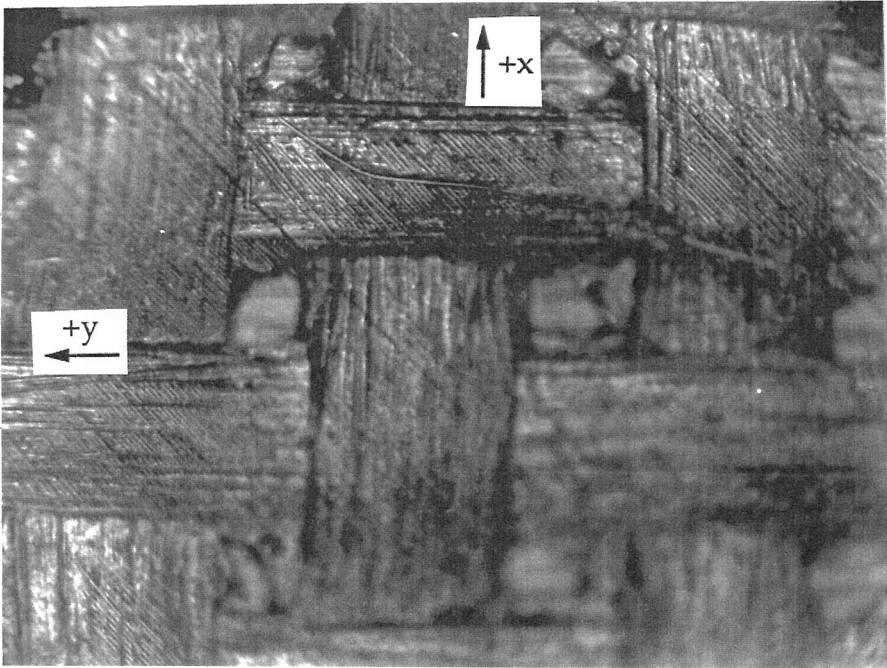
Figure 31. 45° crack on the plate face.
