*Appendix E***PRELIMINARY HIGH CONTRAST GRATING FABRICATION**

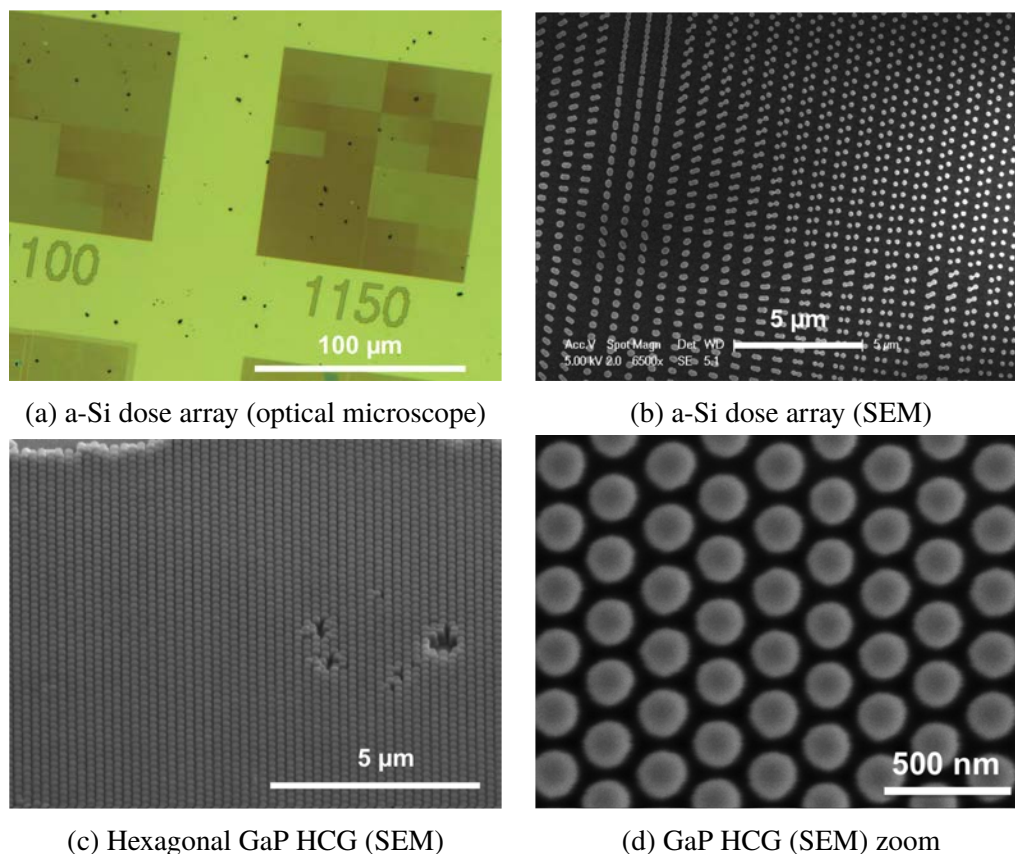
A couple of a-Si gratings and a single GaP dose array were prepared. The a-Si gratings were all patterned by ebeam lithography without an aluminum charge dissipation layer. This caused charge build-up during exposure which led to beam deflection during the pattern writing. The results of this are shown in Figures E.1a and E.1a. The optical image shows a patchwork of domains. Zooming in closer by SEM shows that what should be a hexagonal grating has many distortions including nearest neighbor grating elements subsumed into a single grating element in the bottom left to dimer patterns elsewhere. In contrast, the bottom two images of Figure E.1 shows a uniform hexagonal GaP grating. For the latter sample, a 5 nm Al layer was thermally evaporated on top of the resist to dissipate the charge. (The Al was thermally deposited to avoid exposing the ma-N resist which is also a UV-curable resist with the stray radiation an ebeam evaporation step would produce.) This prevented the beam deflection and resulted in a significantly more accurate ebeam lithography writing step.

Figure E.1: (top) Pattern drift in what should be a hexagonal grating due to charge build-up during ebeam lithography of a-Si film on quartz; (bottom) GaP grating patterned through 5 nm Al without pattern drift.

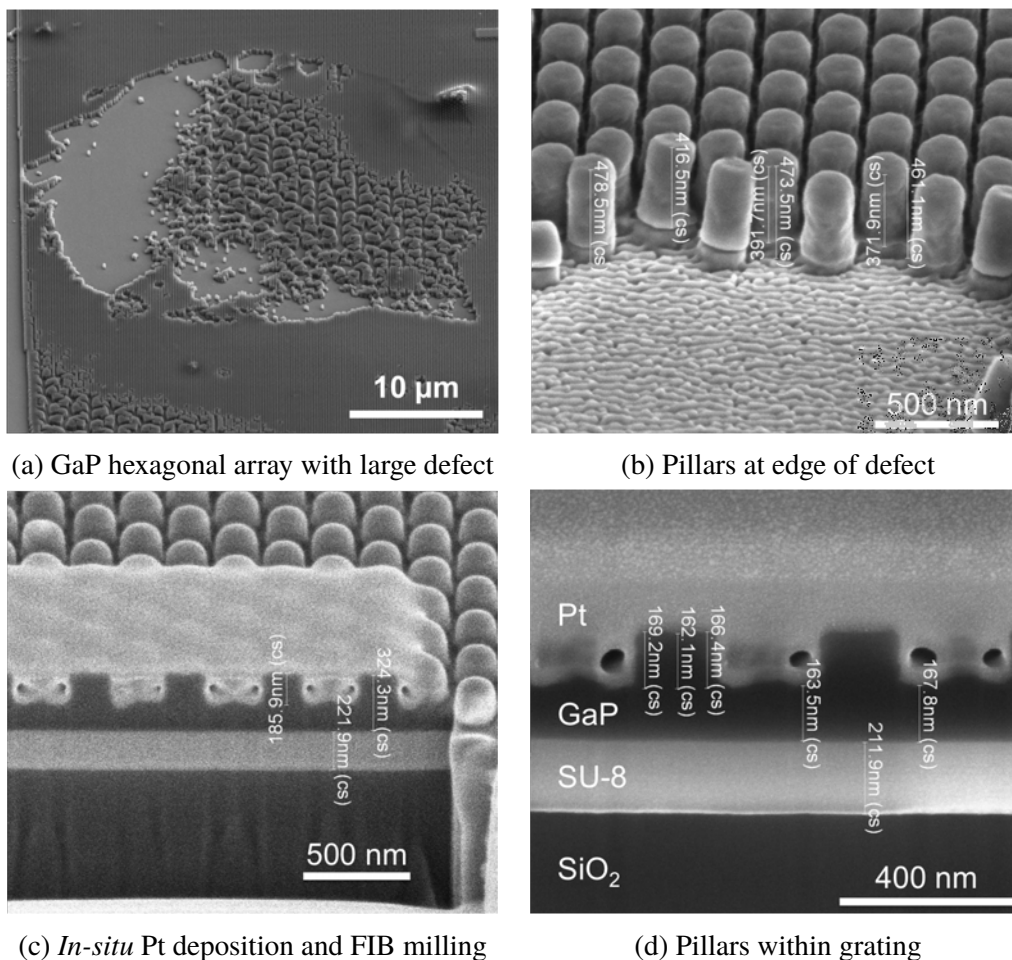
Two sets of SEM images were taken to assess the GaP RIE etch. The recipe was recommended for etching n-type 100 GaP, but the film I used was an intrinsic 112 layer. A dose array was made, and one patch (15 nA beam, 1250 $\mu\text{C}/\text{cm}^2$ dose) was imaged in depth. As shown in Figure E.2a, a large defect was present in one of the dose array segments. Pillars at the edge of this defect were measured (Figure E.2b). Additionally, an *in-situ* Pt deposition and FIB cross-section milling were done at the center of the grating. In both regions, the etch seems to have resulted in pillars with fairly straight side walls. At the defect edge, the etch seems to have got fully through the GaP layer and into the SU-8 as seen in the ridge toward the bottom of

the pillars in Figure E.2b. In contrast, in the more central portion of the grating, the GaP film seems to be etched only part of the way through and the total thickness seems to be less than at the defect edge.

There are many possible regions for the mismatch between the etch results at the defect edge and in the middle of the grating. It is possible the GaP film itself had thickness variations. However, such a ~100 nm variation in a 400 nm films within 100 μm seems unlikely given that the 1 cm by 1 cm film visually appears quite uniform. It is also possible that the ma-N resist thickness varied. The sample geometry was not optimal for uniform spin coating. The SiO₂ substrate 2.5 cm by 2.5 cm with the 1 cm by 1 cm GaP film transferred onto it. This was then cross-sectioned, and the smaller of the two resulting pieces was used for the dose array. The SiO₂ substrate was rectangular, and the GaP film was not centered on the substrate. In addition, there was a ring of SU-8 around the edge of the film. In fact, I attempted to measure the thickness of the GaP layer by profilometry. However,

Figure E.2: While the GaP at the edge of the defect (a) appears to be etched fully through the GaP layer (b), the GaP away from the defect in the bulk of the layer appears only partially etched.

during the wafer bonding process, excess SU-8 from between the GaP, and the SiO₂ substrate leaked out forming a ring around the GaP which was 1-2 orders of magnitude taller than the GaP layer. All of this lends itself to uneven spin-coating of the resist on the sample. Thus in the bulk region if the ma-N thickness was lower, it is possible that the resist was etched through faster, removing material from the top of the pillars during the etch and accounting for the smaller overall thickness. Given the dense packing of the grating elements, it is possible that there was more restricted gas flow during the etch in bulk regions of the grating rather than near the defect edge, giving a high etch rate at the defect edge. These accumulated uncertainties underscore the need for characterization between each processing step to identify the source of such issues. Thus attempts to measure the GaP thickness by profilometry led to the stylus moving the whole sample rather than moving across

Future work in fabricating high-contrast gratings requires optimization of film cleaning, uniformity of the spun-coat resist layer, and optimization of the etch conditions.

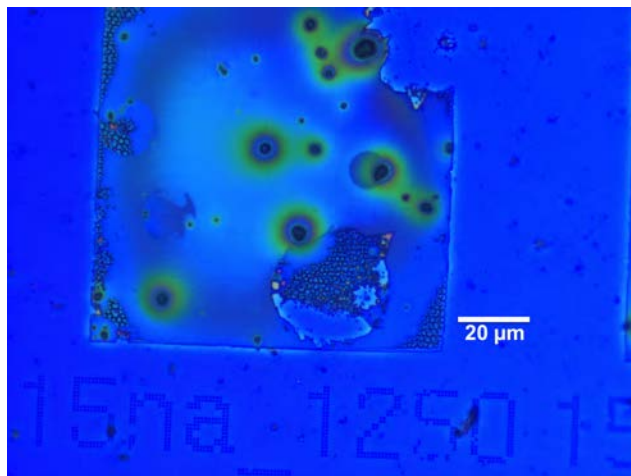
Figure E.3: Optical microscope image of one pattern in GaP dose array showing many defects in the array as well as many particles or dust specs around the grating.

Another remaining concern to be addressed in future HCG fabrication is better cleaning of the semiconductor layer before processing. Figure ?? shows many defects in the grating as well as particles strewn across the surrounding area. Other cleaning options include plasma ashing followed by an oxide etch. If the defects are due to the presence of particles, this will be a problem for large scale uniformity. An additional possible source of defects within the grating is the high dose. The recommended amount for ma-N 2403 is closer to a few hundred $\mu\text{C}/\text{cm}^2$. It is possible that over-exposure caused the resist to bubble, forming some of the defects. Finally, the dust could be embedded in the SU-8 film between the GaP and the SiO_2 substrate.
