Mechanics of Landslides

Thesis by
William M. Cogen

In Partial Fulfillment
of the
Requirements for the Degree of
Doctor of Philosophy

1936

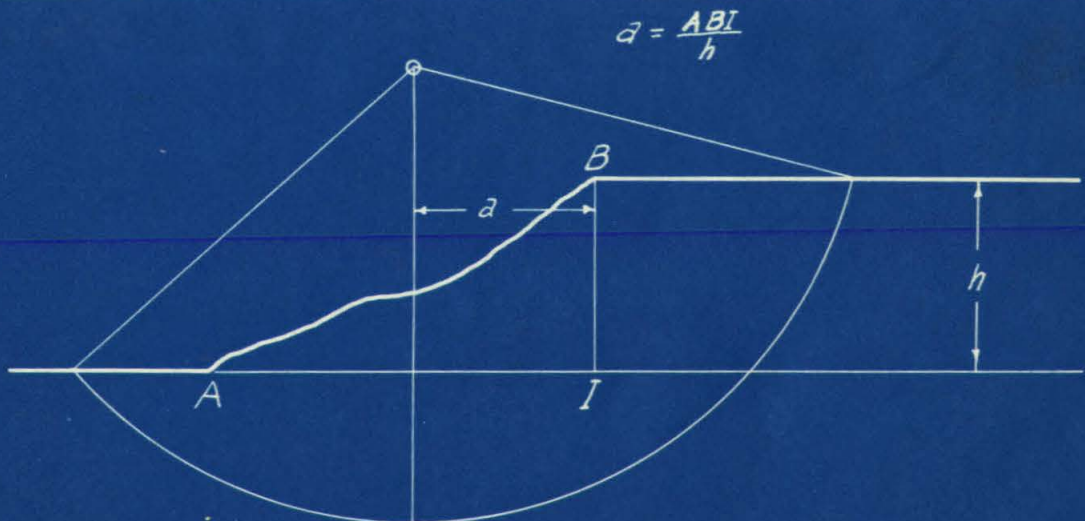
Fig. 5. Illustrating position of line along which center of critical arc falls. Assumption, cohesion only. After Fellenius.

Fellenius also made a critical study of slip-curves which pass beneath the toe of a slope and break out on the lower surface which intersects the slope. He calculated that for ground which possessed only cohesion the center of the most dangerous arc lay on a vertical line removed from the crest of the slope a distance (a), and as the proportion of friction relative to cohesion increased the center of the most dangerous curve moved outward and downward from a point on this line. Figs 5, 6.

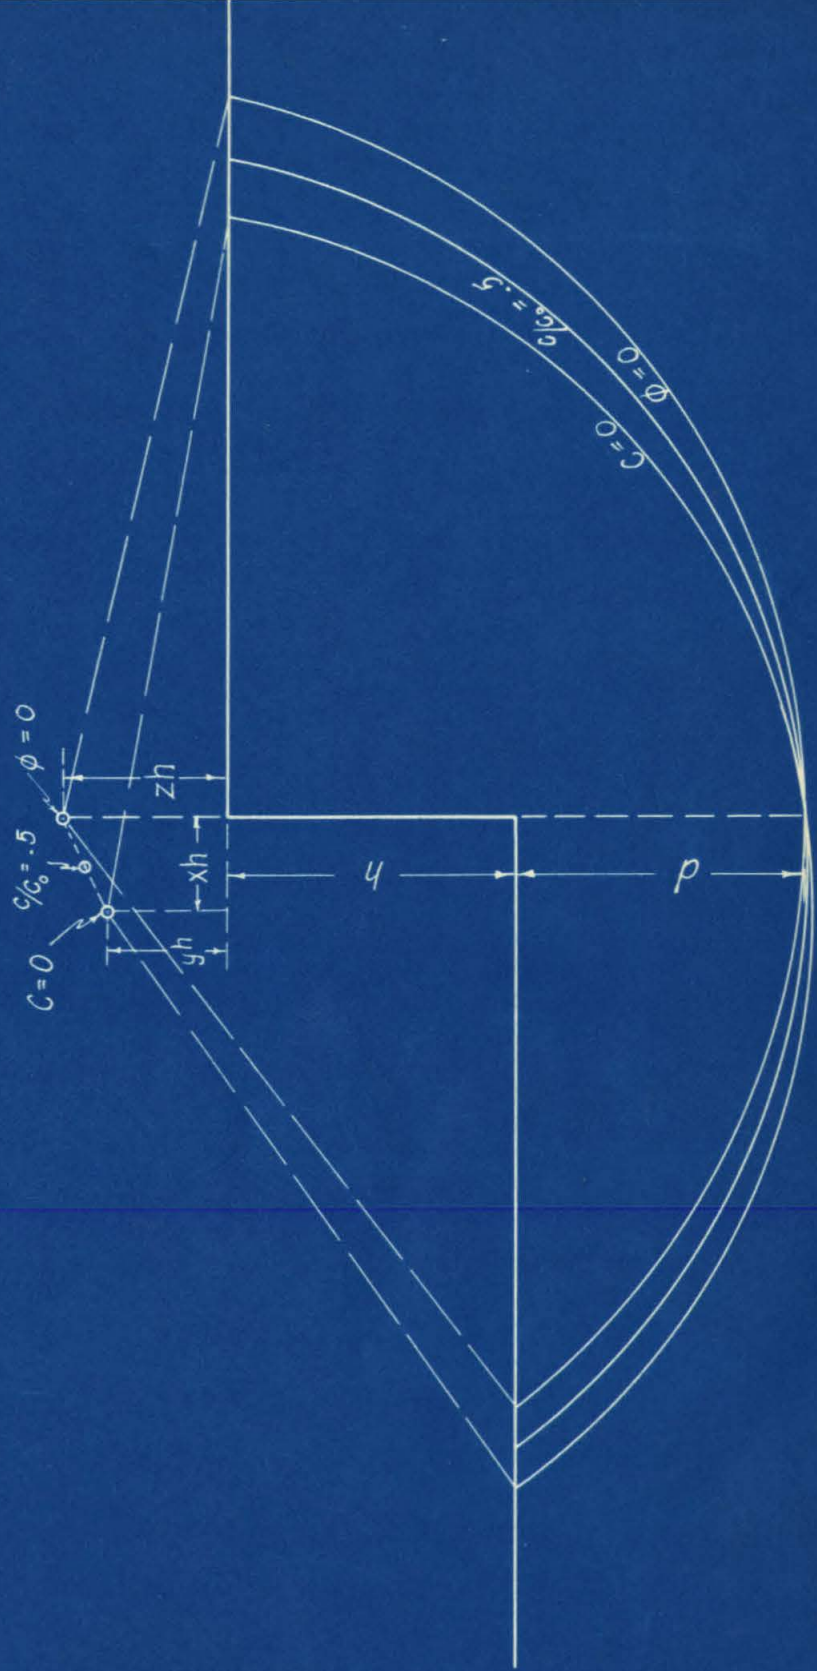
Fig. 6. Illustrating shift of critical slip-surfaces with changes in the relative value of cohesion; one point on the slip-surface is fixed. After Fellenius.

(We have found that for ideal cohesive ground devoid of friction the most dangerous slip-surface lies theoretically at an infinite depth. However the requisite cohesion for equilibrium along a surface lying at shallow depth beneath the foot of the slope is only slightly less than the cohesion required along the infinitely deep lying surface.

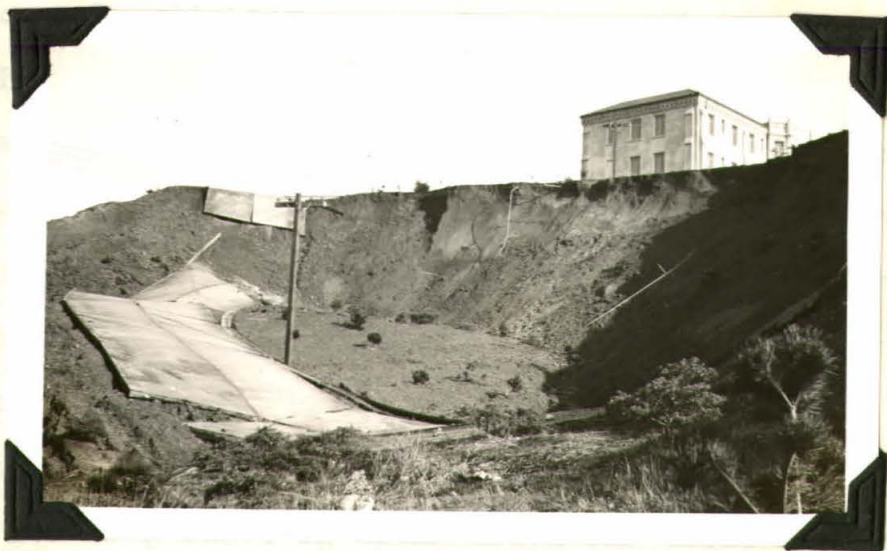
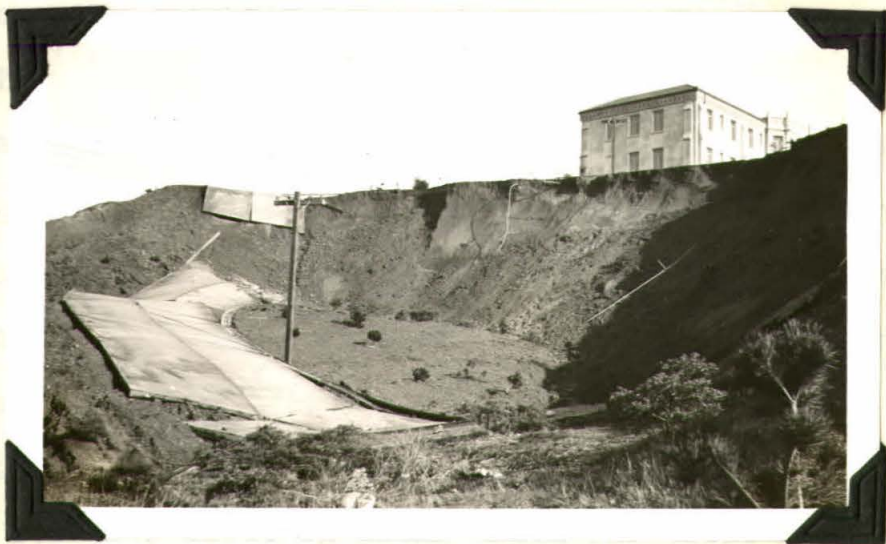
Fig. 11. Escarpment formed by landslide at its upper edge. Parker Avenue slide.

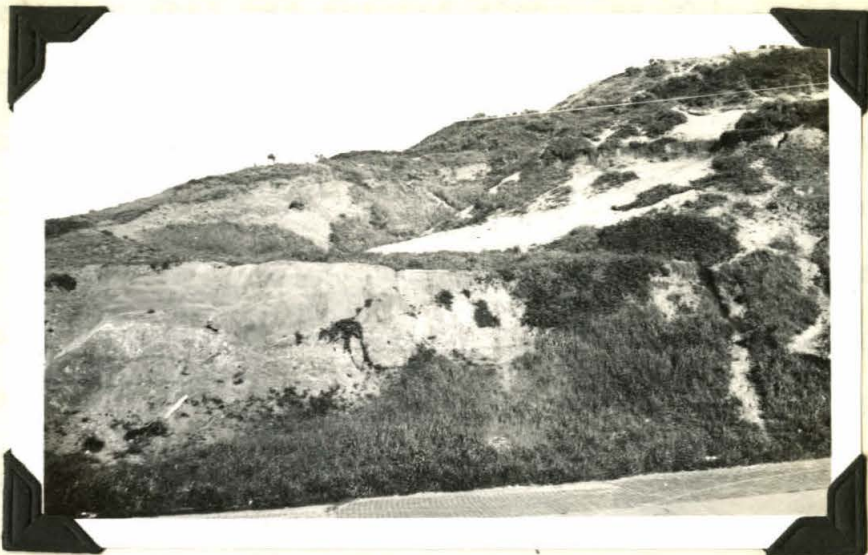
Fig. 10. Cut-crop along Parker Avenue showing contact between sandstone and greenstone. at the base of the hill. The sandstone is light in color and the greenstone is dark in color. The contact is a sharp, wavy line.

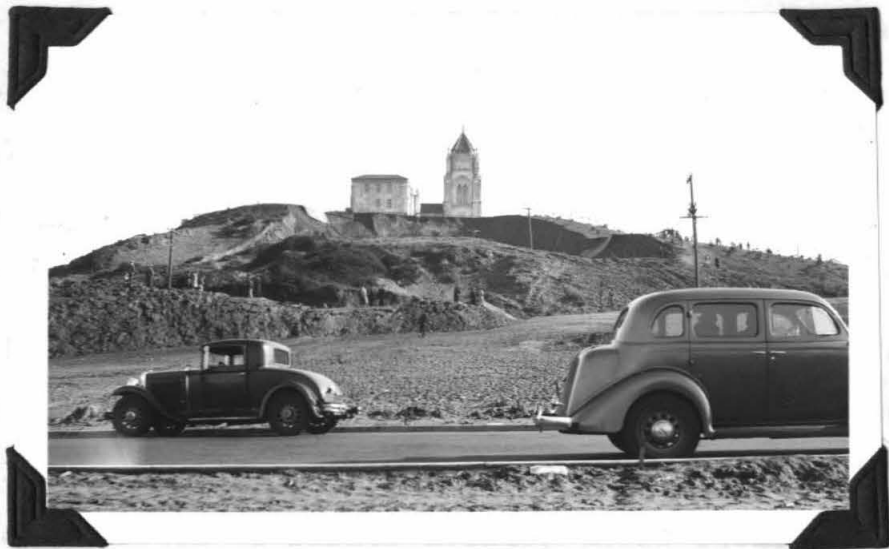
Fig. 12. View of Parker Avenue landslide looking eastward.

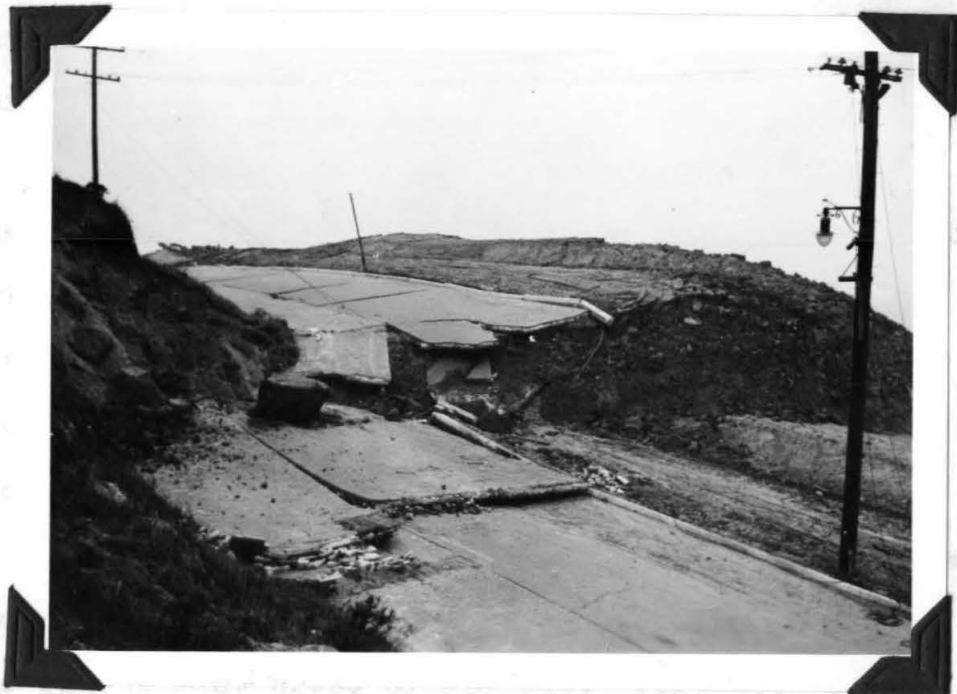
Fig. 13. Offset in pavement of Parker Avenue along northern edge of landslide.

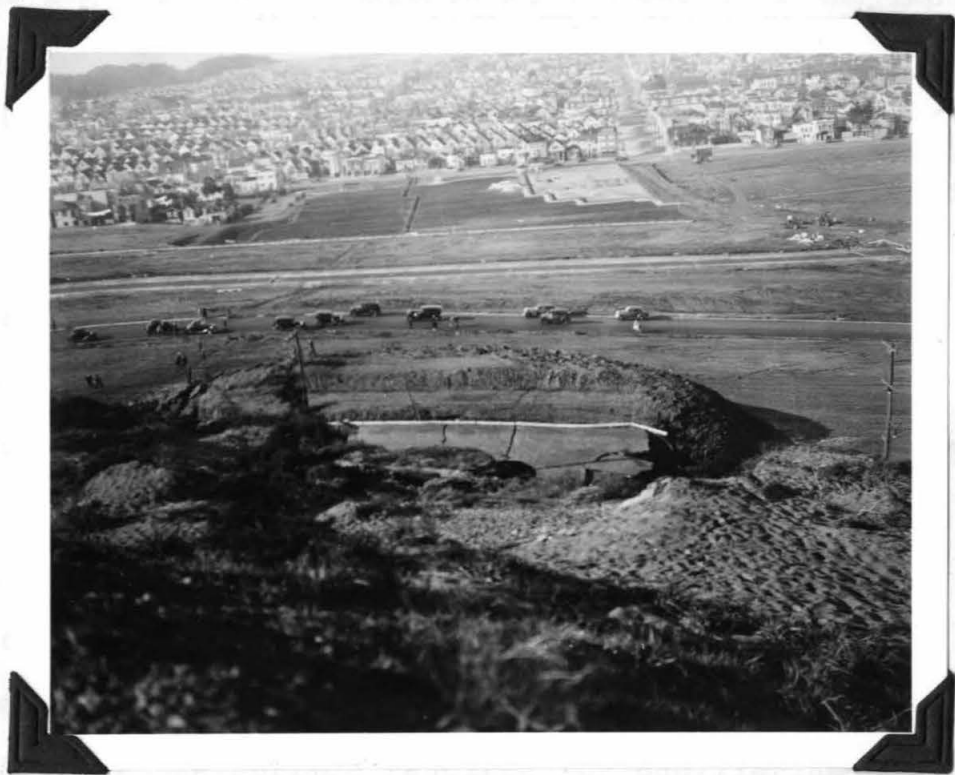
Fig. 14. Upthrust mound at the foot of Parker Avenue landslide. View looking westward.

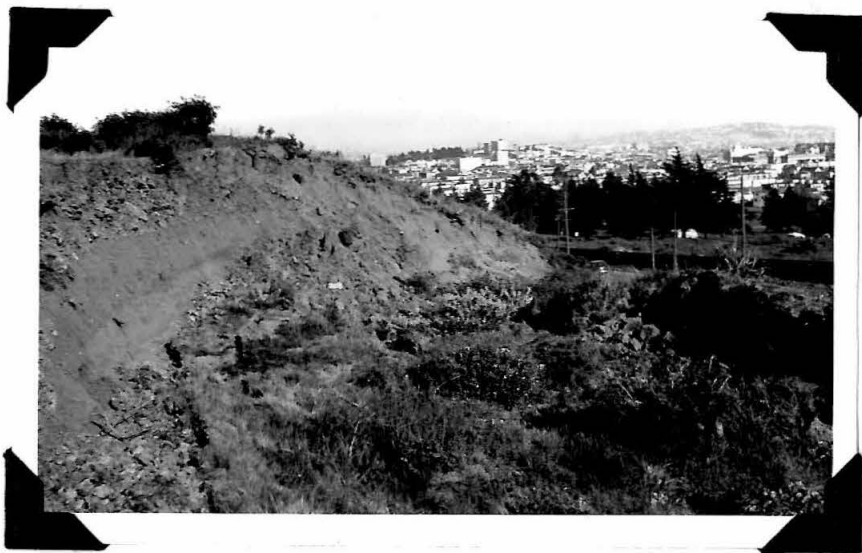
Fig. 29. Escarpment along upper edge of landslide B.

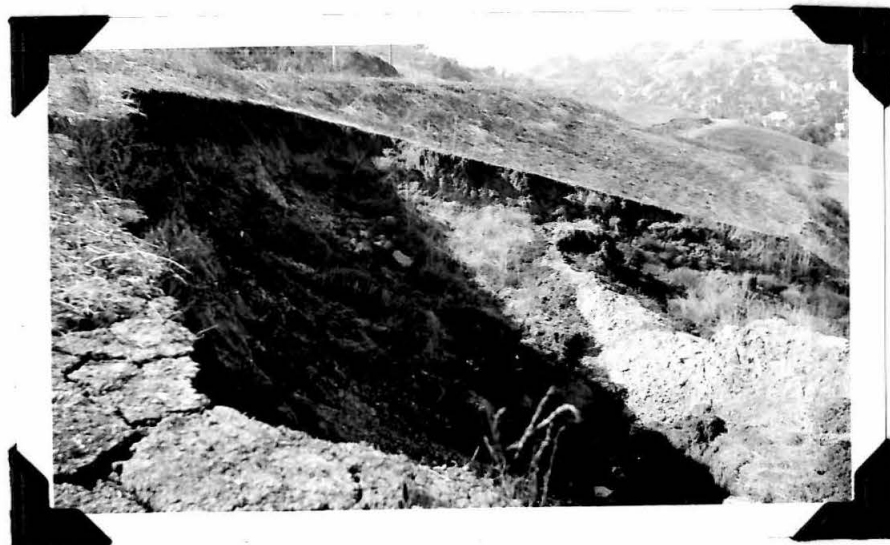
Fig. 35. Upper edge of Huntington landslide.

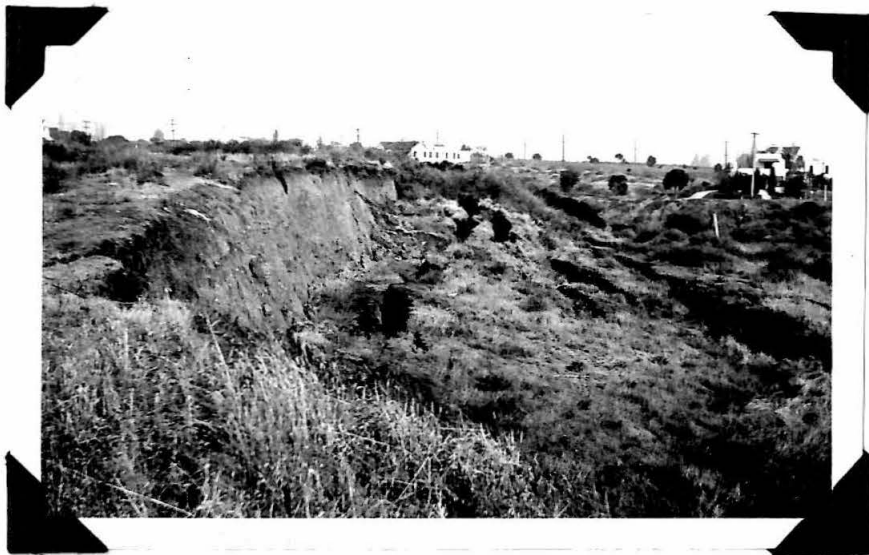
Fig. 38. Uper edge of Potrero slide showing open cracks. View looking northward.

brink. Immediately after the great rain storm of December 31, 1933 a downward displacement of several inches was observed to have occurred along this crack. From that date on movements continued to occur, usually following heavy rain storms. The recently measured vertical displacement of eighteen feet at the upper break of the slide represents the accumulated dislocations for a period of two and one-half years.
