A STUDY OF
SINGLE AND POLYCRYSTALLINE INGOT IRON
UNDER REPEATED STRESS

Thesis by
Frank Ambrose McClintock

California Institute of Technology
Pasadena, California

1949

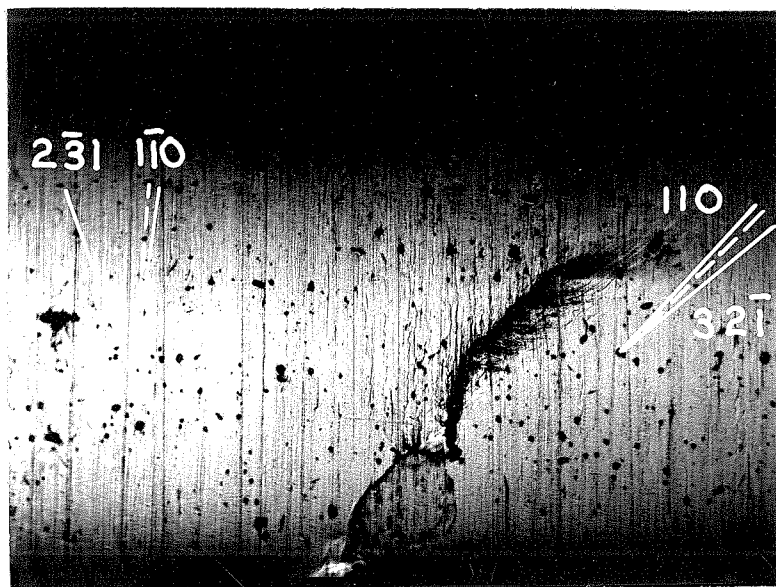
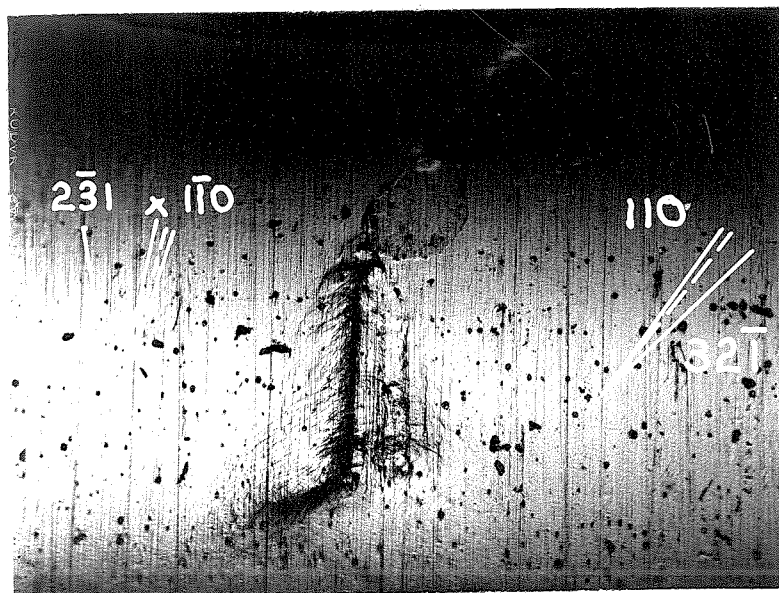
V-16 20,000 psi for 381,000 cycles
 22,100 psi for 89,400 cycles
 $s_3 = -0.043$ in. $\phi = 315\frac{1}{2}^\circ$

V-16 20,000 psi for 381,000 cycles
 22,100 psi for 89,400 cycles
 $s_3 = -0.045$ in. $\phi = 305^\circ$

V-16 20,000 psi for 381,000 cycles
 22,000 psi for 131,900 cycles
 $S_3 = -0.070$ in. $\phi = 317^\circ$

V-16 20,000 psi for 381,000 cycles
 22,000 psi for 131,900 cycles
 $S_3 = -0.050$ in. $\phi = 286^\circ$

Figs. 11 to 14, taken at the same two times as the previous set of figures, show another crack starting from a crystallite. Plastic deformation was rather severe along both ends of the crack. Fig. 3 shows the specimen after failure, which occurred after 34,300 more cycles. The plane seen as a bright surface on the left, and edgewise on the right, was the lower end of the principal crack. A visual check indicated that it contained the $[111]$ direction, whereas the crack shown in Figs. 11 to 14 appeared to contain the $[1\bar{1}1]$ direction. A summary of the rate of crack growth is given in Table 4. From this table it appears that cracks grow at an accelerating rate, and that they grow fastest when the metal is least deformed.

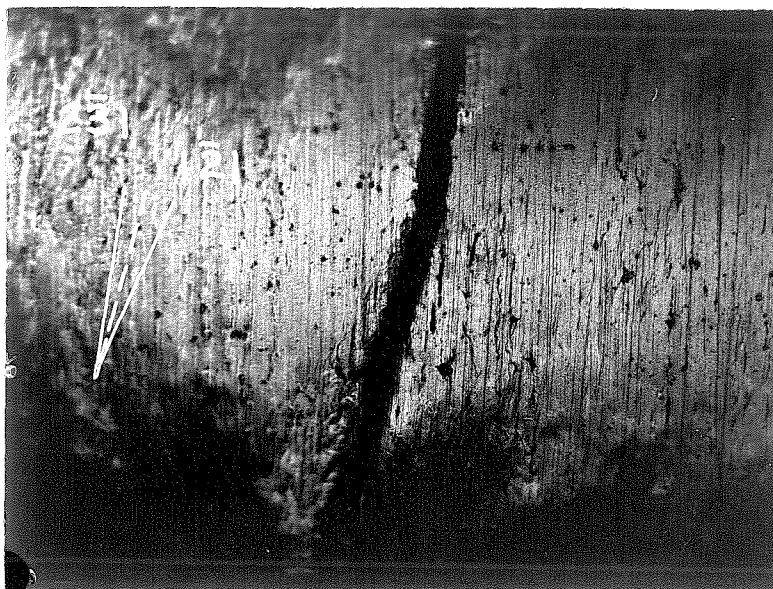
Fig. 15 88X

III-17 19,800 psi for 300,000 cycles
 21,800 psi for 146,700 cycles
 $S_3 = 0.025$ in. $\phi = 114\frac{1}{2}^\circ$

The region shown in Fig. 15 had been examined at 380X before testing and again after 300,000 cycles and showed no change, so this crack must have developed entirely at the higher stress. It extended only one picture-width in either direction from the region shown. The sides were probably spread apart by the severe deformations in the last few cycles before failure. The crack seems to be composed of two straight lines, one of which corresponds

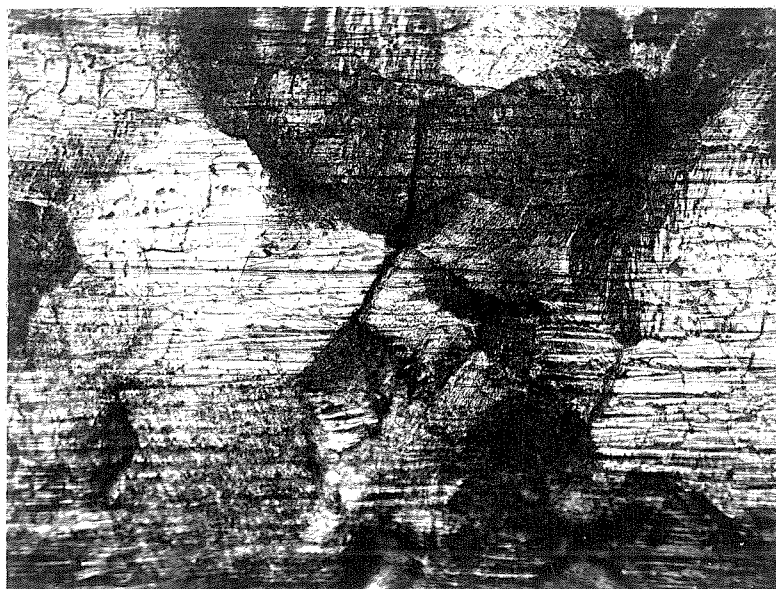
Fig. 22 88X

VIII-3 Annealed at 1700 F 1 hr; cooled at 100 F/hr
 27,000 psi for 60,000 cycles
 $S_3 = -0.05$ in. $\phi = -32^\circ$

Specimen VIII-3 was run for 60,000 cycles and then examined with the microscope. Fig. 22 shows an area containing a crack at 88X. The crack runs diagonally between

two grains and then up into a single grain. Fig. 23 is a photomicrograph at 380X of another point showing in more detail the oxidation taking place on the surface. The author feels that this is really oxidation and not massed slip lines reported by others (8), (9), (10) because of the brown and blue colors observed. So many cracks were seen in this specimen that failure was believed imminent. After another 30,000 cycles, however, the cracks had grown only a limited amount and the specimen was reannealed. It did fail after the next 12,800 cycles.

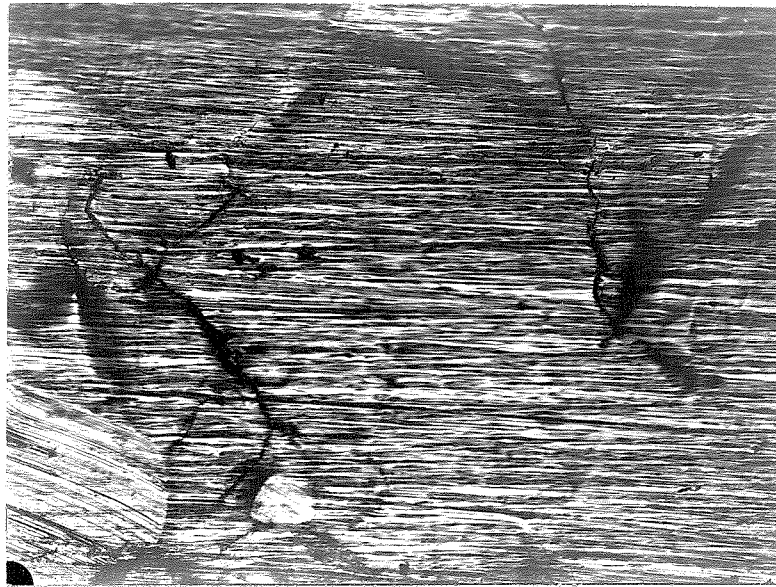
Fig. 24 88X

VI-11 27,000 psi for 60,000 cycles
 $S_3 = 0.08$ in. $\phi = 154^\circ$

Specimen VI-11 was annealed, repolished, and re-run for 60,000 cycles. Fig. 24, taken at the end of this time, shows what appear to be two cracks in the surface. The diagonal markings on the surface in the lower left corner were due to accidentally striking the specimen during examination. The specimen was then annealed, repolished, and run to failure, which occurred after a further 42,400 cycles. The same area is shown in Fig. 25. The cracks had not been visible after repolishing, but it is evident that the left hand crack had only been covered over. Since only 0.0006 in. was removed from the surface in polishing (less than 1/16 in. at the magnification used), the right hand crack, if such it was, must have been quite shallow.

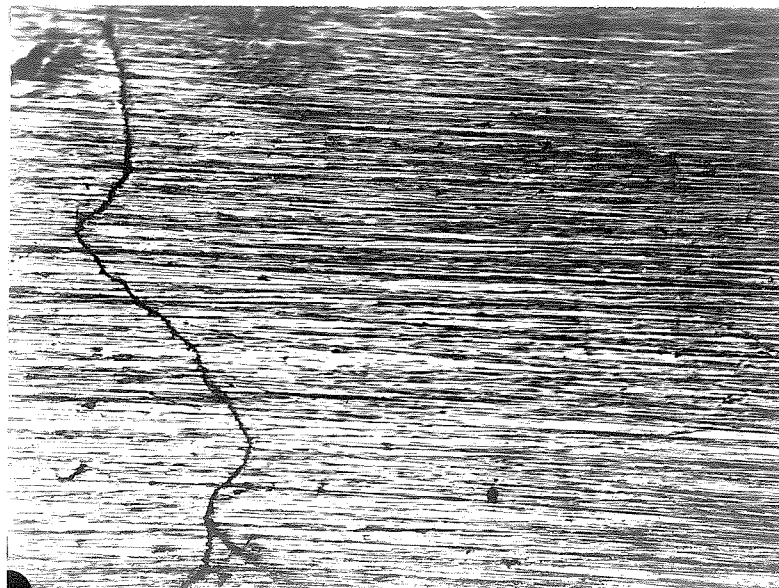
Fig. 25 88X

VI-11 27,000 psi for 102,400 cycles with
 reanneal and repolish
 0.0006 in. removed from surface
 S_3 0.08 in. $\phi = 154^\circ$

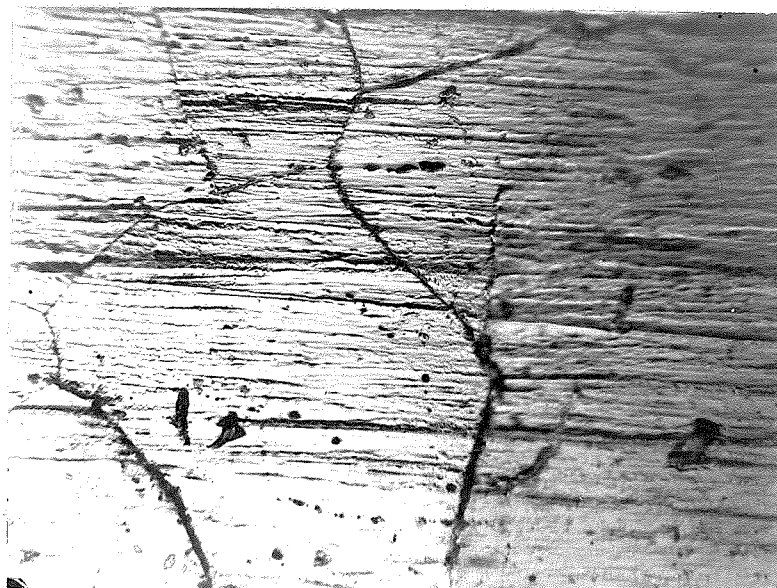
VI-1 27,000 psi for 30,000 cycles
 $S_3 = -0.02$ in. $\phi = -7\frac{1}{2}^\circ$

VI-1 27,000 psi for 30,000 cycles
 Etched 20 sec. in 10% HNO_3 in methanol
 $S_3 = -0.02$ in. $\phi \approx -7\frac{1}{2}^\circ$

Specimen VI-1 was run only 30,000 cycles after the first anneal and repolish. Several cracks were found, two of which are shown in Fig. 26. Fig. 27 shows the same region after etching and indicates that the cracks were certainly associated with grain boundaries, although the left hand crack has turned off into a crystal. In order to get some idea of the amount of cold work done on the specimen by the fatigue test, it was annealed first at 1100 F and then at 1300 F, after which a few new grains were seen. 1300 F is the temperature at which iron

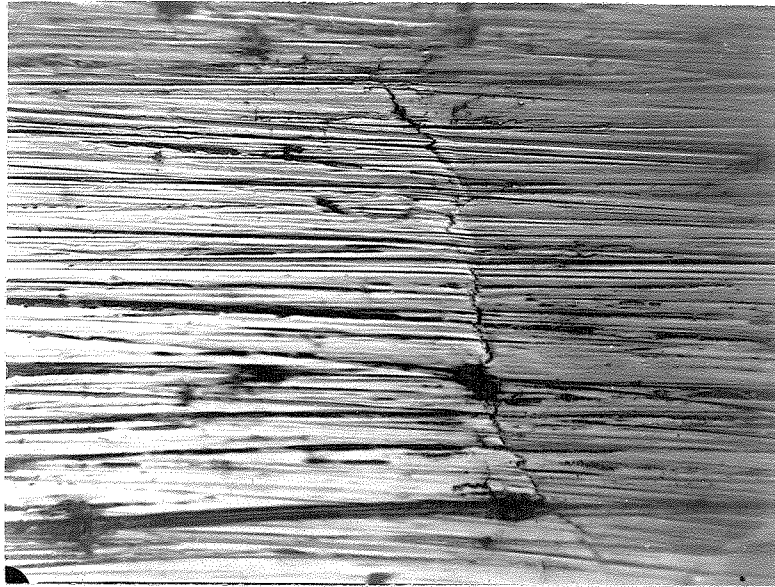
Fig. 29 380X

IX-13 27,000 psi for 45,000 cycles
 $S_3 = -0.01$ in. $\phi = 58^\circ$

Specimen IX-13 was then run for 15,000 cycles and nothing which could be definitely called a crack was visible. After 30,000 cycles a few questionable lines appeared such as that shown in Fig. 28. These disappeared on annealing, repolishing, and rerunning for another 15,000 cycles. The crack shown in Fig. 29 was noticed this time, however, and it was decided to run the specimen to failure and watch the crack grow rather than to continue with the annealing process. The resulting series is shown in Figs. 30 to 35. The out-of-focus blobs along the edge of the crack in Fig. 35 were apparently rust "flowers", for they came into focus above the rest of the specimen and were orange brown in color. They are probably due to the same thing as the fretting corrosion which is observed in press fits under alternating stresses. They were observed in cracks in other specimens as well. After a total of 135,000 cycles, the fatigue machine was beginning to run rough, indicating that failure was imminent, so the test was not continued. Figs. 36 and 37 show the crack, which was the major one of the specimen, after etching for 40 seconds in 10% nitric acid in methanol. The crack

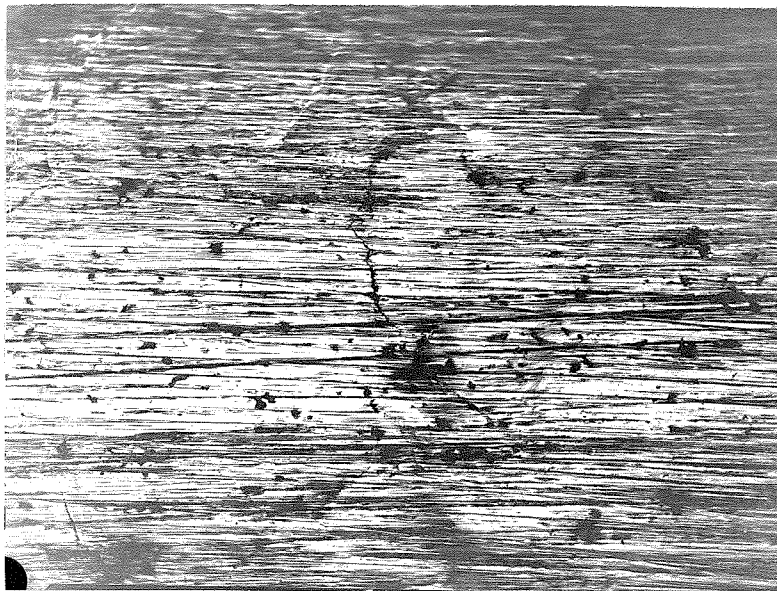
Fig. 31 88X

IX-13 27,000 psi for 60,000 cycles
Same region as Fig. 27

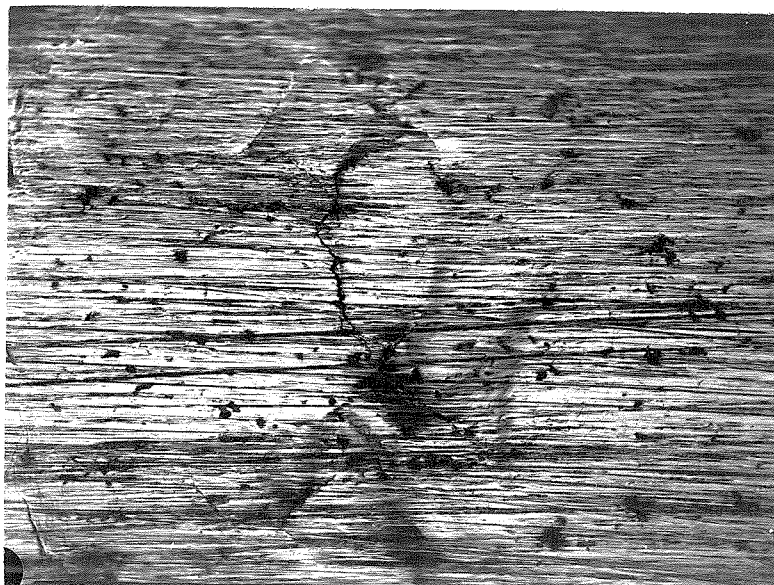
Fig. 32 88X

IX-13 27,000 psi for 75,000 cycles
Same region as Fig. 27

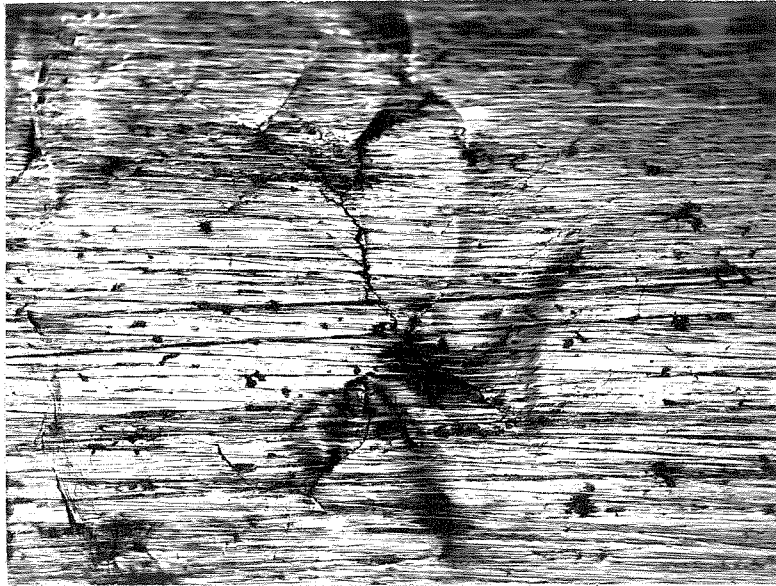
Fig. 33 88X

IX-13 27,000 psi for 90,000 cycles
Same region as Fig. 29

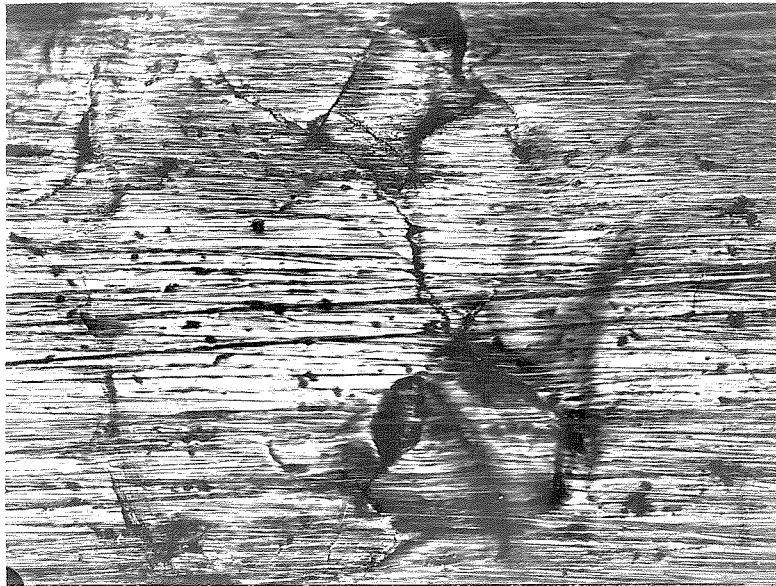
Fig. 34 88X

IX-13 27,000 psi for 105,000 cycles
Same region as Fig. 29

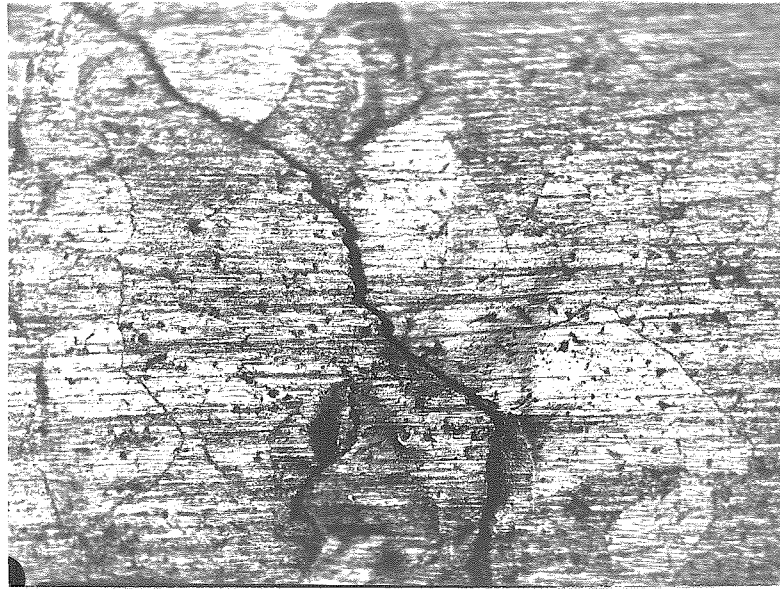
Fig. 37 88X

IX-13 27,000 psi for 120,000 cycles
20 sec. etch in 10% nitric acid in methanol
Same region as Fig. 27

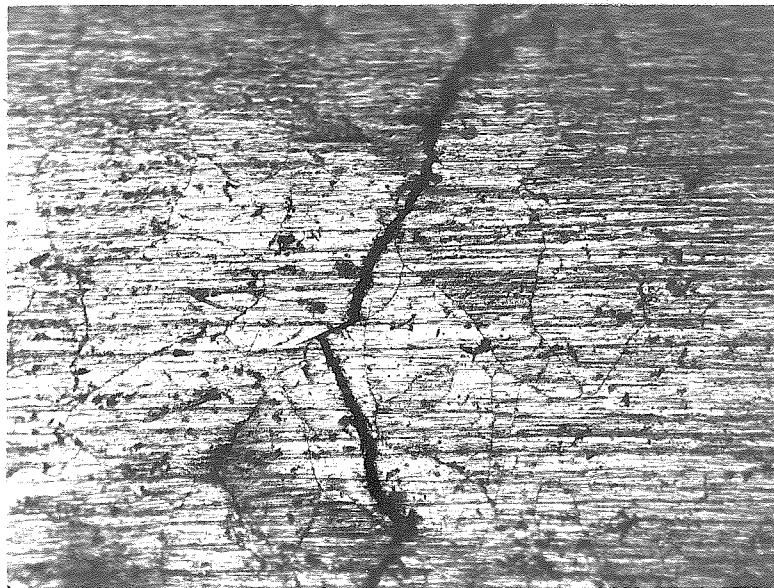
Fig. 38 88X

IX-13 27,000 psi for 120,000 cycles
20 sec. etch in 10% nitric acid in methanol
Different region from Fig. 27

evidently started near the boundaries of a very large grain. Fig. 38 shows a crack in another part of the specimen where the grain size was more nearly normal. It should be noticed that the crack usually cuts across the grains, but occasionally follows the grain boundaries as described by Lucas (11) and Ewing and Humphrey (8).

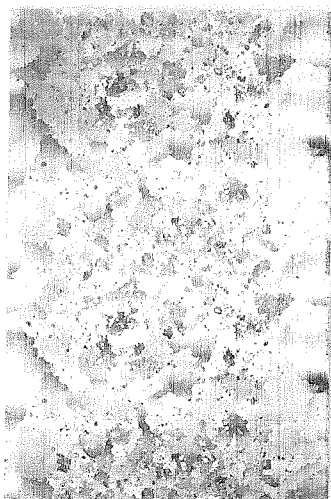
Fig. 44 1X

VI-16
Strain 0.030
1590 F - 1630 F 91 hrs
Strain 0.029
1635 F - 1645 F 93 hrs

Lighting was furnished by a No. 2 photoflood light 25 in. above and 38 in. behind the lowest position of the specimen. With a film speed of 64 and the camera stopped to f32, a satisfactory exposure was obtained by setting the control at 4 to 10 depending on the surface condition. This resulted in an exposure time of $1/6$ to $1/25$ sec. Figs. 44 to 48, discussed below, were taken with this apparatus.

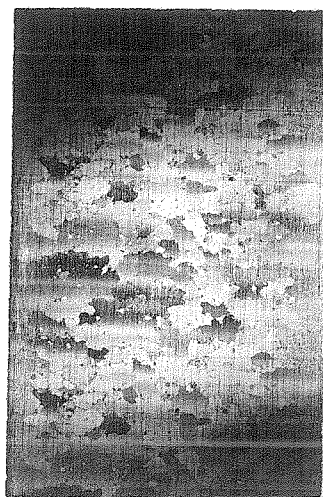
Fig. 45 1X

IX-16
Strain 0.030
1595 F - 1625 F 95 hrs
Polish
1635 F - 1645 F 93 hrs

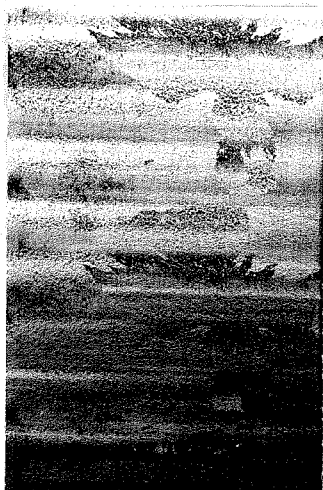
Fig. 46 1X

V-22

When the large crystals grow, they sometimes grow all the way to the surface, as shown in Fig. 46. It is also interesting to note some growth out on the shoulder. Sometimes the surface was covered with a thin section of crystallites, as others have found (13), (25), (26). Figs. 47 and 48 show Specimen VI-6 after a light polish and after removing 0.003 in. from the surface.
