THE RELATIVE SLIDING WEAR RESISTANCE OF SOME HARD ALLOYS

Thesis by

In Partial Fulfillment of the Requirements for the Degree
of Doctor of Philosophy

California Institute of Technology

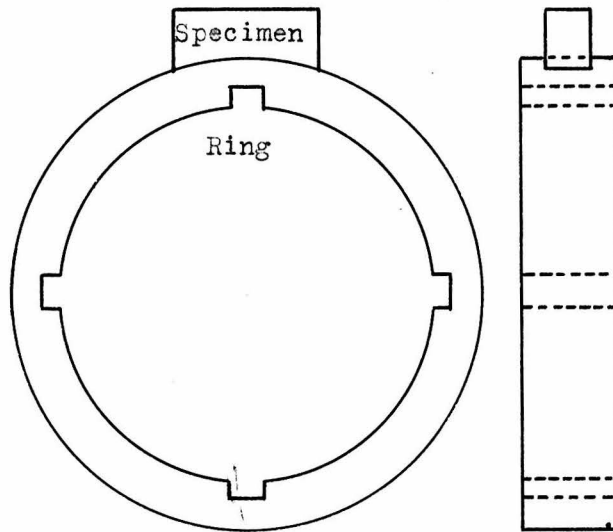
Sketch of Specimen and Ring

having a cross sectional area one-fourth by three-fourths of an inch, or seven-sixteenths by seven-eighths of an inch, depending upon the test being made. The larger specimens were used for low pressures and the smaller ones for high pressures. The surface of contact on the specimen is ground on the same radius as the rings against which it wears. The axis of curvature is parallel to the

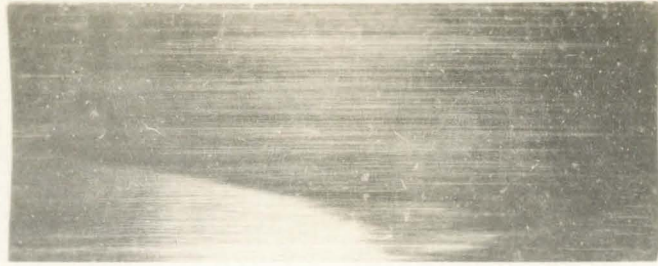
Figure 8.

A-1 5X

dark area is the worn surface which was mirror bright. However, slight ridges may be seen. This specimen was run on ring A-7 at a pressure of 300 pounds per square inch and at a surface speed of 393 feet per minute. Figures 9 and 10 show a cross-sectional view of the worn edge at a magnification of 150 diameters. At the top of the picture is the copper plate and below is the structure of the specimen. Figure 9 shows the surface unetched and Figure 10 shows the structure after etching ten seconds in a solution of 1% nitric acid in methyl alcohol. The edge is smooth, clean cut, and shows no evidence of distortion. The structure of the specimen is characteristic of white cast iron. The white areas are cementite, Fe_3C , and the dark areas are grains of pearlite, which is the eutectoid of iron and iron carbide.

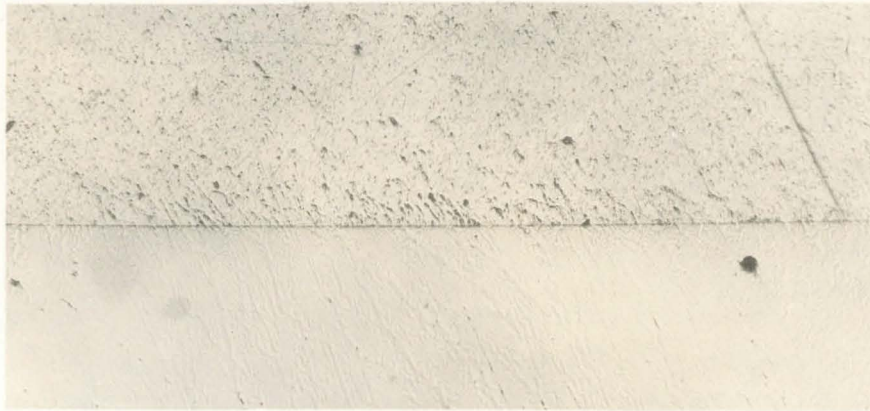
Figure 9.

A-1-A Unetched 150X

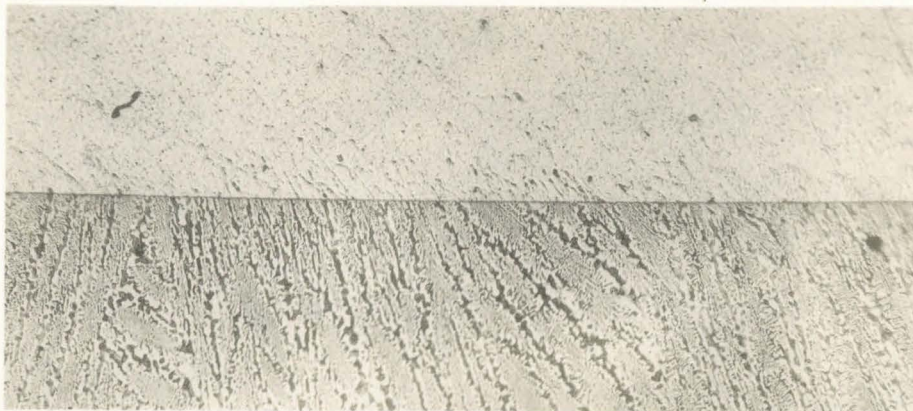
Figure 10.

A-1-B Etched 150X

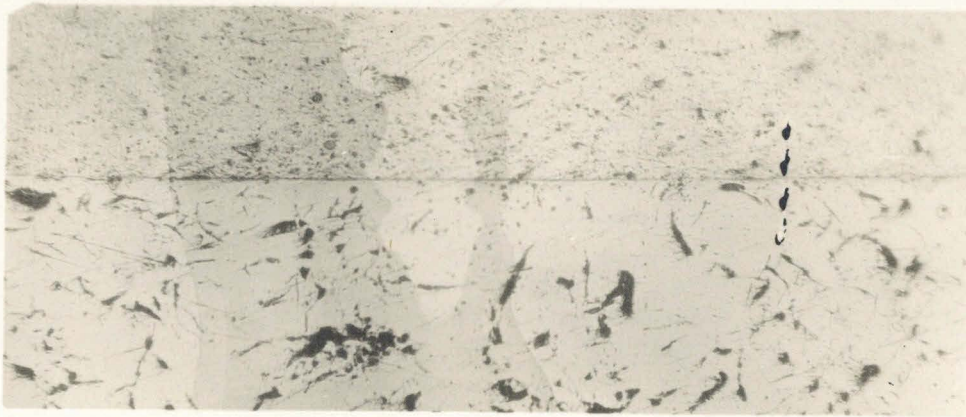
Figure 16.

C-25-A 150X

macrograph of the surface after test is shown in Figure 15. The surface was only slightly ridged and was quite smooth. Figures 16 and 17 show the worn edge and the structure of the gray cast iron unetched and etched, respectively. The edge is straight and smooth showing no evidence of distortion or a layer of worked metal.

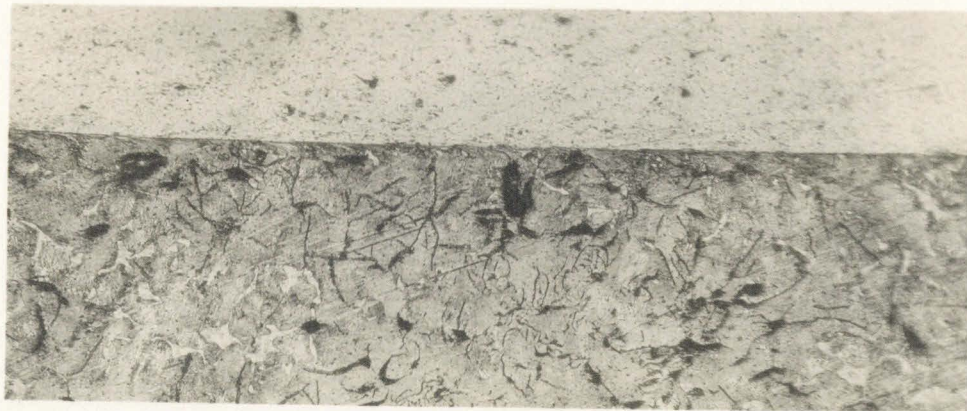
Figure 17.

C-25-B 150X

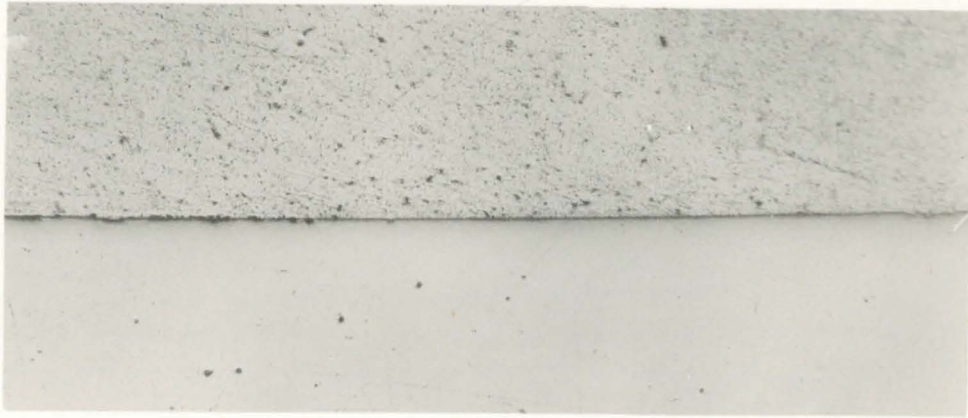
CH-4-A 150X

Figure 18 is a macrograph of the worn surface of specimen CH-4 which was run on ring B-26 at a load of 300 pounds per square inch and at a surface speed of 786 feet per minute. The surface after test was mirror bright except for a few dull places. A cross section of the worn edge, unetched, at a magnification of 150 diameters is shown in Figure 19. Further investigation showed that a worked layer had formed in some places. Figure 20 shows the thickest section of this layer at a magnification of 400 diameters after etching. The severity of the working is clearly shown. This is a very good example of the process by which wear takes place by cold hardening. The material is worked until cracks form which separate fragments from the rest of the material. The fragments are then easily worn away. Figures 21 and 22 show the surface where no worked layer has formed. The magnification is 400 and 1000 diameters, respectively, in each picture.

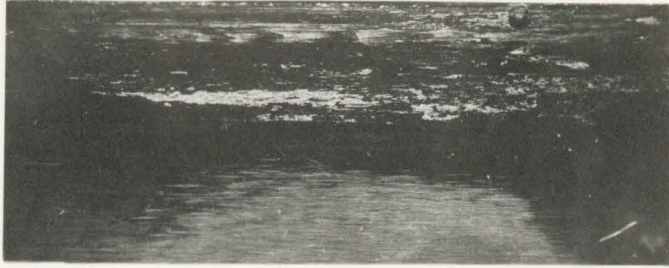
WC-3 5X

Specimen WC-3 was run on ring B-7 at a load of about 400 pounds per square inch and at a speed of 786 feet per minute. After test the surface was mirror bright, but slightly galled in places, as shown in the macrograph, Figure 27. Figures 28 and 29 show the edge and structure after etching, at a magnification of 150 diameters. These two views show the edge on each side of the blow-hole seen at the upper right-hand corner of the macrograph. The surface towards the end of the specimen on the section through the blowhole is smooth. The surface on the other side, towards the middle, is galled. Figure 28 shows the edge towards the middle which is a layer of worked metal corresponding to the galled surface. Figure 29, taken on the other side, shows no layer. This condition corresponds to the smooth surface. Further, the surface at the center of the specimen on a section through the blow-hole is smooth. The cross section of the edge at this point is shown at a magnification of 150 diameters in Figure 30. Figure 31 shows the same area at a magnification of 400 diameters.

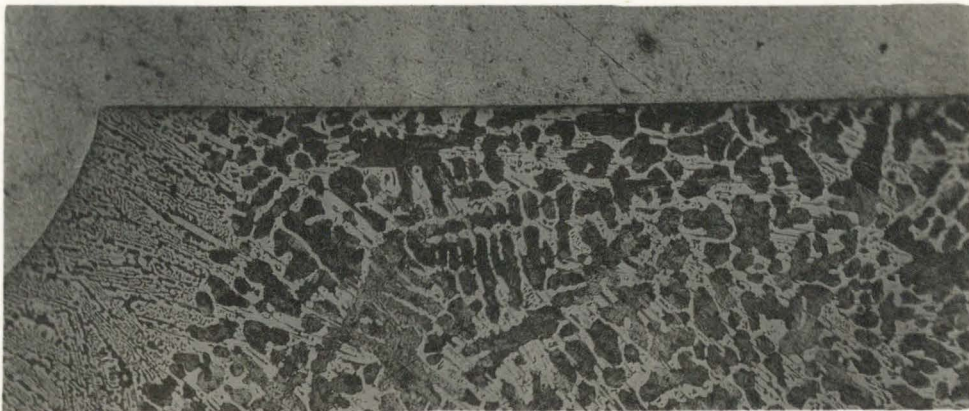
Figure 29.

WC-3-B 150X

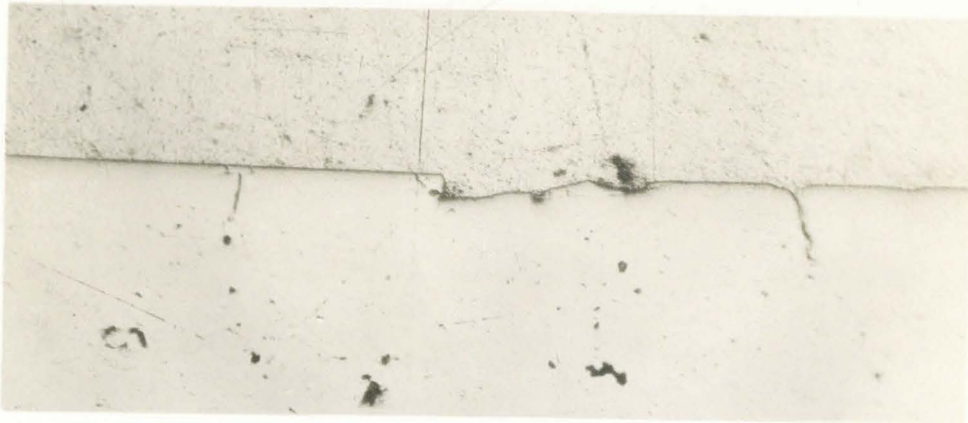
Figure 35.

WC-5-A 150X

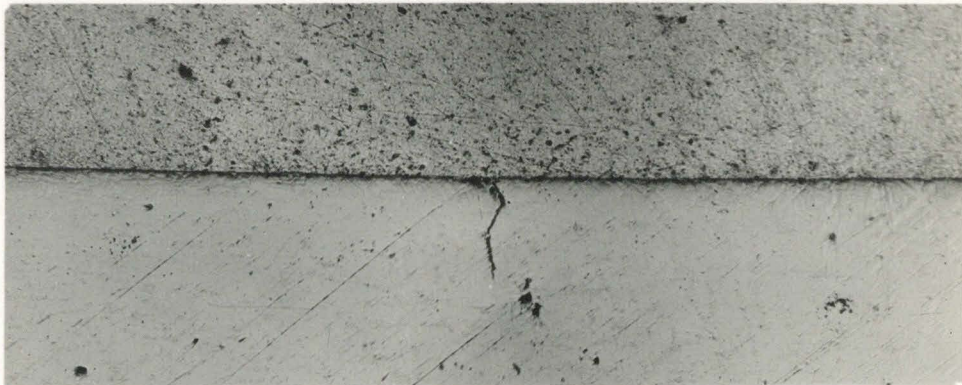
Figure 38.

B-19-A 150X

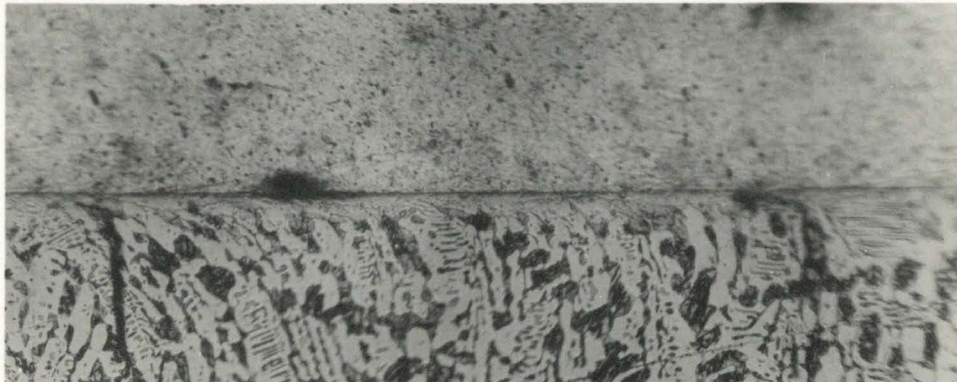
Figure 39.

B-19-B 400X

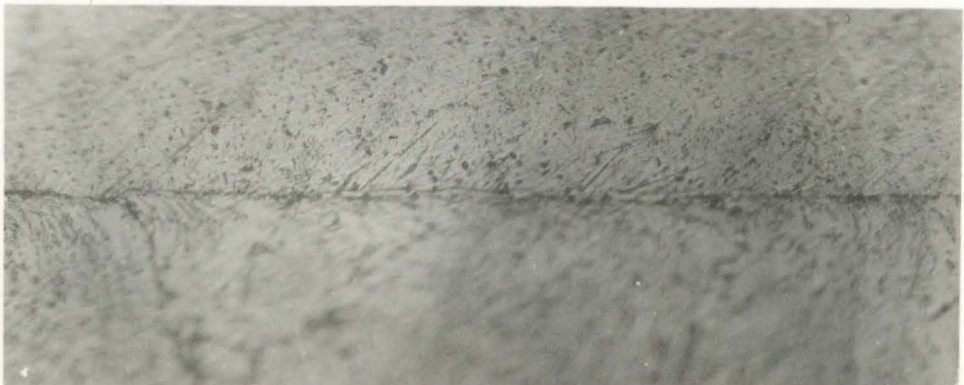
Figure 44.

St-3-C 400X

ture after etching electrolytically in a 10% solution of NaOH and a 10% solution of HCl is shown in Figure 43. Figure 44 shows the edge at a magnification of 400 diameters. There is a slight indication of a worked layer and a higher magnification would have been desirable. This was impossible, however, due to the fact that the electrolytic etch is very severe and the edge was rounded off. Note that the edge is not straight, but has a wavy character.

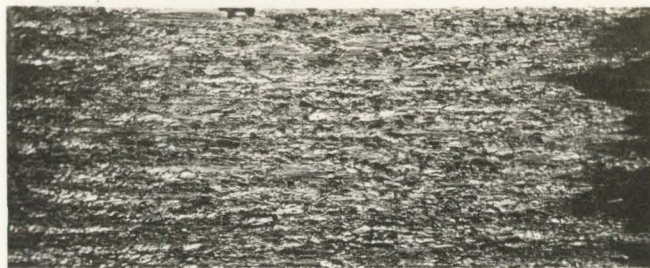
The condition of the surface of specimen WC-8 which was run on ring B-11 at a load of 300 pounds per square inch and at a speed of 1180 feet per minute is shown in Figure 49. The surface is very

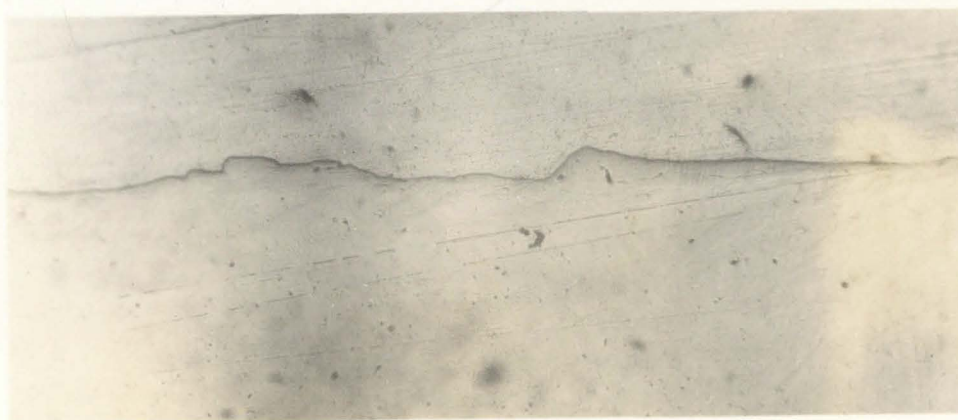
Figure 50.

rough and badly galled. Figure 50 shows the edge unetched, at a magnification of 140 diameters, and Figure 51 shows the same area after etching. The contour of the edge is very uneven and a layer of worked metal has formed. This layer did not appear on the entire surface, as is shown in Figure 52, where the grains have been cut evenly. In Figure 53 is shown another area where a layer is present and considerable working is evident. Surface cracks are clearly seen which run parallel to the edge. One large fragment has been broken away during the process of wear. The magnification of the last two pictures is 1000 diameters.

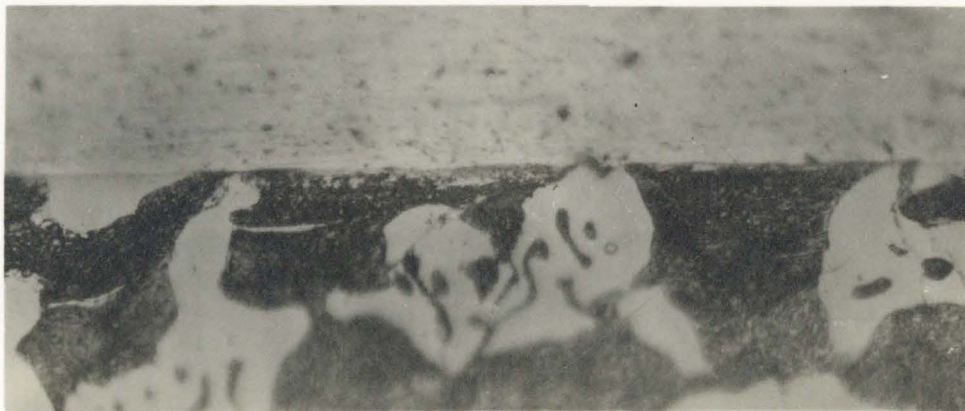
Figure 52.

WC-8-D

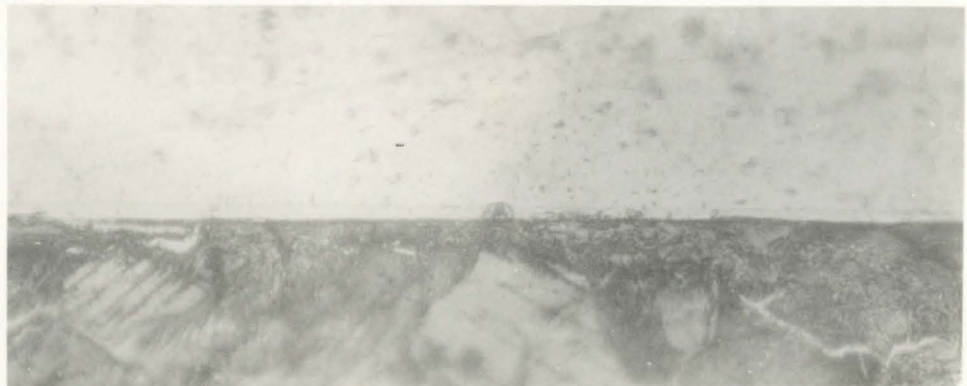
N-4-C 1000X
Figure 57.

Specimen N-4 was run on ring B-25 at a load of 300 pounds per square inch and at a speed of 786 feet per minute. The galled condition of the surface is shown in Figure 54. The edge, unetched, is shown in Figure 55 at a magnification of 150 diameters. Note that there are several surface cracks which run approximately at right angles to the edge. Figure 56 shows the structure after etching, at a magnification of 150 diameters. The structure appears to be quite different than that of N-2, which was shown in Figures 24, 25, and 26. There are not as many hard nitride needles in the structure of N-4 as there are in N-2. Figure 57 shows the structure at a magnification of 1000 diameters and shows evidence of a layer of worked material. This layer extends over the entire length of the specimen at this section.

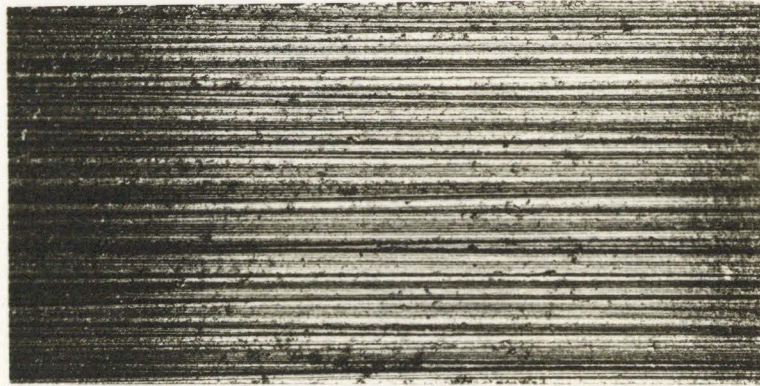
C-19 5X
Figure 59.

Most of the grey cast iron specimens were ridged to some extent depending upon the conditions of the test. Specimen C-19 is a typical example. The surface after test is shown in Figure 59. The edge and structure are shown at a magnification of 150 diameters before and after etching in Figures 60 and 61, respectively. Note that one fragment has been lifted from the surface and that another has been worn away. The structure is typical of a grey cast iron and consists of ferrite, pearlite, and graphite.

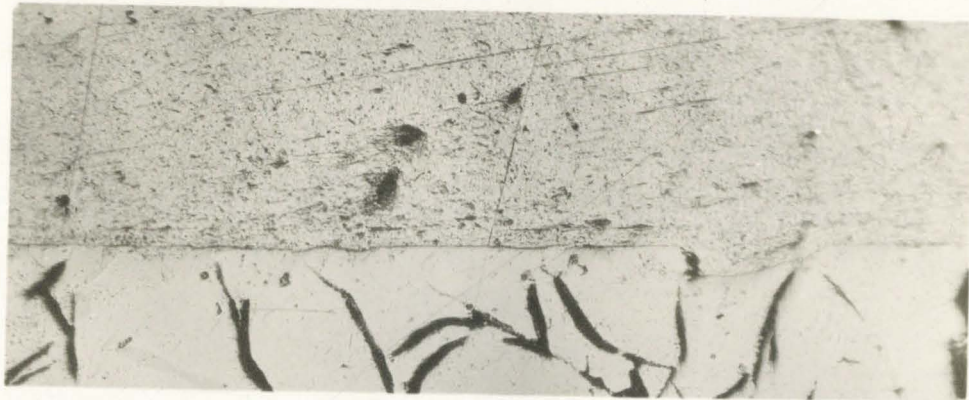
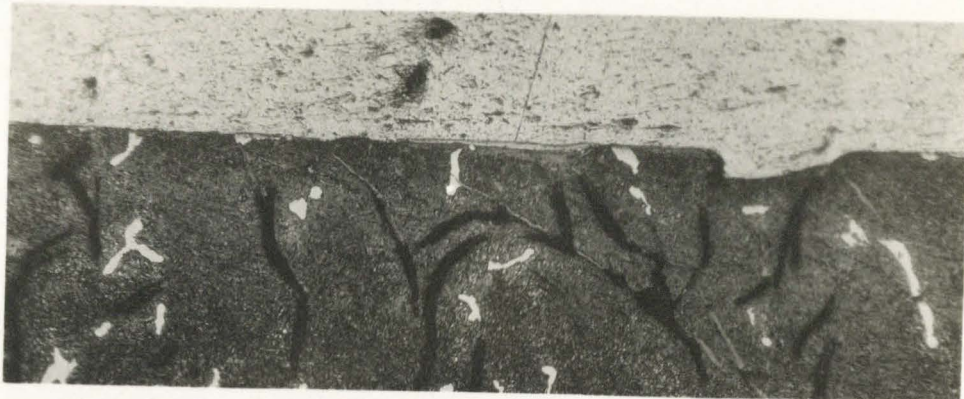
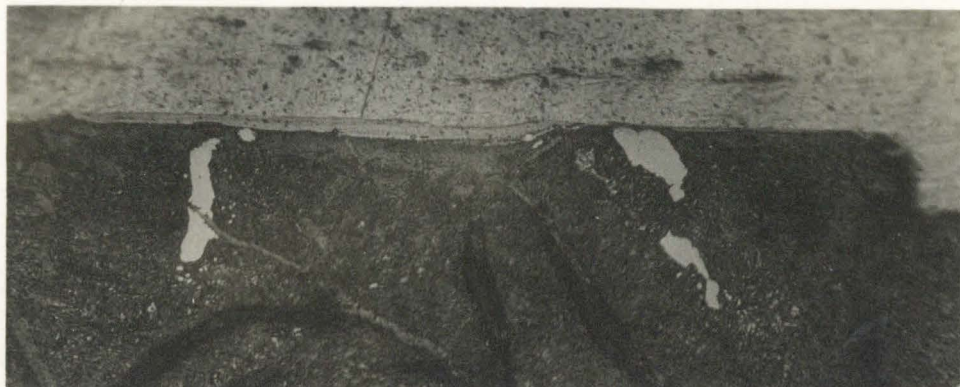
Specimens E-5 and E-6 were run simultaneously under the same conditions. They were run against rings B-21 and B-22, respectively, at a load of 300 pounds per square inch and at a speed of 786 feet per minute. After test the surfaces were ridged and galled, as shown in Figures 67 and 71. The edge is shown unetched in Figures 68 and 72 at a magnification of 150 diameters. The rough character of the surface is clearly seen. Figure 69 shows the edge and structure of specimen E-5 after etching at a magnification of 150 diameters. The typical grey iron structure is evident and a thin layer of worked metal can be seen. The same area at a magnification of 400 diameters is shown in Figure 70. The structure and edge of specimen E-6 after etching is shown in Figure 73 at a magnification of 150 diameters. This specimen also exhibits a layer of worked metal. The appearance of the surfaces and the structures of these two specimens is practically the same.

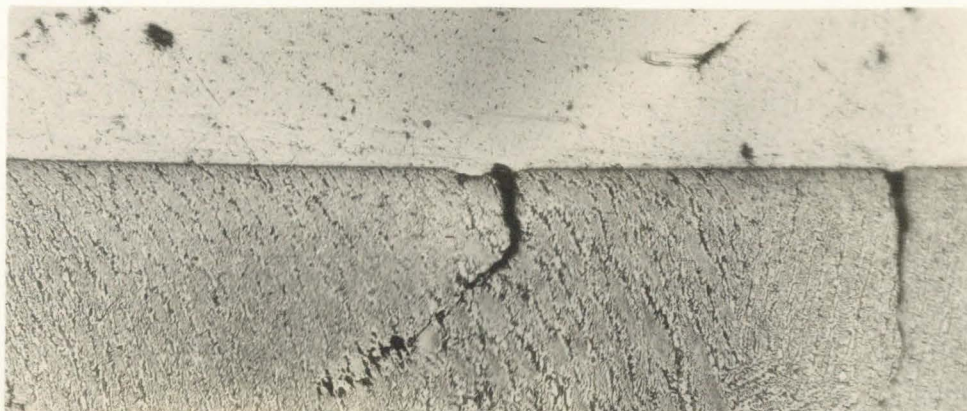
Figure 76.

A-4-B 150X

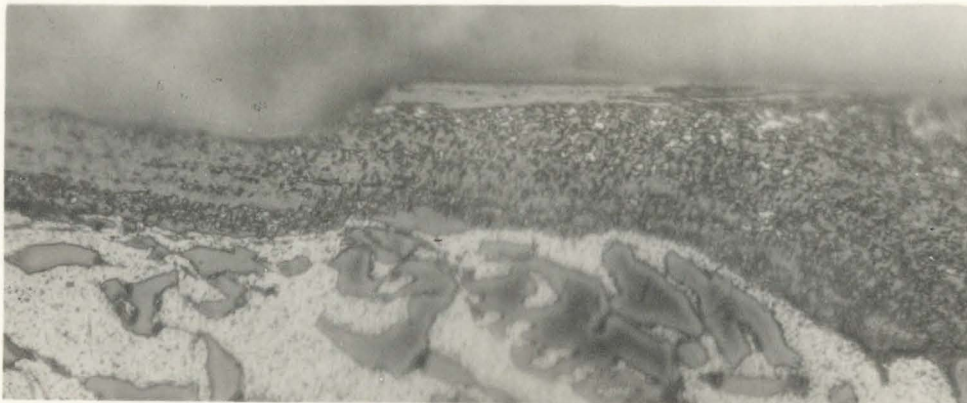
Figure 82.

WC-5-I 400X

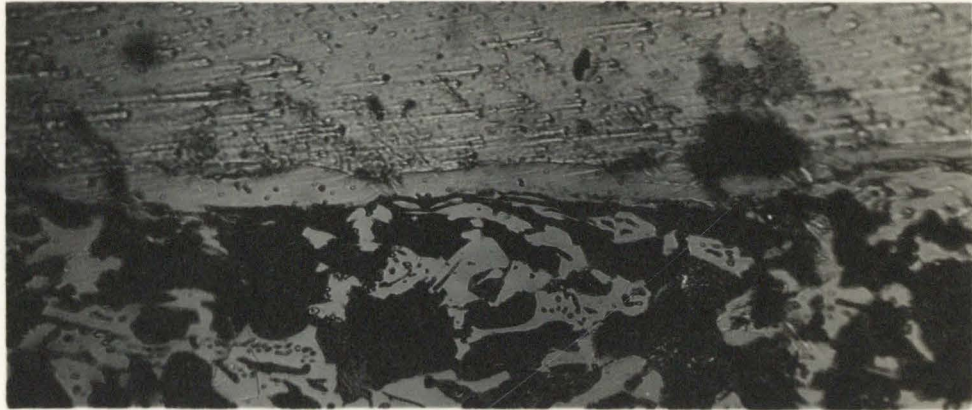
Figure 85.

WC-11-A 400X

After the X-ray analysis was completed the specimen was plated with copper and prepared for metallographic investigation. Figure 85 shows the structure and the layer at the section which was cut by the X-ray beam.

Due to the fact that some of the reflections appearing on the film were faint and others were broad, the accuracy of measurement was not very good. However, several reflections were without a doubt due to the iron carbide. On films WC-11-1 and WC-11-3 reflections were obtained from both films from the following planes of iron carbide; 003, 103, 122, 114, and 125. There was some doubt about other reflections, but these are sufficient to show that the layer contains iron carbide if these reflections are from the layer. The intensity of reflection from planes below the surface rapidly diminishes with the depth. For iron, planes at a distance of ten microns from the surface in the direction of the beam will reflect with only one-half the intensity of planes on the surface. Since Fe_3C has about the same density as iron, the absorption will be about the same. The thickness of the layer at the section on which the X-ray beam was directed was about ten microns. The beam, however, intersected the surface at an angle of not more than about 15° . Therefore the distance travelled by the beam in the layer was considerably more than ten microns, and the reflections which appear on the film are quite surely to be from the layer and not from the material below. Therefore, it is quite certain that the layer does contain Fe_3C . In addition, a

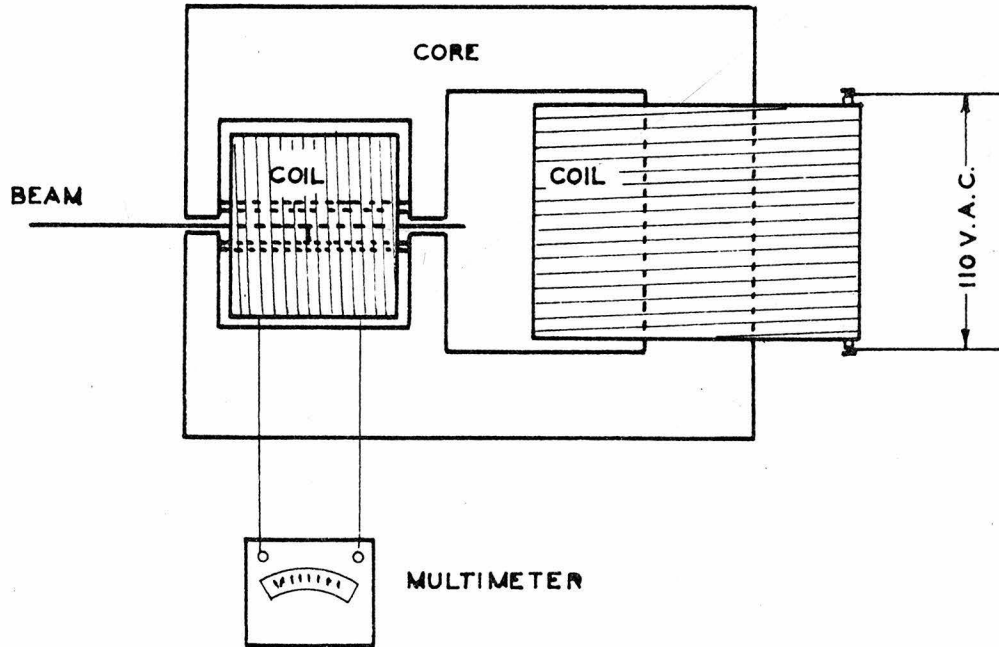
FIGURE 51.

was also not sensitive enough, probably due to its design and construction. It was replaced by a magnetic circuit, which is shown in Figure 91. This circuit is the same as that used in old magnetic loud speakers. The results with this instrument were satisfactory when the load on the diamond point was less than about 23 grams. The deflection limit of the instrument would not allow greater loads.
