A METHOD FOR RECORDING AND STUDYING
CRACK GROWTH IN THE CORROSION FATIGUE OF METALS

Thesis by

Robert Clarence Brumfield

California Institute of Technology

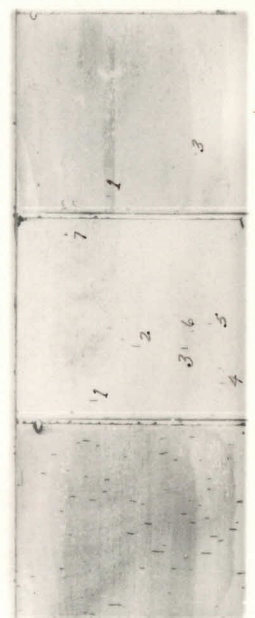
Fig. 16. Sulfur Prints of Crack Patterns at Increasing Depths in Specimens E-5, 6, 7, and 8. (Numbers in parentheses are depths as percentage of radius.)

In order to study the cracks formed in the metal, Figure 14, page 14, halves of damaged specimens were cut in a lathe to successively smaller diameters (greater radial depths). After each cut was made the specimens were etched to open up the cracks, soaked in Na_2S and sulfur prints made of the crack patterns formed at these radial depths. A sample sulfur print is shown in Figure 32, page 47. Series of sulfur prints made at successive radial depths in specimens E-5, 6, 7, and 8 are shown in Figure 16, page 15.

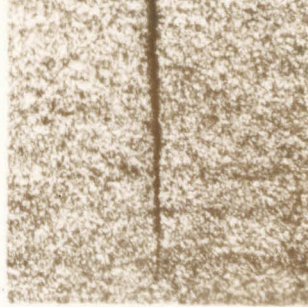
Fig. 21. (Right)
Fissure in E-6
at 500 X.

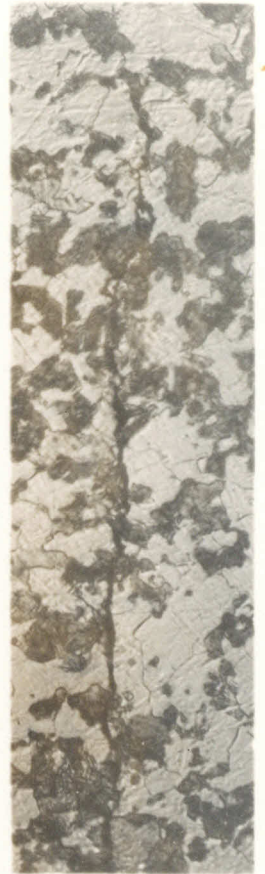
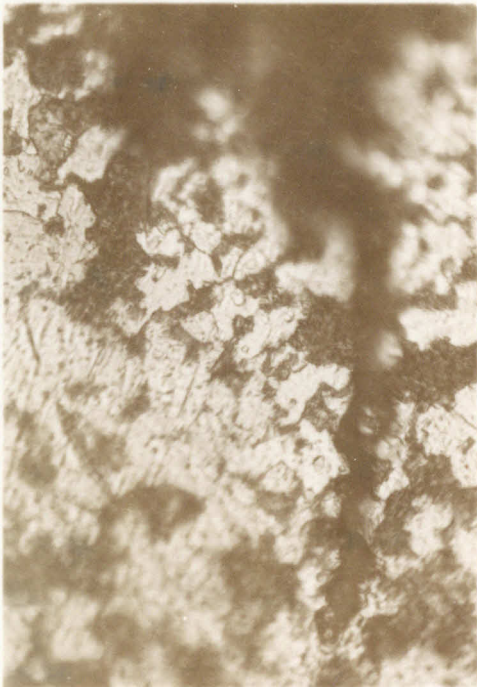
Fig. 22. E-8 at 500 X.

when they could not be detoured. Figure 22 seems to show that in pitting, the pearlite was attacked more readily than the ferrite grains.

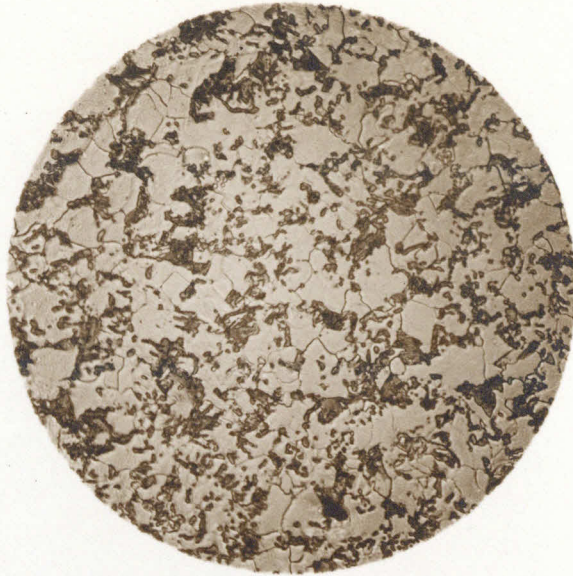
Fig. 28a. Specimen Steel SAE X 4130
at 500 X, Nital Etch.

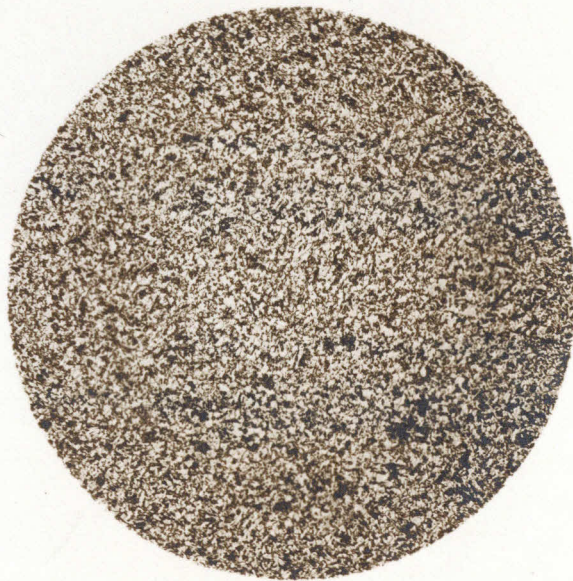
Fig. 28b. Specimen Steel SAE X 4130
at 100 X, Nital Etch.
