FATIGUE STRENGTH OF
METAL SANDWICH TYPE CONSTRUCTION

Thesis by
William E. Lamb

In Partial Fulfillment of the Requirements
For the Degree of
Aeronautical Engineer

1949

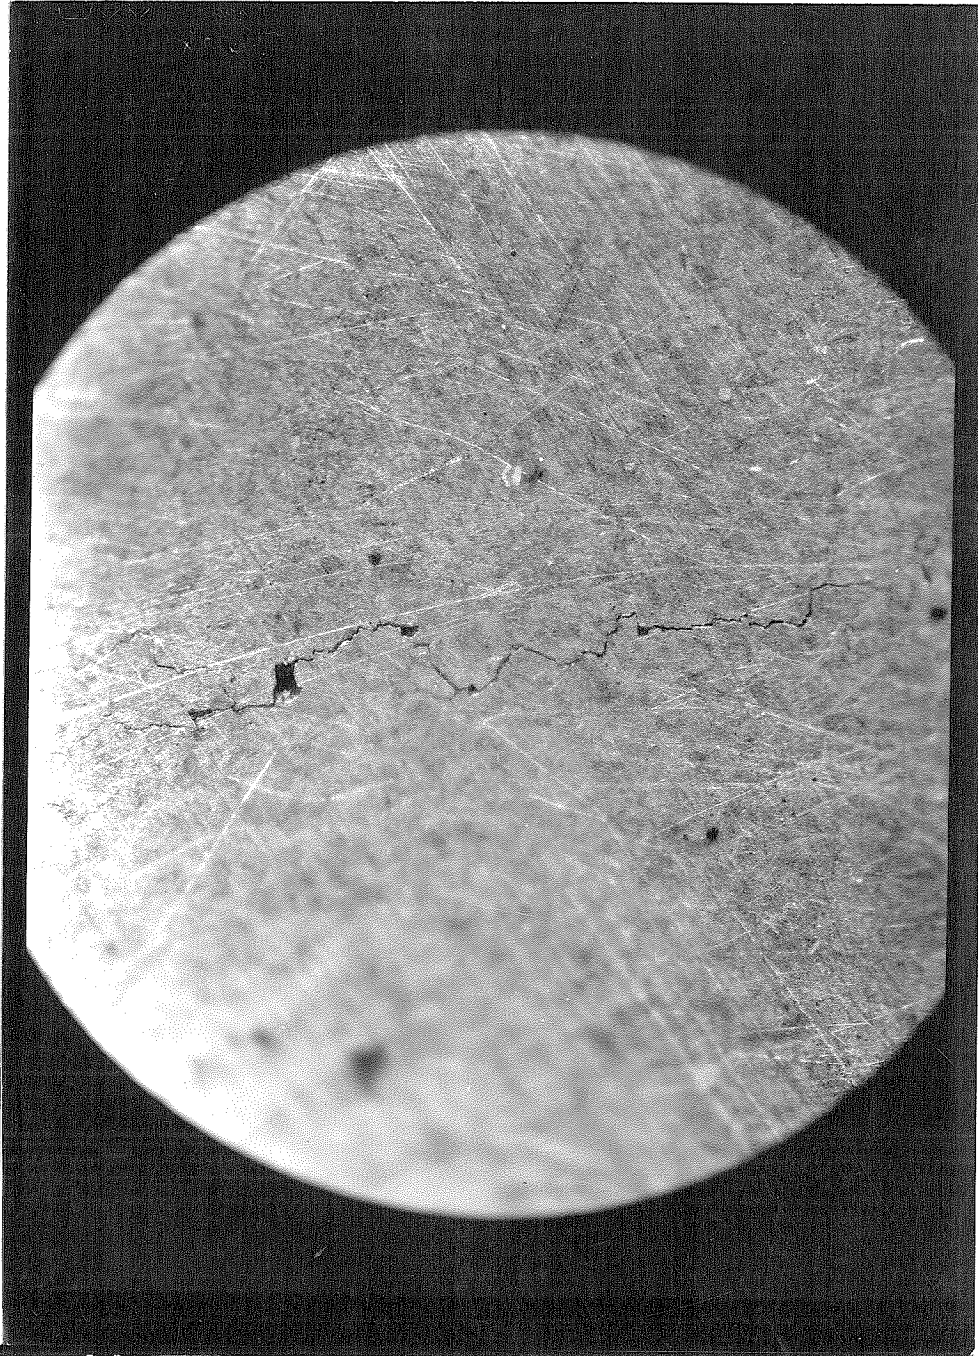
Photomicrograph of Crack with Filament and Cement Removed

Magnification 50 x

Figures 8 and 9 indicate the effectiveness of the crack detection. Figure 8 shows a crack across a saddle point with the graphite fracture ensuing. Figure 9 shows one of these cracks with the graphite and

cement removed. Many machine stoppages occurred with the crack causing the shut-down so fine as to be barely visible at a magnification of 40 times. It was necessary in almost all cases to utilize a resistance meter to determine in which saddle the crack occurred before the failure could be found.
