# An Experimental Investigation of the Failure of a Stepped Composite Plate

Thesis by  
Steven C. Gortsema

In Partial Fulfillment of the Requirements for the Degree of  
Aeronautical Engineer

## Abstract

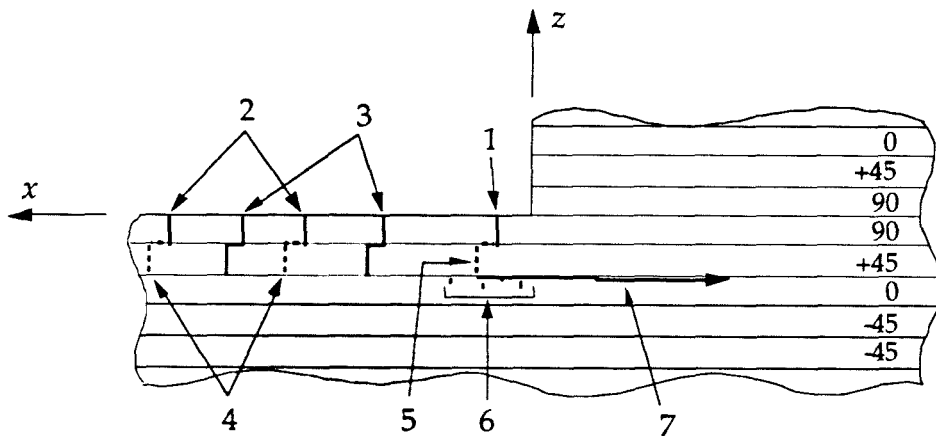
Figure 9. Damage development on the positive edge.\*\*

moment loadings at each step have been included for one of the specimens.\* These are expressed as a percentage of the moment loading at ultimate failure for this specimen,  $M_{fp}$ . Also, to aid the reader in understanding the damage descriptions, the events which occur in each step are illustrated in Figure 9. Thus, as the loading increases on a specimen, one would trace through the following levels of damage development:

1. ( $M \approx 39\%$  of  $M_{fp}$ ) The  $90^\circ$  ply (plate interface ply) cracks near the step, usually at values of  $x$  between 1 and  $1\frac{1}{2}t$ , where  $t$  is the ply thickness (Figure 10a).

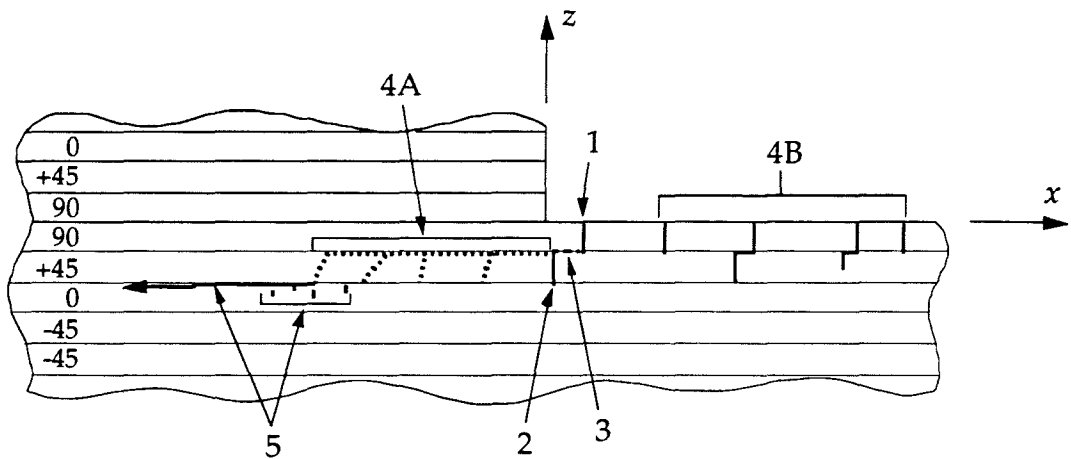
Figure 11. Damage development on the negative edge.

1.  $\{M \approx 41\%$  of  $M_{fn}$ , where  $M_{fn}$  is the moment loading at ultimate failure for this specimen} The first damage seen on the negative edge is also the cracking of the  $90^\circ$  ply near the step (Figure 12a).<sup>††</sup> This crack, and the others which later develop in the  $90^\circ$  ply, cross the entire width of the specimen.\*

- (i) This process usually begins with the interface crack propagating farther away from the step and then turning into the  $45^\circ$  ply. However, sometimes the crack in the  $45^\circ$  ply appears before the extension of the interface crack, as shown by the crack near the bottom of Figure 12c. In Figure 12d, the same interface crack propagated farther along the specimen before turning into the  $45^\circ$  ply.
- (ii) Next, the  $45^\circ$  ply crack farthest from the step grows almost all the way across the ply. Then the delamination crack (interface crack) grows along the interface, and turns into the  $45^\circ$  ply again. This process is repeated several times as the load is increased (Figure 12e, "4A" in Figure 11).

As this delamination process starts to occur, additional cracking begins to develop on the plate edge on the other side of the step where  $x$  is greater than zero ("4B" in Figure 11). Some of these new cracks cross both the  $90^\circ$  and  $45^\circ$  plies, but the damage by the corner appears the most severe throughout the entire test when viewing the negative edge.

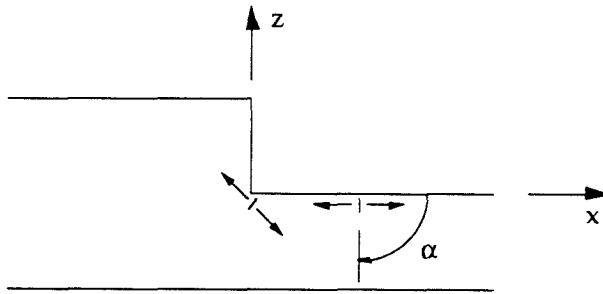
Figure 13. Directions of maximum normal stress calculated from the results of Kubr's numerical study.

run straight across the plies, regardless of how close they are to the corner. This observation seems to contradict the numerical, asymptotic solution by Kubr, which would indicate that the lines of principal stress in the plate interface ply directly below the step (-z direction) are 45° different from the lines of principal stress in the same ply out away from the step (+x direction) (Figure 13).

These two features indicate that the failure process is not entirely driven by the nature of the "analytical stress singularity," as may be widely believed. It is true that failure does initiate *near* the corner, but since it is not right *at* the corner, one can deduce that the precise structure of the geometry and of the singularity does not completely govern failure initiation. It seems that for composite materials, the local variation in material parameters, combined with the inherent ability of composites to redistribute loads away from regions of high stress, often prevents the singularity from dominating the failure mechanism. This suggests that in modeling a stepped composite plate, it may not be wise to spend a lot of resources on developing a precise

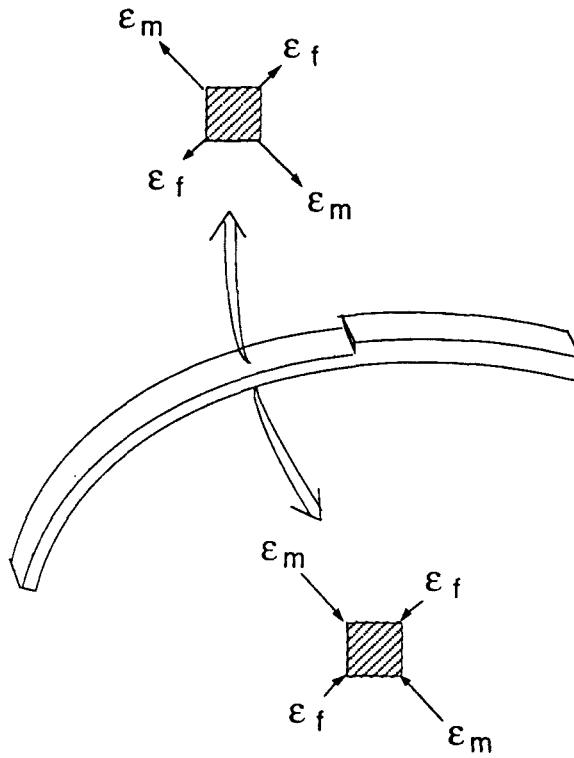
Figure 14. Specimen twist mechanism.

One other effect which contributes to the location of maximum stress is the twisting of the specimen. This effect is mainly caused by the 45° plies near the surface of the plate, as shown in Figure 14. For a given axial stress, there is a larger strain transverse to the fibers than parallel to them. This skews the axis about which the specimen bends, giving a smaller radius of curvature, and therefore a higher bending stress, along the negative edge.

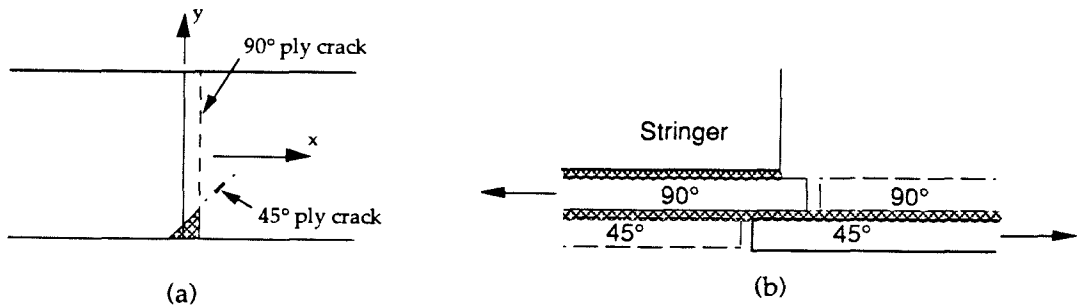
Figure 15. Region of high shear stress.  
(a) plan view (b) negative-edge view.

When a crack in the 45° ply forms near the end of the step by the negative edge, a triangular region of the interface is isolated (Figure 15a), causing it to be loaded with a very high shear stress. This is most easily seen by considering a force-balance diagram of the cracked portion of the specimen near the negative edge (Figure 15b):

The plies are under a tensile loading away from the crack because of the bending. Since both the 90° and 45° plies are unable to support a tensile stress near the transverse cracks, the entire force is transferred through the small overlapping region of the interface. This makes the shear stress in this area very high, causing the interface to fracture. Therefore, for this lay-up, the damage development indicates that delamination initiation is caused by interlaminar shear stress.\* Although this feature appears to be a direct result

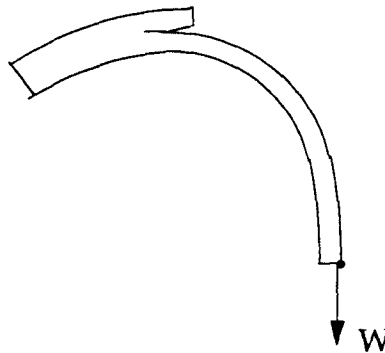
Figure 17. Delamination caused by different bending stiffnesses.

- (ii) The discontinuity in bending stiffness also contributes to this opening stress since the plate tends to deflect much more easily than the plate-stringer combination (Figure 17).

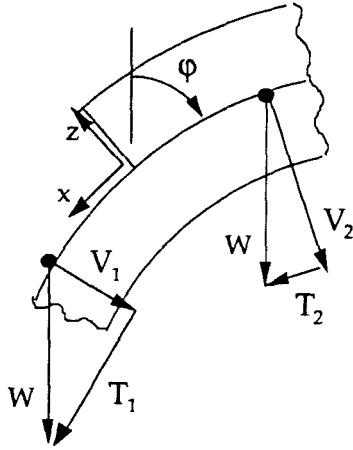
Figure 18. The relation of beam shear force to delamination tip position.

One difficulty in partially attributing the delamination propagation to beam shear force is that in a two-dimensional drawing, this seems to be an unstable process. Figure 18 implies that as the delamination crack tip moves in the  $-x$  direction, the shear force at the crack tip increases if the load angle,  $\phi$ , is less than  $90^\circ$ . This apparent instability seems to contradict the negative-

edge observations, which indicated that the early stages of delamination were a stable process.

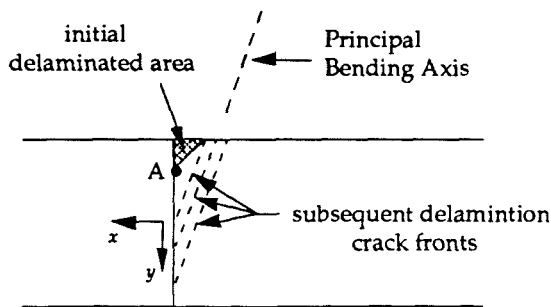
Figure 19. Plan view of delamination crack advance.

However, when viewing the delamination crack front in plan view (Figure 19), one realizes that the amount of new surface area per unit crack advance increases as the delamination grows across the specimen. In terms of the Griffith criterion for crack advance, this increases the total energy required for each subsequent unit of crack propagation. Therefore, since the required energy is increasing as the shear force is increasing, it is no longer clear whether the process is unstable.

- (i) After the initial 45° triangular delamination crack forms, the highest stress is at point A in Figure 19.
- (ii) The part of the crack front by point A then propagates until the crack front is parallel to the principal bending axis.
- (iii) The crack front then advances uniformly until it reaches the positive edge of the specimen.

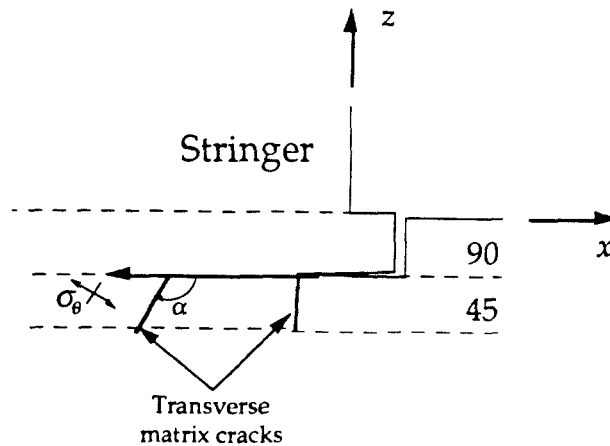
Figure 21. Cracking in the 45° ply on the -x side of the step.

Another part of the delamination mechanism that should be explained is its relation to transverse matrix cracking in the 45° ply, as observed on the -x portion of the negative edge (Figure 21).

Referring to Figure 21, after the delamination crack travels along the interface, away from the previous crack in the 45° ply, the tensile stress below the crack tip increases. This causes the circumferential stress at the delamination tip,  $\sigma_\theta$ , to increase in directions below the interface. When  $\sigma_\theta$  in some direction below the interface is significantly larger than  $\sigma_\theta$  on the

interface, the crack kinks into the 45° ply.\* When the crack impinges on the 0° ply, the composite's resistance to fracture, e.g.,  $\sigma_{\theta}|_{crit}$ , becomes much larger, causing the crack to arrest. Now that there is a free surface crossing the 45° ply by the delamination crack tip, the ratio  $S$  (defined in the footnote) is maximum along the interface. Therefore, when the load is high enough, the crack propagates along the interface, and the process repeats.

terms of the ratio  $S \equiv \frac{\sigma_{\theta}}{\sigma_{\theta}|_{crit}}$ . When  $S$  for some direction below the interface becomes larger than  $S$  on the interface (and larger than 1), the crack kinks in the direction of  $S_{max}$ . As shown in Figure 21, the angle,  $\alpha$ , at which the crack crosses the 45° ply in the region on the -x side of the step is not always 90°, as it was on the +x side.

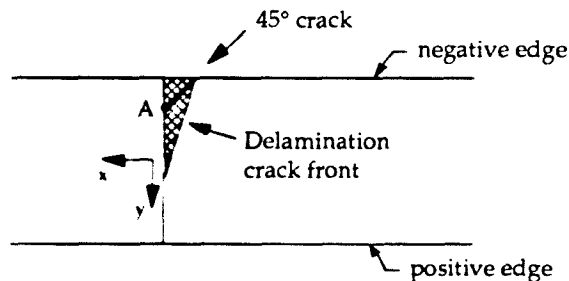
Figure 22. Plan view of delaminated area.

It should be pointed out that this explanation can be modified to account for the occasions when the delamination crack resumes its propagation along the interface before the crack in the 45° ply reaches the 0° ply. In order to understand this situation, the reader must again be reminded of the three-dimensional shape of the delamination crack. Since the crack front lines up with the principal bending axis and not with the 45° fibers, the apparent kinking of the delamination crack as seen from the negative edge leaves most of the delamination crack front unchanged (Figure 22):

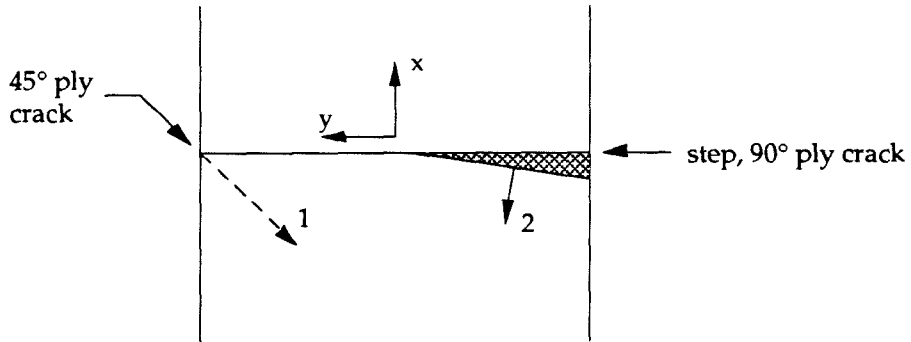
Figure 23. Contributions to "mode III" displacement.

When the local loading by the intersection of the corner crack and the positive edge reaches a critical value, this crack, too, extends across the 45° ply. After the load is raised slightly higher, a substantial increase in mode III displacement of the crack is observed. The perceived mode III displacement is

the  $y$  component of the  $45^\circ$  ply crack-opening displacement, which is believed to have two sources (Figure 23):

First, as the crack in the  $45^\circ$  ply propagates into the specimen, the crack-opening displacement at the free edge increases. Second, as the  $90/45$  delamination spreads across the specimen, the curvature of the  $45^\circ$  ply increases as the portion of the plate below the delamination ( $-z$  direction) peels away from the stringer and  $90^\circ$  ply above the delamination. This increase in curvature causes the tensile stress in the  $45^\circ$  ply to increase ahead of the delamination tip as well as behind it, thus increasing the opening stress and crack-opening displacement of the  $45^\circ$  ply crack near the corner. This second contribution is believed to be the cause of the damage noise which preceded the perceived mode III displacement.

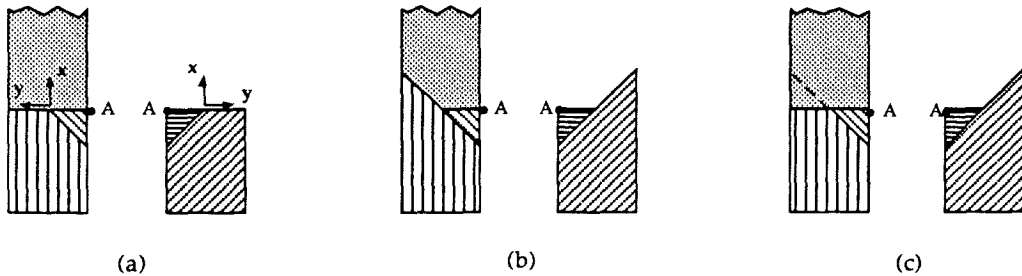
Figure 25. Alternative fracture surfaces.

The  $90^\circ$  plate interface ply prevents the  $45^\circ$  ply below it from separating freely at values of  $x$  greater than that for the  $90^\circ$  crack. One way in which the  $45^\circ$  ply can peel away from the plate differently than shown in Figure 24 is if some of the fibers break where they cross the  $90^\circ$  ply crack (Figure 25a). Another method that allows this to be achieved requires the  $90^\circ$  fibers in the plate interface ply to break where they cross the  $45^\circ$  ply crack (Figure 25b). One other way is for the  $90/45$  and the  $45/0$  interfaces to delaminate by the triangular portion of the  $45^\circ$  ply protruding above the step (Figure 25c). This will then allow the  $45^\circ$  ply to be pulled out from underneath the  $90^\circ$  ply when it separates.

Since the first two alternative mechanisms shown in Figure 25 require large numbers of fibers to fracture and separate, it is easy to see on physical grounds why the observed fracture surface requires less energy. For the surface of Figure 24 to be created, the  $90/45$  delamination crack must continue

Even though the third mechanism which would allow the 45° ply to separate at positive values of x usually involves less total delamination area, it doesn't occur because the stresses are much less where x is positive. In particular, the mode I opening stress for the 90/45 interface is almost negligible on the +x side of the 90° separation crack. Neither of the mechanisms which contribute to delamination propagation have a significant effect on the peel stress in this region. As illustrated in Figure 26, the existence of a significant interlaminar tensile stress caused by beam shear force requires the 90° ply to move in the opposite direction as the 45° ply does. This is not the case on the +x side of the 90° separation crack.

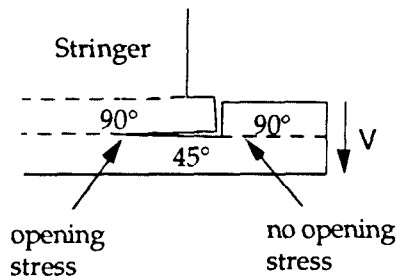
Figure 26. The contribution of beam shear force to the opening stress on the 90/45 interface.

Also, a significant opening stress in this region due to bending would require a sizable change in bending stiffness between the portion of the plate with the 90° plate interface ply and the portion without it. This also does not occur. Therefore, the stress levels needed to delaminate the 90/45 interface on the +x side of the step do not exist. This makes it clear why the fracture surface consistently appeared as shown in Figure 24.

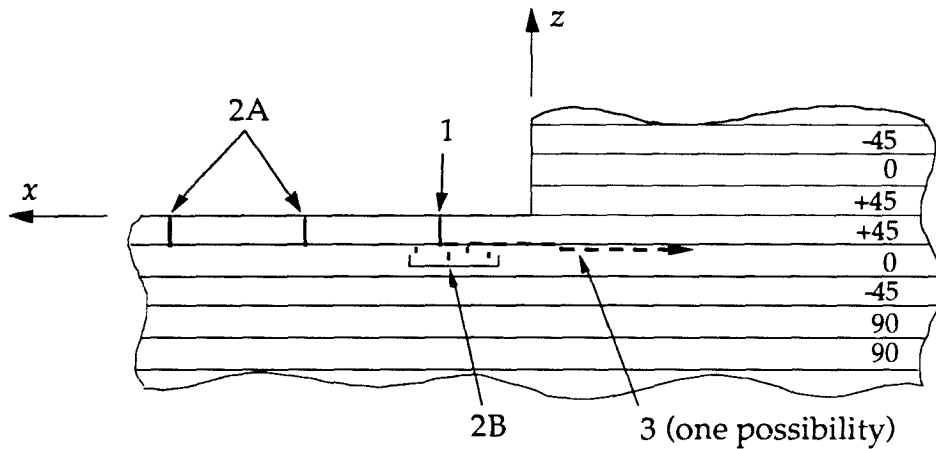
Figure 27. Damage development on the positive edge.

1.  $\{M \approx 77\% \text{ of } M_{fp}\}$  Damage is normally heard before the first crack is seen, indicating that damage does not initiate on the positive edge. However, when the first crack does reach the edge, it is usually a few ply thicknesses away from the corner (Figure 28a).
2.  $\{M \approx 93\% \text{ of } M_{fp}\}$  As the load angle increases, more cracking is seen farther away from the step at larger values of  $x$  (shown by "2A" in Figure 27). However, not nearly so many cracks develop on the edges of the case 2 specimens as did for cases 1 and 4. When viewing the positive edge of a case 2 specimen, only 2 or 3 cracks are seen before failure, compared with over a dozen cracks in the case 1 and 4 tests.

At approximately the same load,  $0^\circ$  fiber fractures are often observed ahead of the  $45^\circ$  ply crack nearest the corner (shown by "2B" in Figure 27). In some cases this crack even turns and begins to propagate stably in the  $-x$  direction along the  $45/0$  interface (Figure 28b).

3.  $\{M = M_{fp}\}$  At this load level, the specimen fails catastrophically. However, the final fracture location is not always predictable when viewing the positive edge. For example, even though the location of the final fracture appeared to be quite obvious for the specimen shown in the previous two figures, the actual place where the specimen failed did not even contain a crack before it peeled apart (Figure 28c).

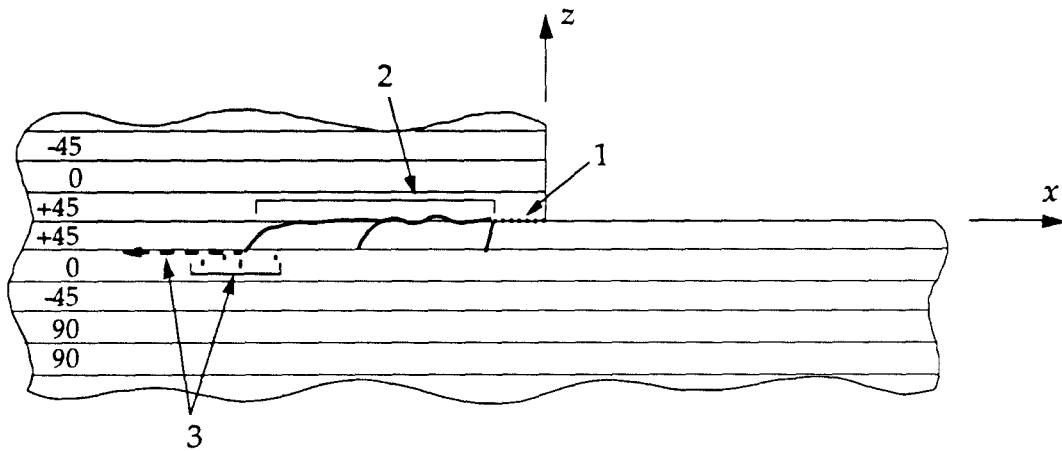
Figure 29. Damage development on the negative edge.

1.  $\{M \approx 70\% \text{ of } M_{fn}\}$  The first damage to appear on this edge is a crack on the 45/45 interface. This crack originates from the corner and travels in the -x direction. Unlike case 1 and 4 tests, the delamination here does not usually occur after the appearance of a crack in the 45° ply. The significance of this

point will be discussed later when delamination initiation mechanisms are considered. It should also be noted that in one of the case 2 specimens tested, a significant amount of damage noise was heard before the interface crack appeared on the negative edge. This observation indicates that damage initiation occurred in the interior of this specimen.

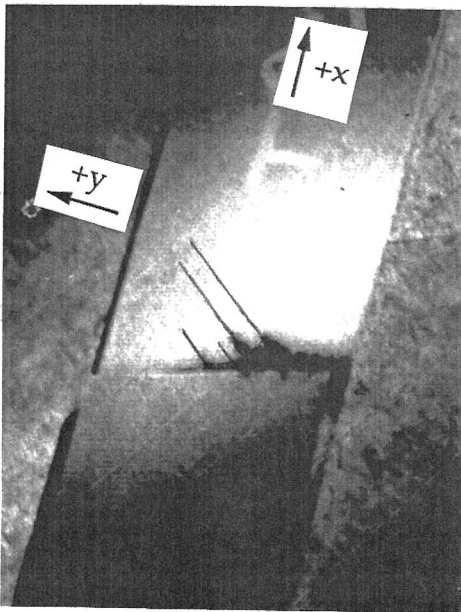
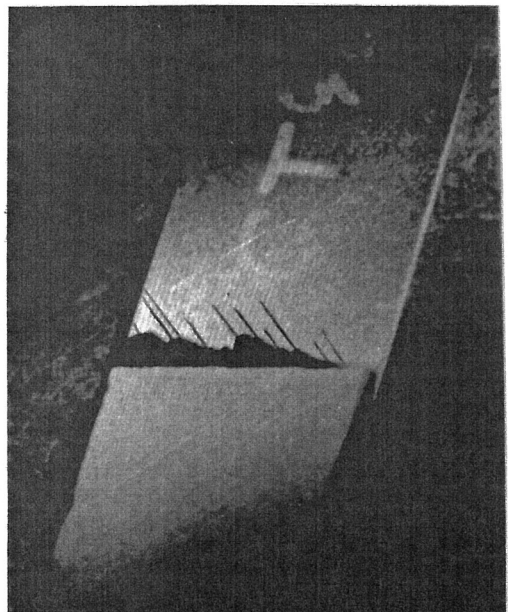
Figure 32.<sup>en</sup> Penetrant-dye inspection of the plate face. (a) prior to catastrophic failure. (b) after catastrophic failure.

Several of the case 2 specimens were inspected post-mortem using penetrant dye.<sup>†</sup> The dye was applied to the top face of the plate near the step to learn more about the development of cracking in the 45° plate interface ply. The results of this inspection clearly showed that the cracks were scattered across the width of the specimen near the step. By comparing the cracks in a specimen that was not tested to catastrophic failure (Figure 32a) to one which had failed (Figure 32b), one can see that the cracks become more numerous as the test progresses. Also, inspection of one specimen which was tested only to

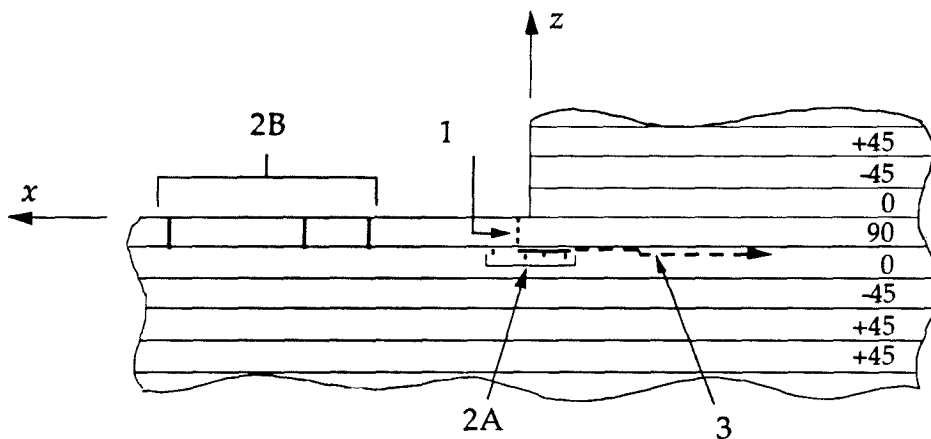
Figure 33. Damage development on the positive edge.

1.  $\{M \approx 45\% \text{ of } M_{fp}\}$  As in the case 1 and 4 tests, the damage process begins with a crack in the  $90^\circ$  ply near the step. However, for this lay-up the crack tends to be located closer to the corner (on average, about  $\frac{1}{4}$  of a ply thickness from the corner).
2.  $\{M \approx 95\% \text{ of } M_{fp}\}$  At sufficiently high local loading, the corner crack turns in the  $-x$  direction and propagates stably along the interface. As this happens, several fractures appear in the nearby  $0^\circ$  fibers ("2A" in Figure 33).

At approximately the same loading, additional cracking develops in the plate interface ply at larger values of  $x$  ("2B" in Figure 33). However, at no point in the test do these cracks appear more severe than the damage by the corner.
