Dynamic Characteristics of Woodframe Buildings

Thesis by

Vanessa Sabrina Camelo

Doctor of Philosophy

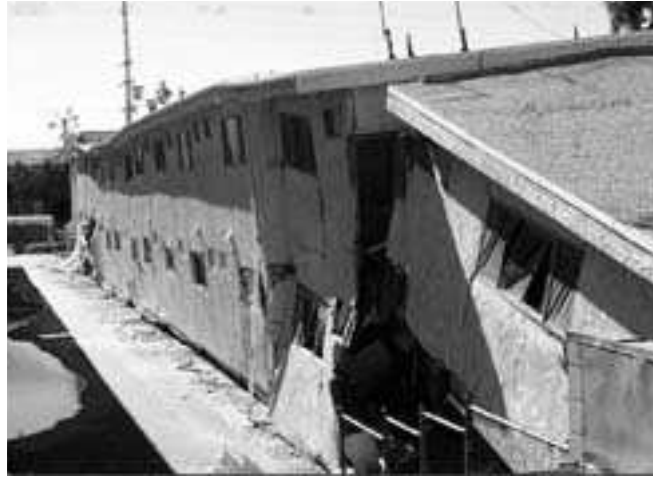
Figure 1.1: Northridge Apartments (collapse of 1st floor garage)

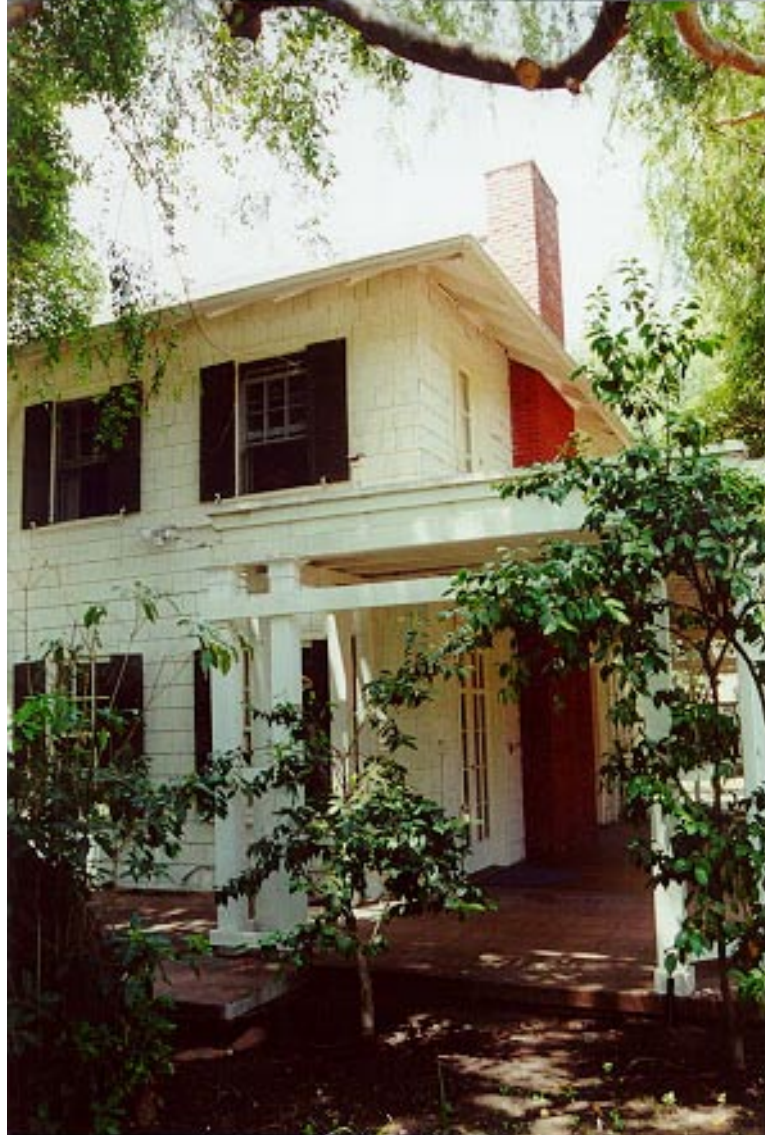
Figure 4.4: 2-Story House on S. Catalina Ave., Pasadena

This building was shaken successfully using the Harvey Mudd shaker. The equipment was setup at the second floor level, placing the shaker at the top of the main stairway over a sheet of plywood and wedged between planks of wood, which were then screwed into the plywood below (see Figure 4.5). The intent was to avoid any damage to the carpeting beneath, so the assembly could not be bolted to the floor. Instead, the shaker assembly was fixed between the landing walls by squeezing it into place, in order to provide maximum shear transfer to the building. Six seismometers and ten accelerometers were located as shown in Figures 4.6 and 4.7, respectively.

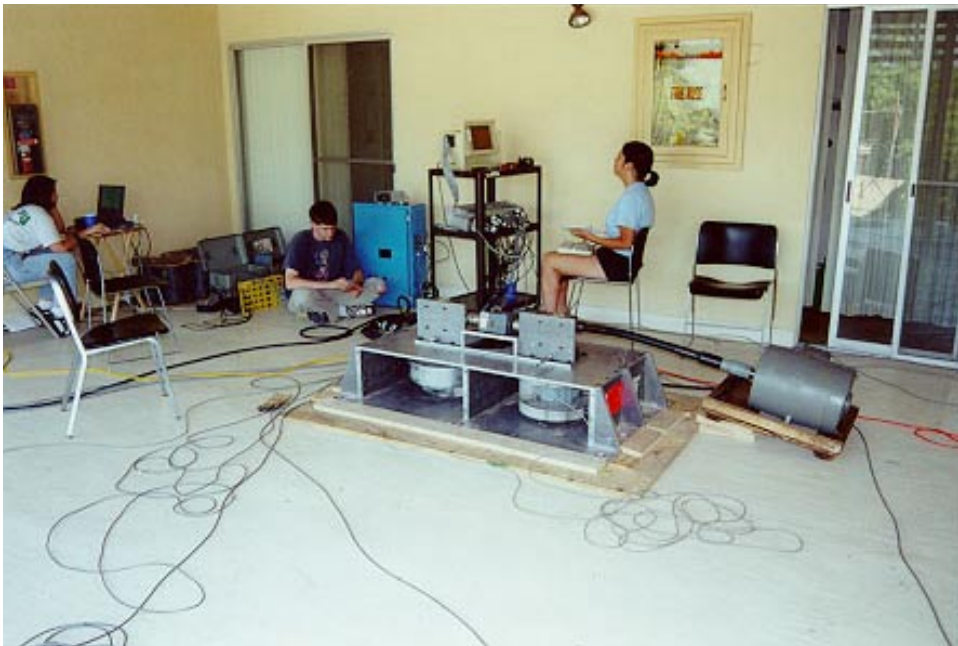
Figure 4.15: Experimental Setup

This building was shaken successfully using the Harvey Mudd shaker, which was placed at the third floor over a sheet of plywood and wedged between wood planks which were secured to the floor deck below using nails and screws. See Figure 4.15 for a picture of the experimental setup and Figure 4.16 for the seismometer locations.

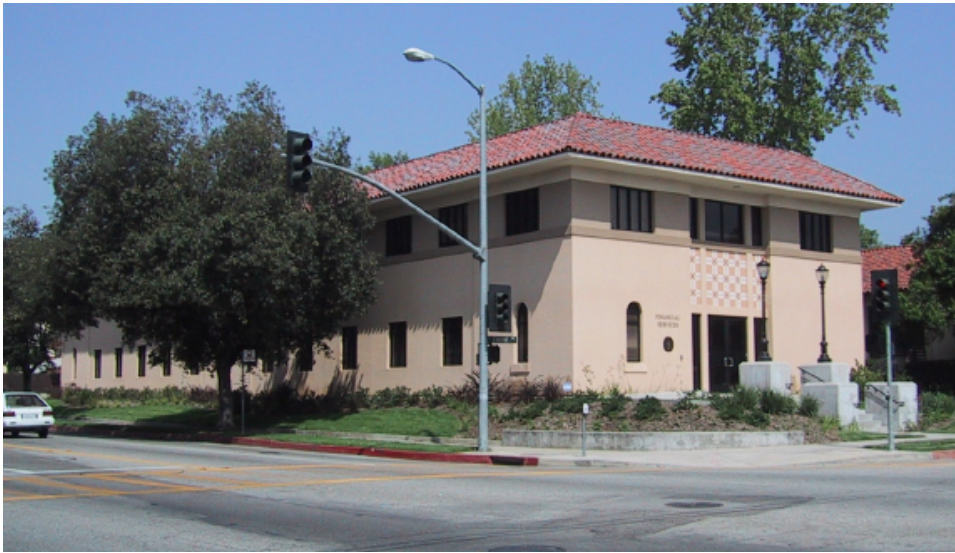
Figure 4.22: 2-Story Office Building on S. Chester Ave., Pasadena

This building is owned by the California Institute of Technology and is located near the campus (see Figure 4.22). It was under construction at the time of the testing, with all plywood sheathing, asphalt and tile roofing, and concrete flooring in place, but no interior or exterior finishes (no drywall or stucco at time of testing). This is a rectangular building with steel ridge beam and center columns, and a small steel moment frame supporting the east end of the ridge beam due to window openings. There are no interior shear walls (all interior walls are drywall partitions on metal studs). The first floor plan area is approximately 5600 square feet (140'x40').

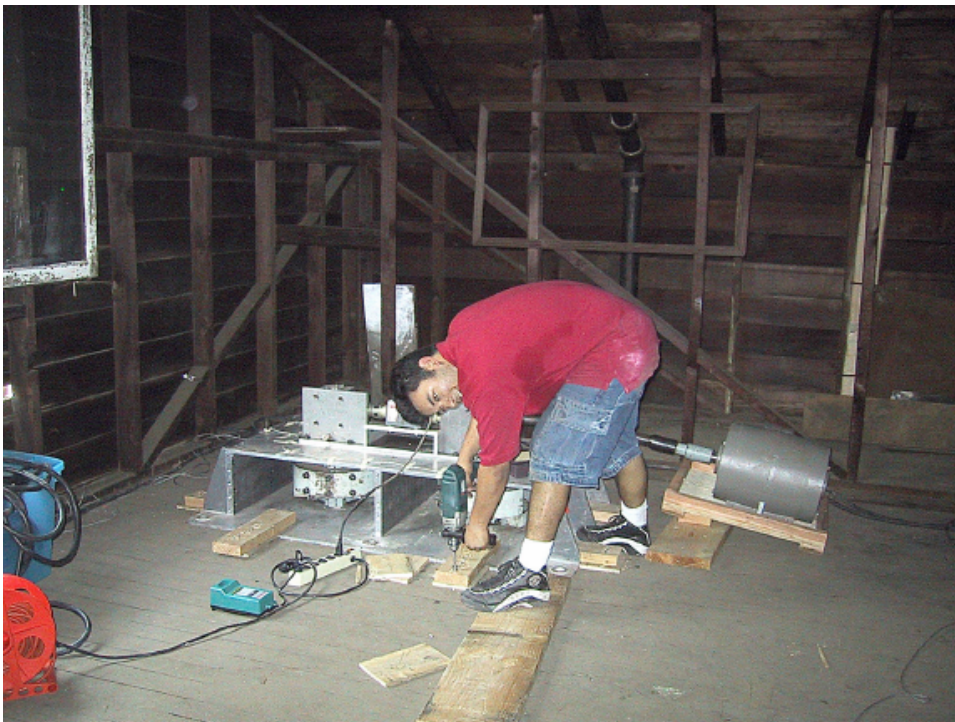
Figure 4.28: Experimental Setup

The shaker and all accelerometers were placed at the second floor. This building was shaken using the Harvey Mudd shaker, which was bolted to the floor diaphragm using tension rods. Screws then were driven through the planks, the plywood and the floor deck below to secure the shaker assembly. The building response was recorded using seven accelerometers belonging to Harvey Mudd College, since the stronger shaking of this building were causing the Ranger seismometer signals to be clipped. See Figure 4.27 for the accelerometer locations and Figure 4.28 for a picture of the experimental setup.

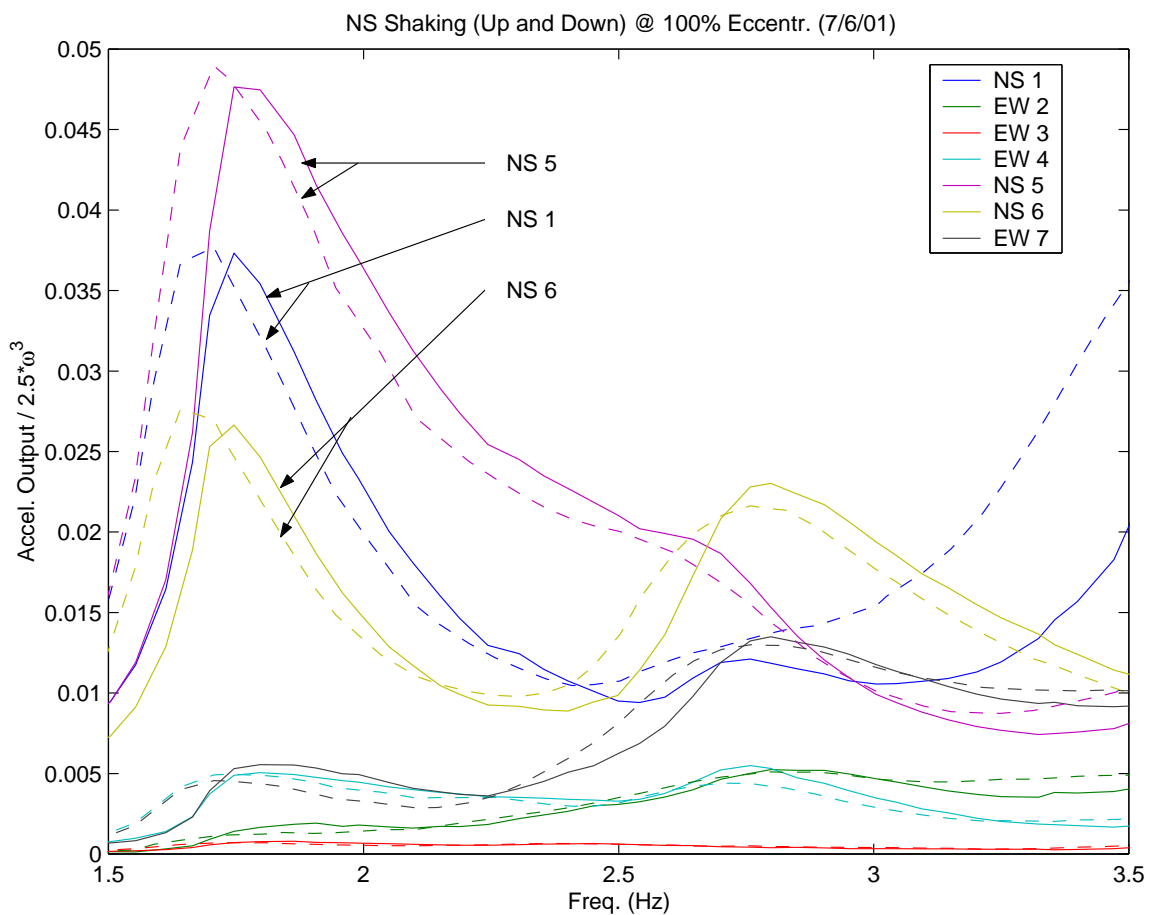
Figure 4.29: Forward and Backward Frequency Sweep

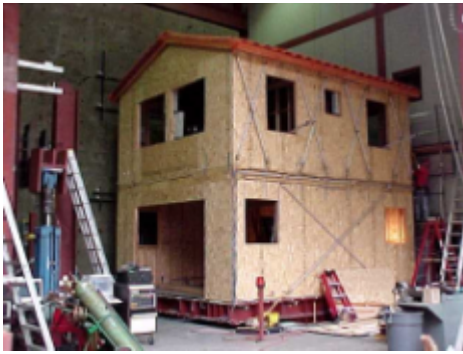
Figure 5.1: Phase 9

levels 1, 2, 3, 3r, 4 and 5 for Phase 9 testing (no stucco, see Figure 5.1), and at levels 1, 2, 3, 4, 4r, 5 and 5r for Phase 10 testing (exterior stucco, see Figure 5.2). Channels D1, D2, D3 (NS), E1 and E3 (EW) were taken as input in the MODE-ID analysis (see Appendix D, Figures D.1 through D.10 for the acceleration time-histories recorded at the shake-table level). The output channels selected were D9, D11, D13 in NS direction and E4, E6 in EW direction at 2nd floor, and D14, D16, D18 in NS direction and E7, E9 in EW direction at roof. See Figure 5.3 for channel locations.

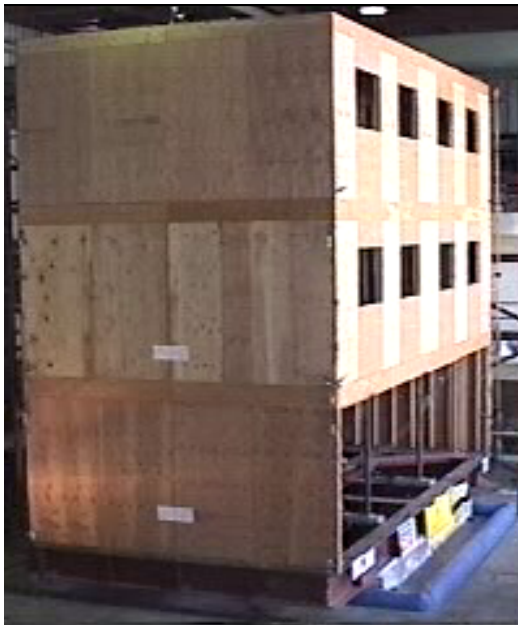
Figure 5.11: Phase I

A 3-story woodframe building with tuck-under parking was tested under Task 1.1.2 of the CUREE-Caltech Woodframe Project. The test specimen was full-scale with respect to height, but the shake-table limited the building dimensions to 16'x32'. The prototype was shake-table tested during three main phases of construction: Phase I - no wall finish materials, no retrofit scheme (see Figure 5.11); Phase II - wall finishes installed, retrofitted structure; Phase III - wall finishes installed, no retrofit scheme (see Figure 5.12). For complete testing details, see Mosalam et al., 2002.

The Phase I structure had no wall finish, only the exterior wall sheathing was in place (see Figure 5.11). To avoid damaging the building, the forced vibration tests were performed with shaker weights restricted to 5%, 10%, 15%, and 20% eccentricity before the Phase I shake-table tests. After the shake-table tests, the building was also shaken at 50% and 100% eccentricity. The building response was recorded for harmonic shaking between 1.5Hz and 5.5Hz, at 0.1Hz increments, in each direction. Each recording was taken for 5 seconds at 1000 samples per second.

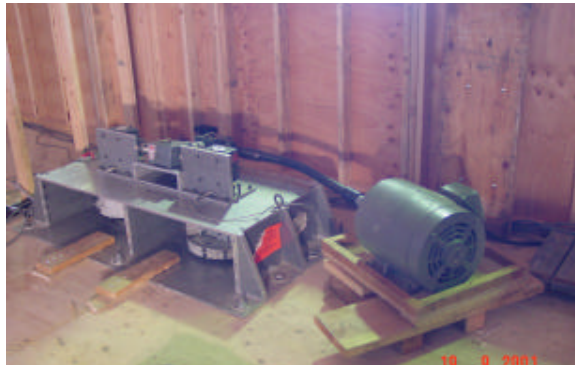
Figure 5.13: Shaker Setup (third floor)

The Harvey Mudd shaker was installed at the third floor of the structure, where it remained throughout all the phases of shake-table testing. The shaker was fastened to the floor diaphragm using tension rods (see Figures 5.13 and 5.14), and the remaining equipment (motor, controller) was secured during the shake-table tests using metal straps. The building response was recorded using two FBA-11 accelerometers at the roof, six FBA-11 accelerometers at the third floor, and six Ranger seismometers at the second floor. Because stronger shaking of the building caused clipping of the seismometer signals, only the accelerometer data (channels 1 through 8) were used to obtain the frequencies and dampings of the structure. See Figure 5.15 for the instrument locations.

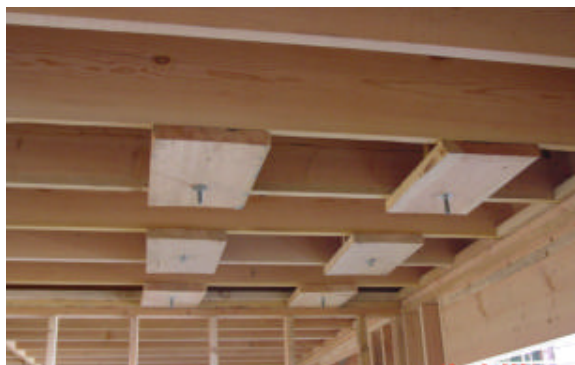
Figure 5.14: Shaker Setup (view of second floor ceiling)

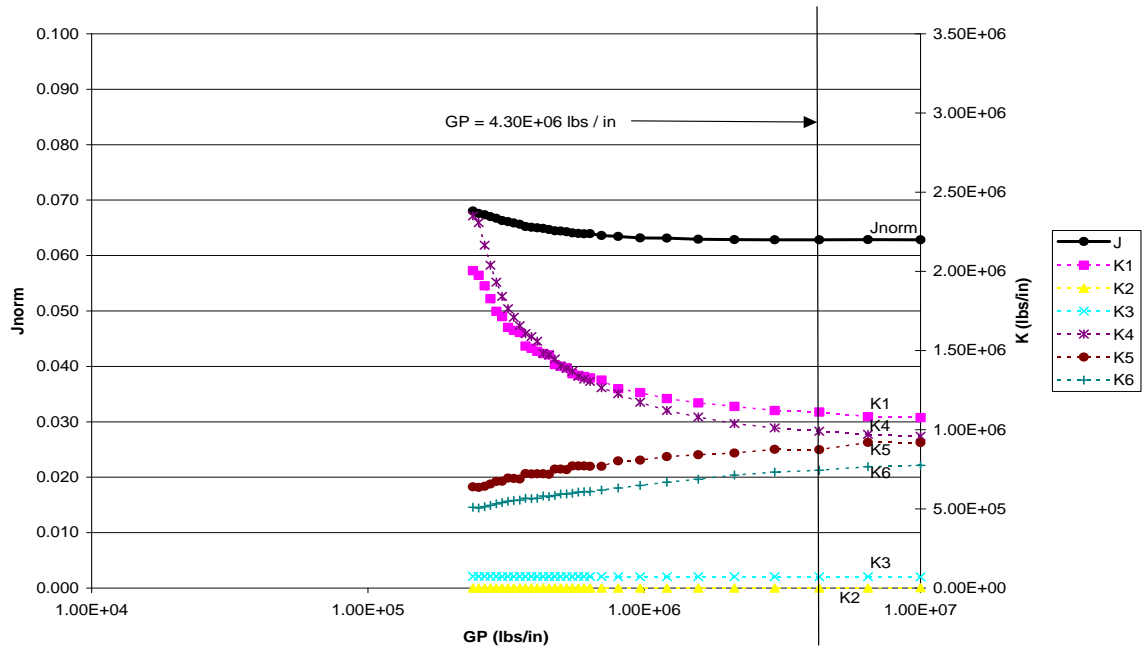
Figure 5.21: Model Sensitivity to Diaphragm Stiffness (after repeated shaking)

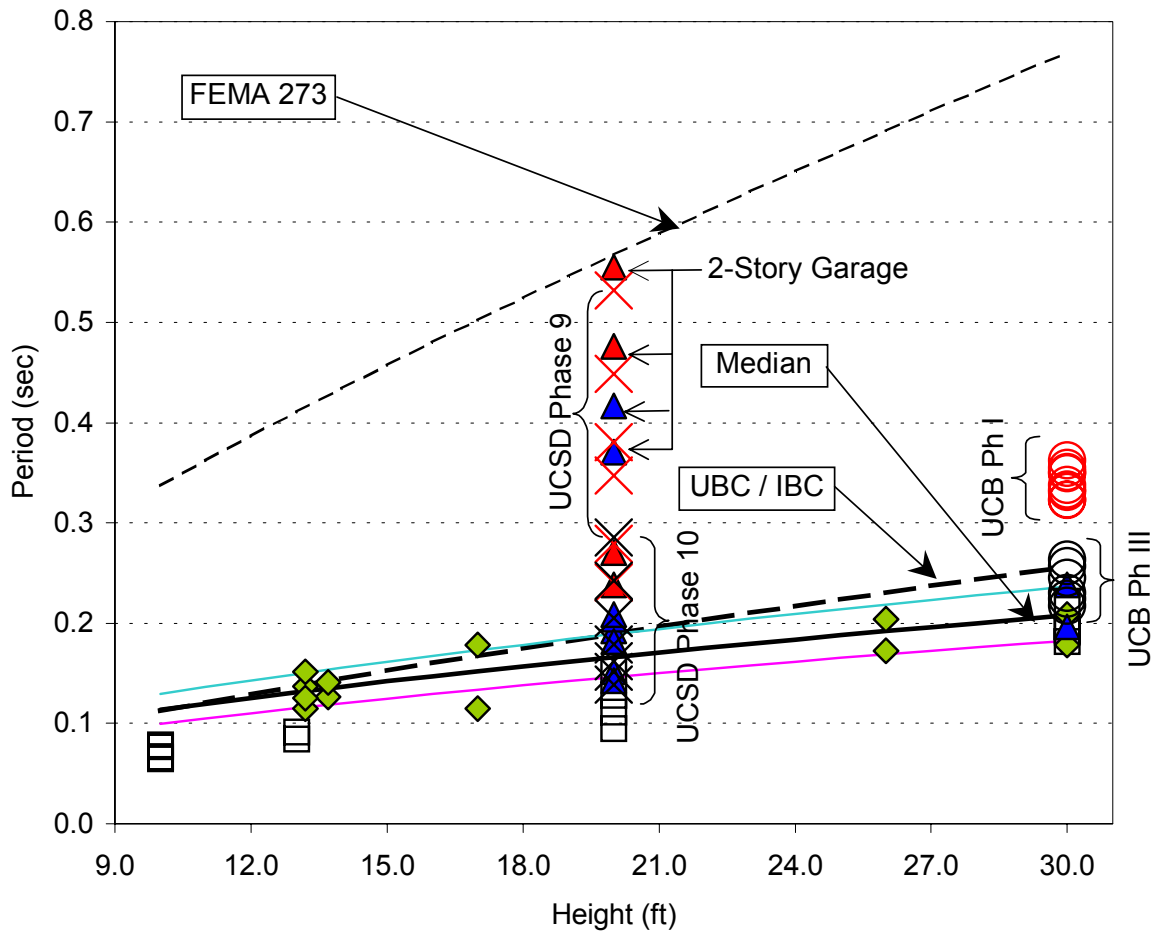
Figure 6.1: Period as a Function of Building Height

a reasonable approximation to the periods of the woodframe buildings examined throughout this project. It must be noted that these periods are for low amplitude of shaking only (drifts less than 0.1%) and also for structures with stiff wall finish materials such as drywall, plaster, stucco, or some combination. The periods for structures under strong shaking or for buildings without wall finish materials would be considerably longer than what is predicted using the UBC-97 formula or the formula found by regression analysis, as seen by the dramatic elongation of the periods of the unfinished shake-table structures at UC San Diego and UC Berkeley as shaking amplitude increased. It should also be noted that the periods given by the FEMA-273 simplified formula (Equation 2.6) are much too high and would underestimate the force demand in the structure. Even though the UBC-97 formula is for low amplitude of shaking, it provides a reasonably conservative estimate of the building period for design purposes, placing most woodframe buildings in the plateau region of the UBC design response spectrum, although these periods may underestimate the drift demand on these structures during stronger shaking.
