AN INVESTIGATION OF THE EFFECTS

WEIGHT GEOMETRY AND TIME

REPEATED TENSION IMPACT TESTING

In Partial Fulfillment of
The Requirements for the Professional
Degree of Aeronautical Engineer

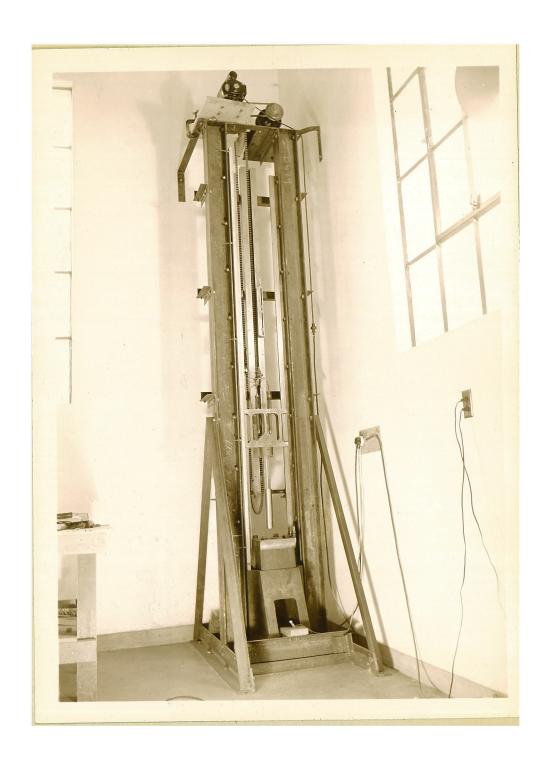
Fig. 1 Falling Carriage Tension Impact Machine

This investigation is one of a series of coordinated projects in the field of repeated tension impact using the GALCIT falling-carriage testing machine. Essentially this machine consists of a falling carriage which moves on vertical guides above a heavy anvil. The upper end of a specimen is screwed into the carriage and to the lower end is screwed a weight of the desired mass. In the anvil, under the center of the carriage, is a hole through which the weight and specimen may pass. The carriage, specimen and weight are raised to the desired height, then released. The carriage falls along the guides until it is stopped abruptly by the anvil. The weight, however, continues on through the hole in the anvil and therefore exerts a dynamic tensile force on the specimen. A photograph of the machine is shown in Fig. 1, and a complete description is given in reference 2 by Beardsley and Coates, who designed the equipment.

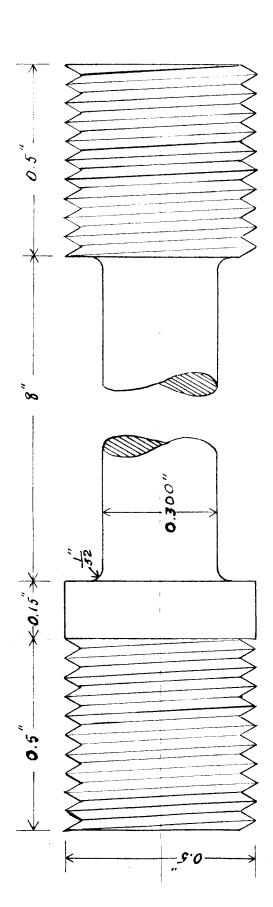
F16.2

The specimens used were machined from standard bar stock of 17ST, 24ST, and 2S aluminum alloys. All specimens were eight inches long, between the shoulders, and were polished to remove machining marks. The two types of specimens used differed only in the fillet radius and the collar at the weight end. The dimensions and details of manufacture of both types are given in Figs. 2 and 3.

Actually, the average elongation of all specimens having a 1/32 inch fillet radius was 4.35 percent whereas the average elongation of all specimens having a 1/4 inch fillet radius was 11.70 percent. Fracture of all except one specimen with the 1/32 inch fillet radius occurred in the fillet, while for the specimen with the 1/4 inch fillet radius the breaks were well scattered throughout the specimen length and only one of them occurred in the fillet. This fact is shown in photographs presented as Figs. 10 to 14.

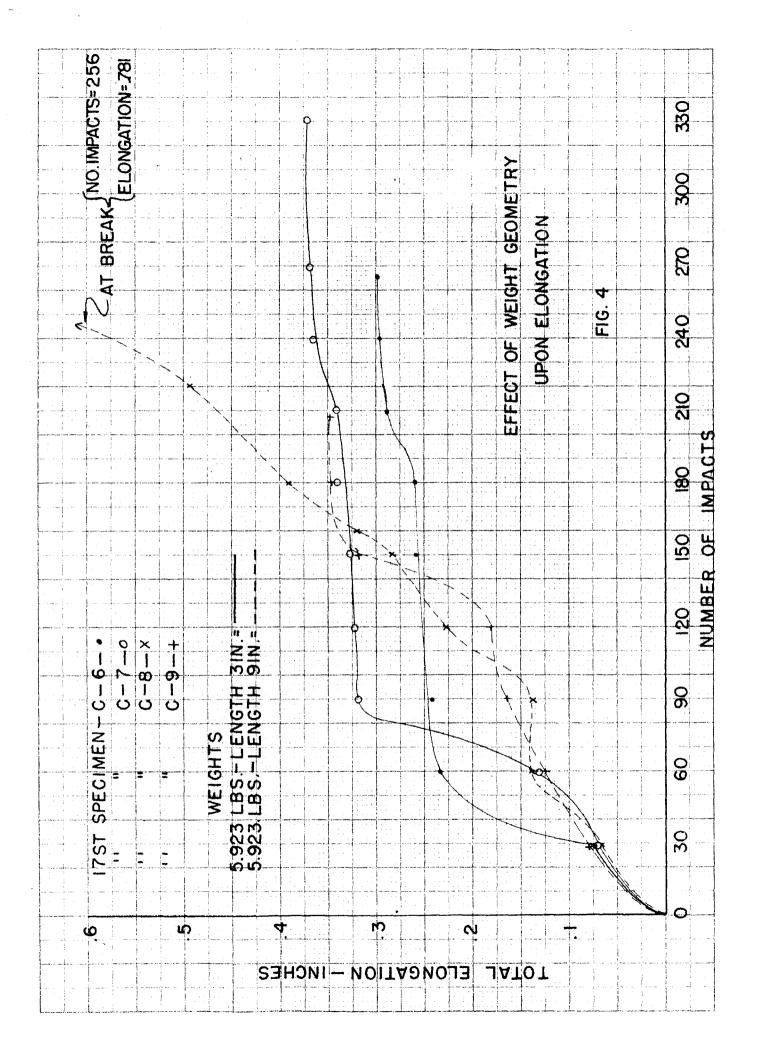
To investigate the effect of weight geometry, four specimens were subjected to impacts until fracture occurred using a height of fall of thirty-three inches. The three inch weight was used on specimens C-6 and C-7 and the nine inch weight was used on specimens C-3 and C-9. The elongation was measured after each thirty impacts. A graph of total elongation versus number of impacts for these four specimens is shown in Fig. 4. These curves show somewhat different

patterns for the three inch weight than for the nine inch weight in that most of the elongation occurs after a larger number of impacts for the longer weight. The study of the influence of weight geometry was continued in succeeding tests.

Two other features of these curves were noted. First, specimens C-6, C-7, and C-9 fractured in the fillet, with an average elongation at break of 0.341 inches, but specimen C-8, which did not break in the fillet, showed an elongation of 0.731 inch at fracture. A review of previous tests on similar specimens showed that nearly all the fractures had been in the fillet. Therefore, the C-type specimen was altered in that the fillet radius was changed from 1/32 inch to 1/4 inch, and a collar was added to the weight end to facilitate marking and the measuring of the elongation. The twenty-two succeeding specimens were of this altered design, and only one of them failed in the fillet.

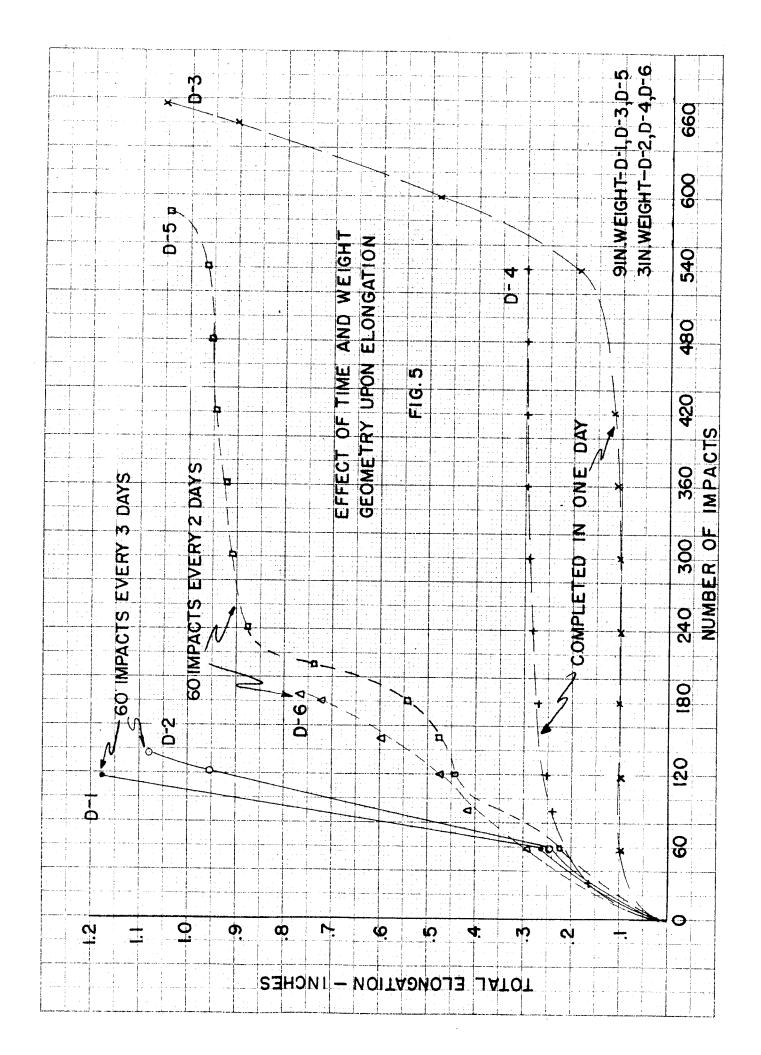
The results of these tests are shown as a plot of elongation versus number of impacts in Fig. 5. This graph indicated that the time interval between each series of siety impacts apparently had a major effect upon the impact properties of the material. It was therefore proposed to conduct similar tests to reproduce these results, using specimens made from 175-T, 245-T, and 25 stock.

Fig. 5 shows an apparent effect of elapsed time upon the impact properties of 178-T duralumin, while Fig. 9 shows that there is no marked effect. A deduction was made that the effect shown in the former figure was due to varying velocities of impact. Nevertheless, it should be emphasized that it is not known definitely that the velocity did change during testing of the D-type specimen, nor that it was nearly constant during the testing of specimen E-9 to E-11. Therefore, it should not be definitely concluded that time has no effect until more accurate data is available. It is concluded, however, that no more investigations should be attempted with the Falling-Carriage Repeated Impact Machine until an accurate method of measuring the velocity of impact is made an integral part of the testing apparatus so that there will be no doubt about the impact velocity. It is also necessary that, for a set height of fall, the velocity of impact be constant as well as accurately measured. Suggestions for alteration of the machine and for design of velocity measuring equipment to obtain these two ends are given in Appendix A.

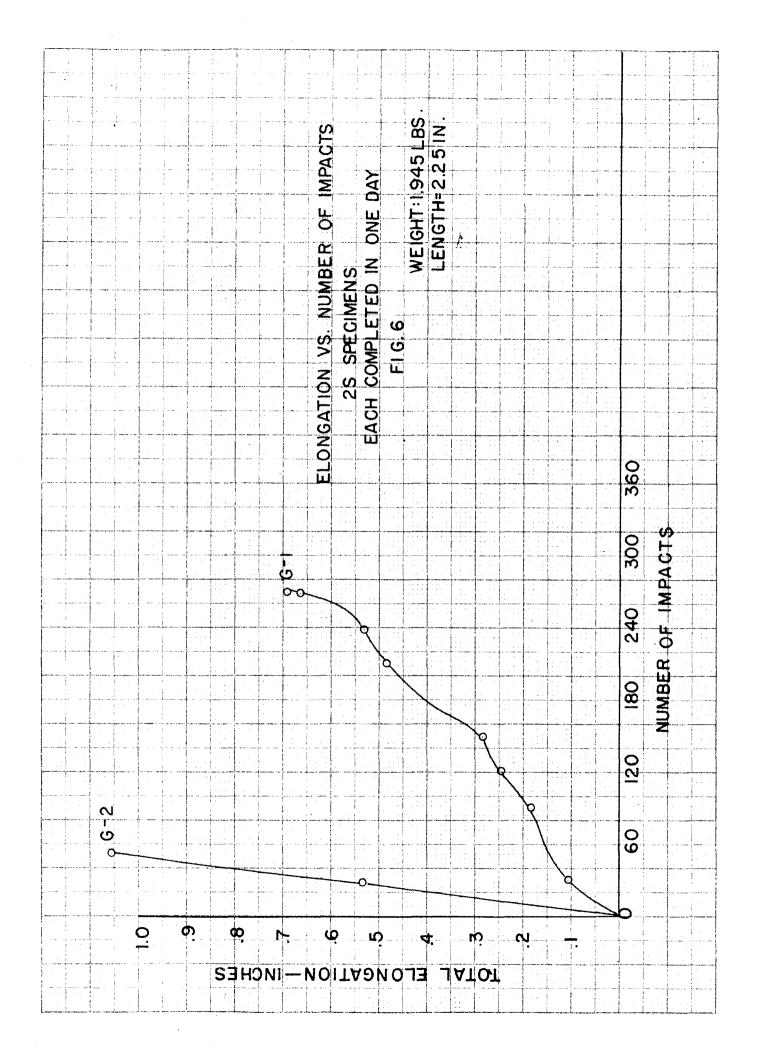
Testing of each of these specimens was completed in one day, but they were tested on two different days, six days apart. The data are plotted in Fig. 6 which shows that the results for the two specimens are widely different, although the conditions of the test were supposedly

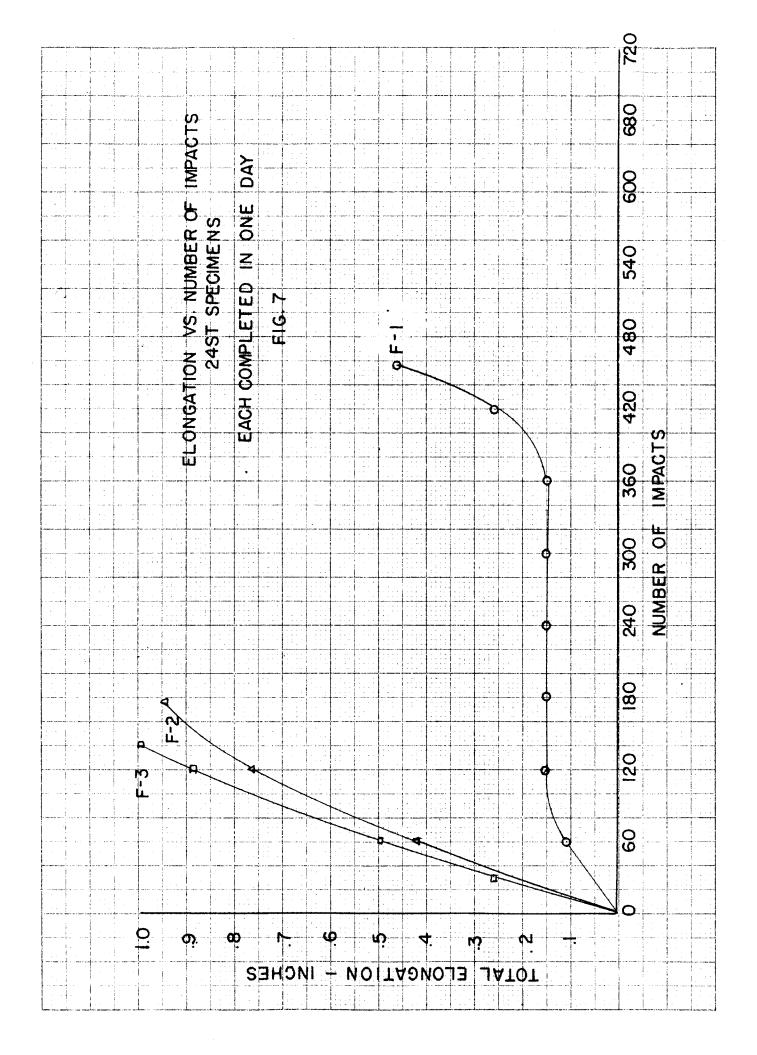
the same. Specimens made from 24S-T stock were designated type F, and numbers F=1, F=2, and F=3 were then tested to fracture, each being completed in one day. A graph of elongation versus number of impacts for these specimens is shown in Fig. 7, and again the curves are inconsistent for no apparent reason. It appeared that some unaccounted for parameter was of major importance.

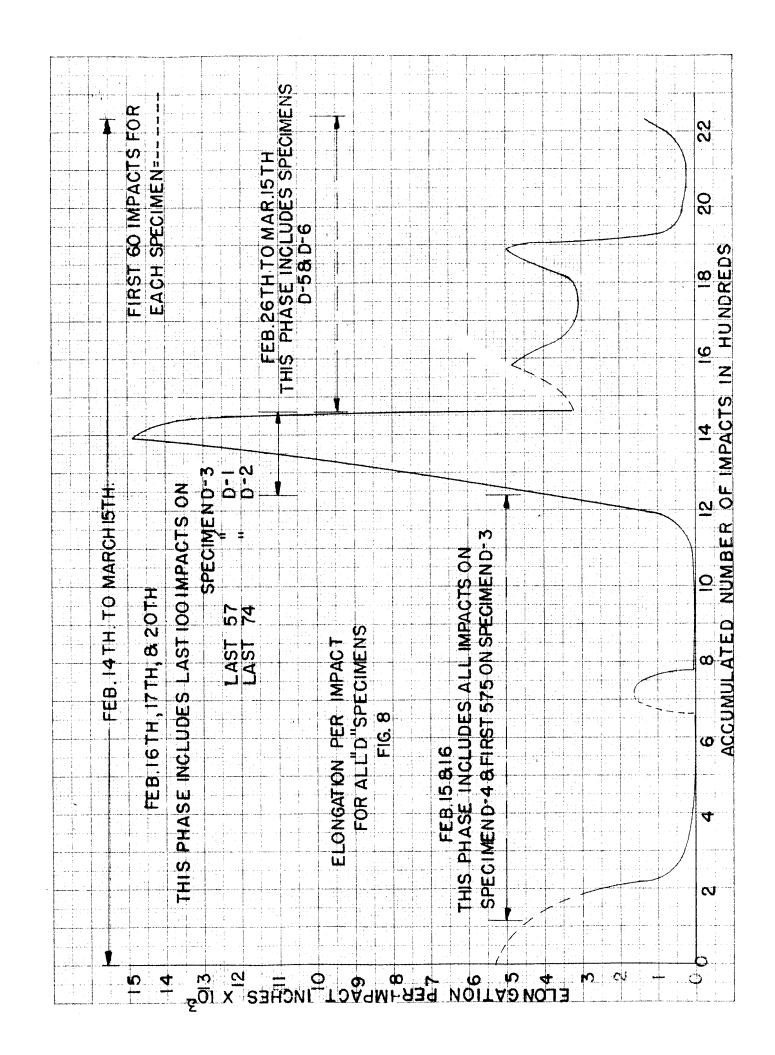
In attempting to explain this very erratic behavior a study was made of all tests made to date. The only logical conclusion which could be reached was that the velocity of the carriage had not been constant. In order to produce the results shown in Fig. 5 it was necessary that the velocity not only had changed, but that it had changed at just the proper time and in the right amount for all six of the D-type specimens. This was necessary in order to produce three sets of two specimens each in which the slope of each pair of specimens was about the same but changed by large amounts from one set to the other. This conclusion, that the velocity had varied in this unfortunate manner, which conclusion is still not definitely proved, is accepted tentatively because of an inability to explain the results obtained in any other manner. An attempt to show how this conclusion was reached is given in Fig. 8.

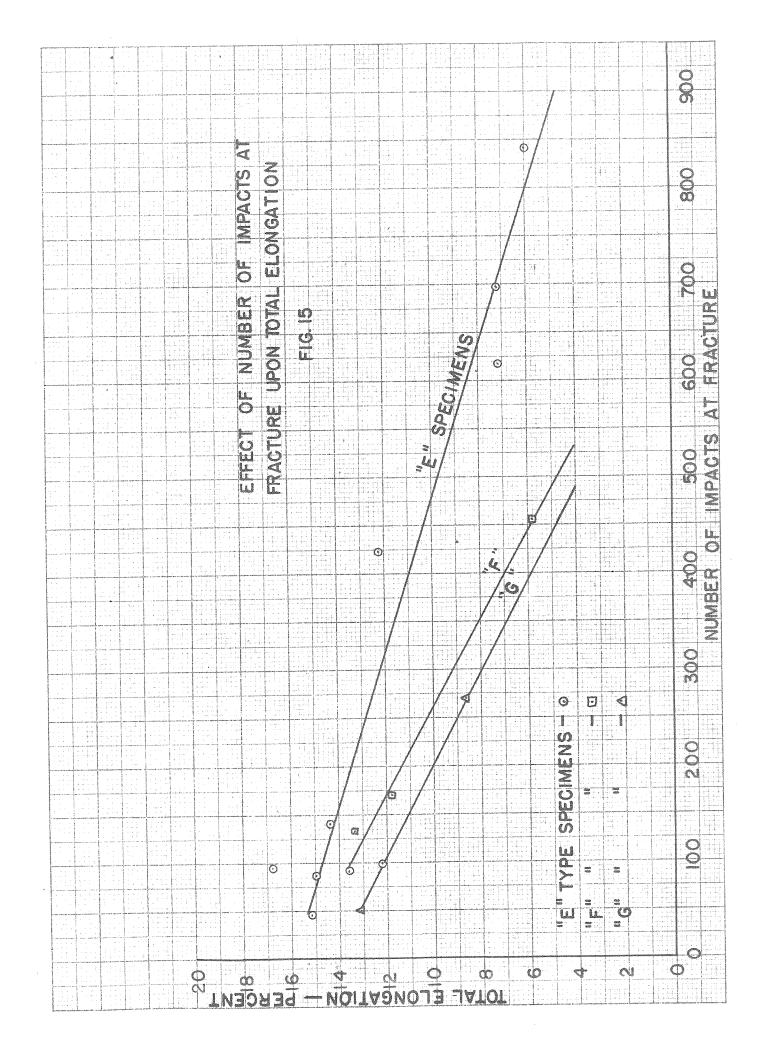
then it would be expected that the elengation at fracture would decrease in proportion. This is shown to be true for specimens of types E, F, and G in Fig. 15. The points forming these curves have considerable scatter, and the points for the D-type specimen cannot be correlated, but it is believed that if the velocity of the carriage had been both constant and accurately known that the curves would have been well defined and probably of the same slope. It is therefore concluded that the larger the number of impacts required to cause fracture, the less will be the total elengation at break.

- 4. 17S-T duralumin is much more susceptible to stress concentrations caused by changes in cross-section than to those caused by small scribe marks.
- 5. In tests of the type conducted, the elongation of the specimen at fracture is inversely proportional to the number of impacts required to produce fracture.

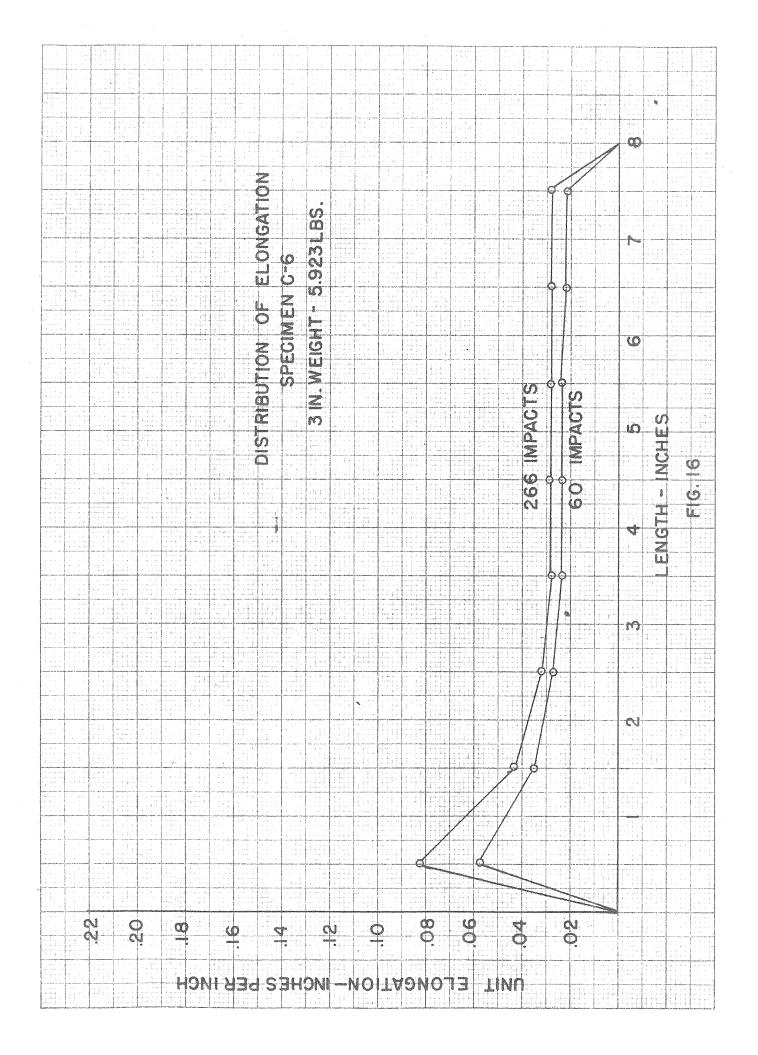
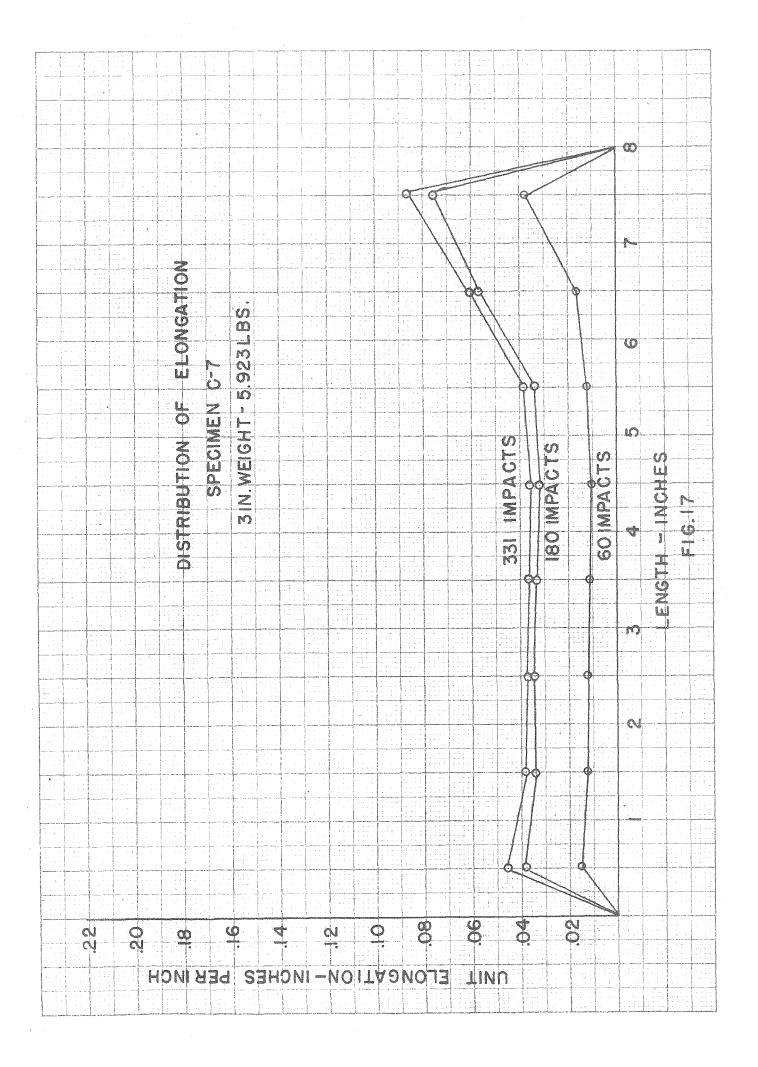
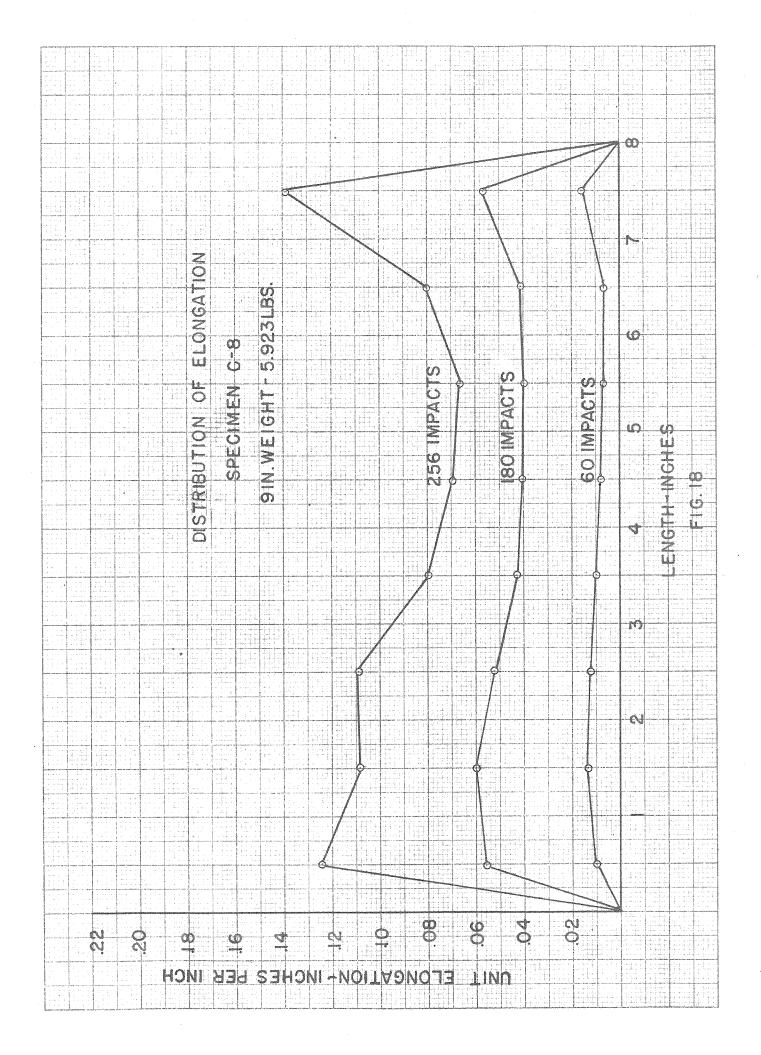
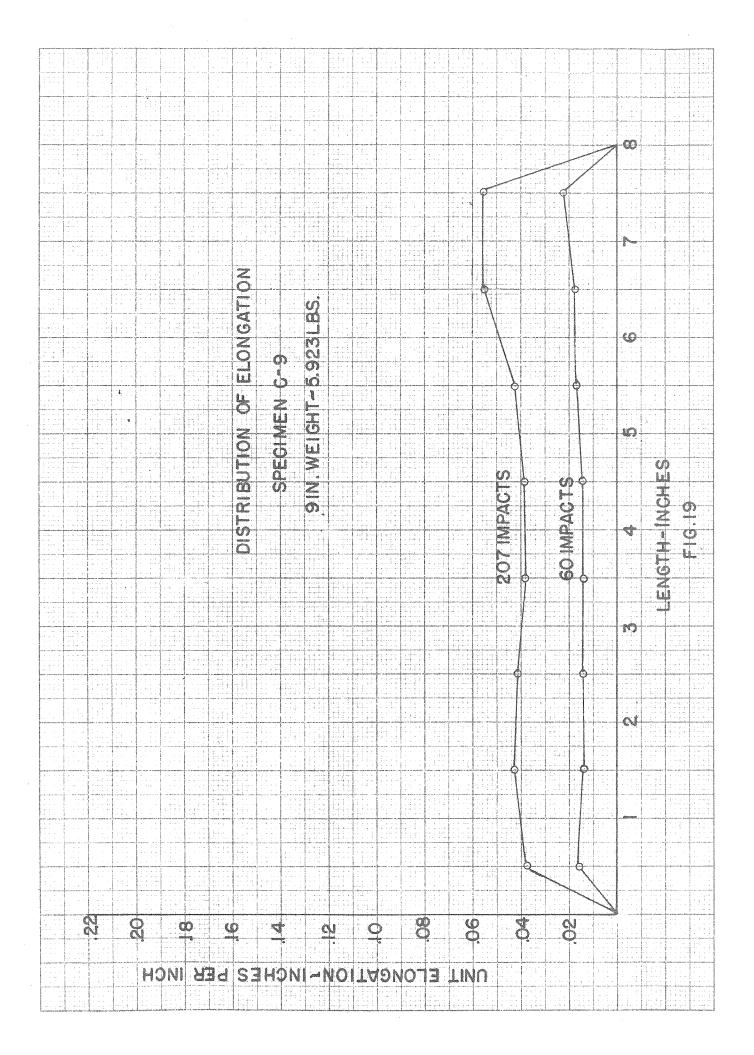
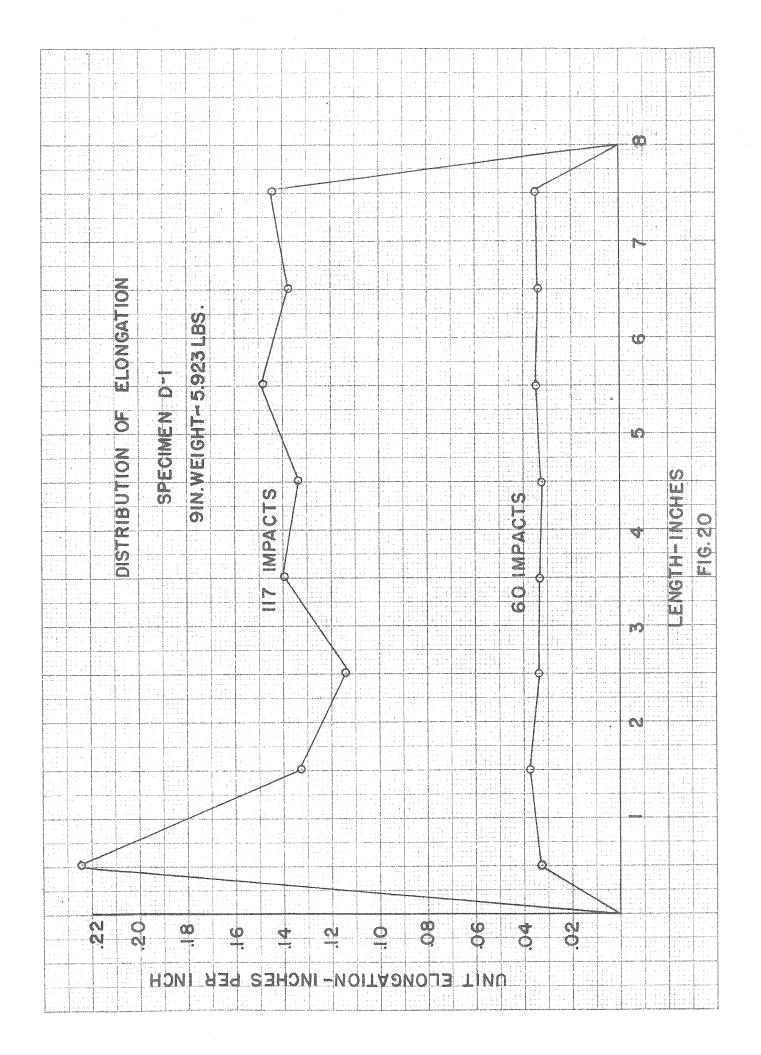
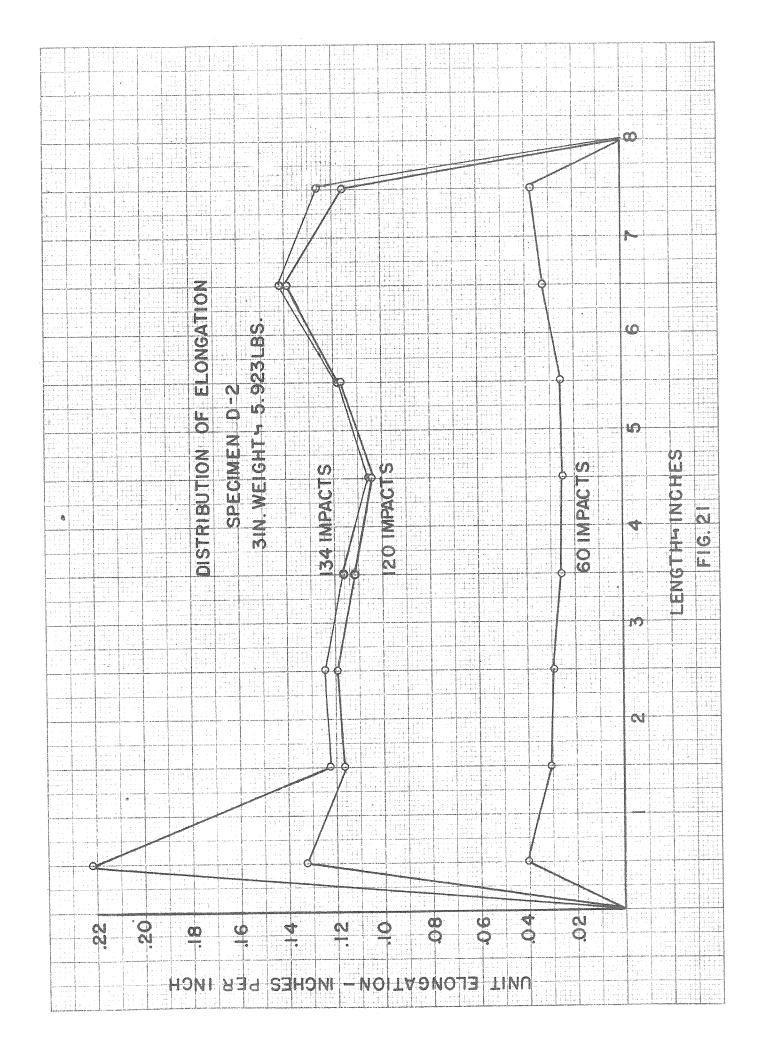
Figs. 16 to 25 inclusive are presented to show the distribution of elongation of typical specimen tested. This distribution is similar to that presented in reference 5 in that the greatest unit elongation occurs near the ends of the specimen. A close examination of these curves of distribution of elongation, of the specimen subjected to impact with the nine inch weight and those subjected to impact with the three inch weight, shows that the greater total elongation at break shown by all specimens subjected to impact with the nine inch

weight is a result of the greater unit elongation in the central portion of the specimen. It is believed that this is a result of the difference in the time of the reflection of the strain waves with the three inch and the nine inch weights.

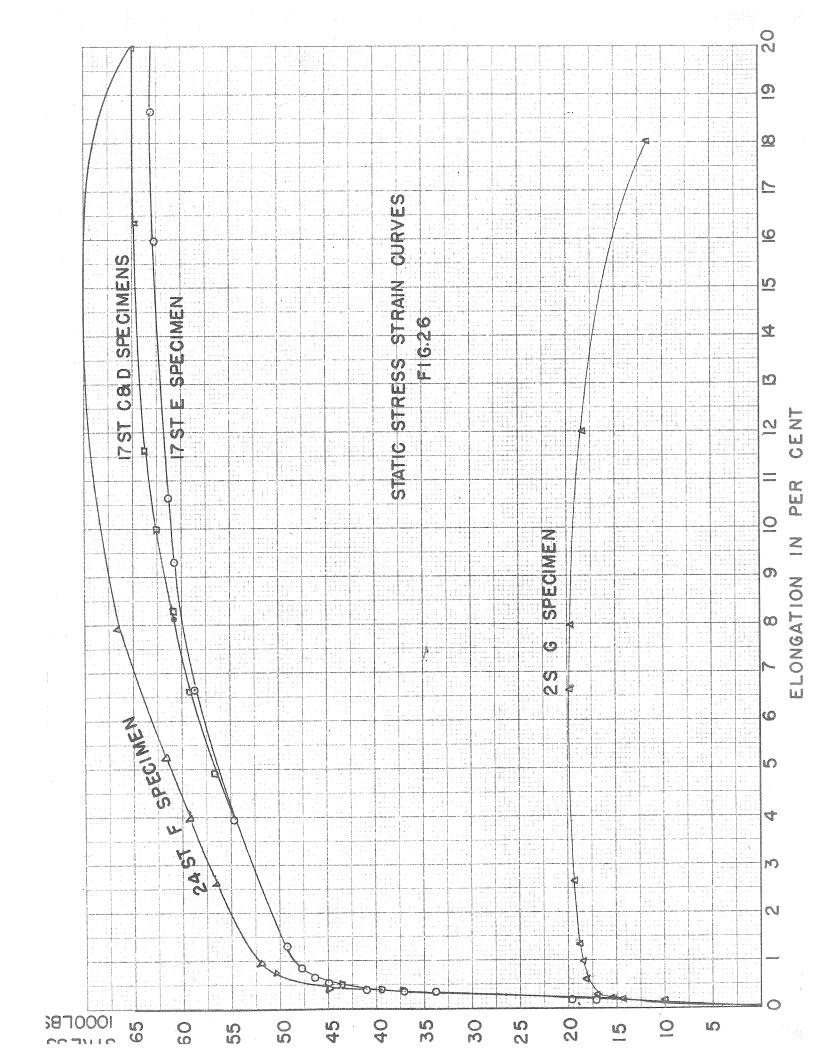
The static stress-strain characteristics of the materials used during the conduct of this investigation are shown in Fig. 25.

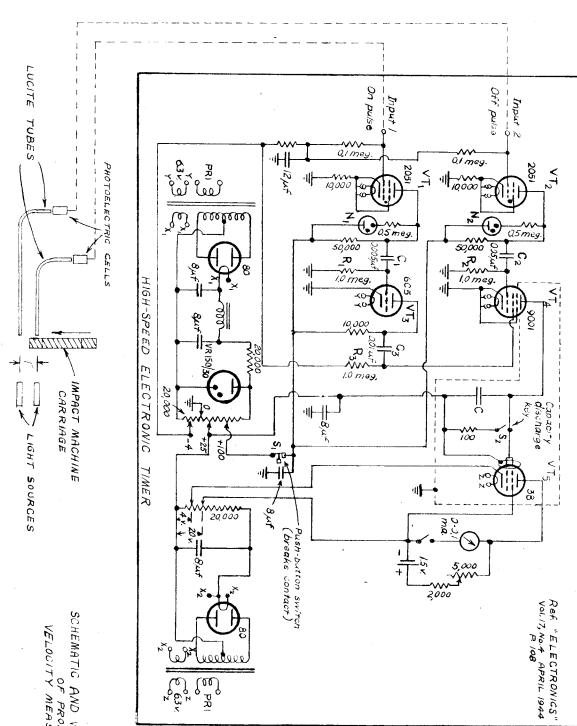
F1G. 27

SCHEMATIC AND WIRING DIAGRAM
OF PROPOSED
VELOCITY MEASURING DEVICE

It is considered mandatory that the installation of the velocity measuring equipment be completed before any additional investigation is made with the subject machine. A suggested system is shown in Fig. 27.
